# Condition Photo Documentation

Pagosa Springs Elementary School

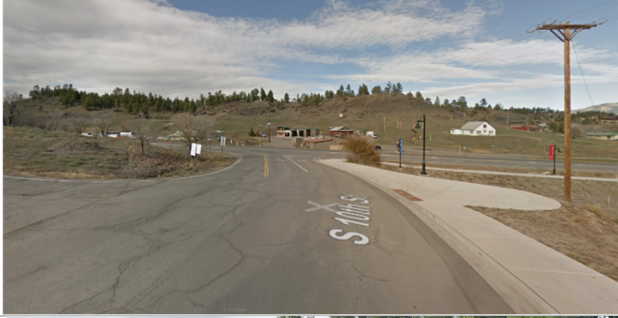
<p><i>There is a sidewalk opposite the ROW from the school site, however no crosswalks /sidewalk connections were observed.</i></p>
b

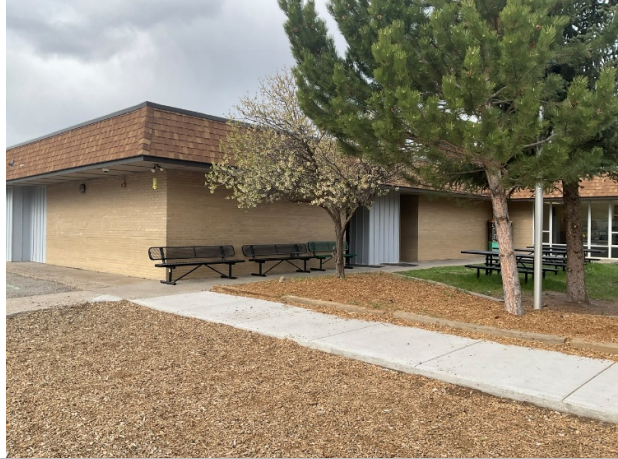
<p><i>The main entry / administration area is setback within a courtyard and natural surveillance is obstructed.</i></p>
c

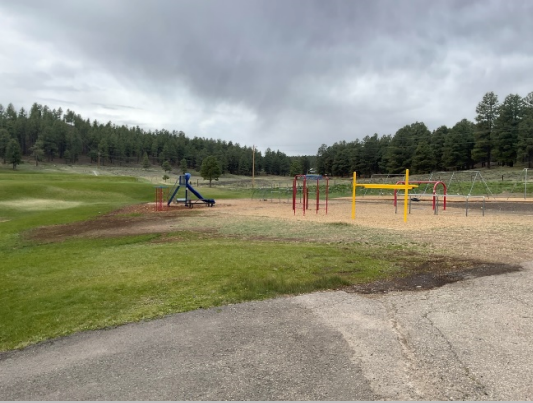
<p><i>-Shade was not observed in the play areas.</i></p> <p><i>-There are soft and hard surfaces in the play area. There was limited hard surface games and could be enhanced.</i></p>
c

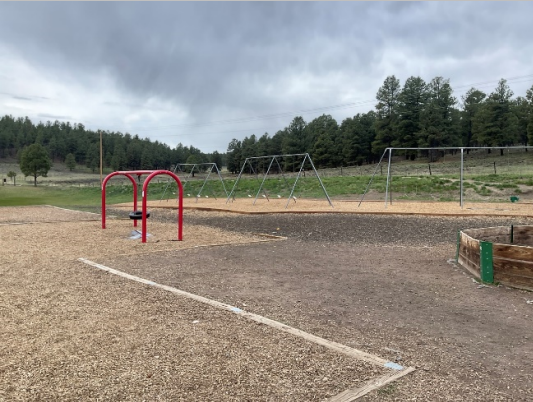
<p><i>Most play areas were observed to be accessible.</i></p>

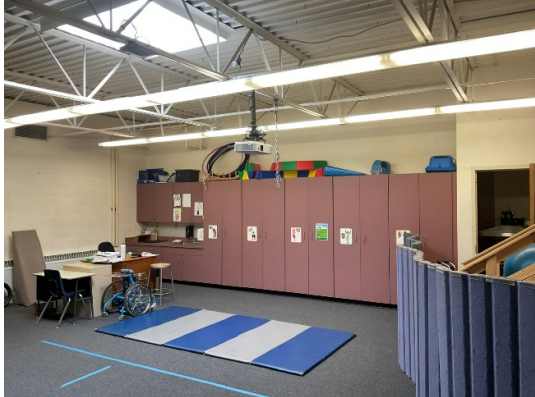
<p><i>There is a special ED classroom but not for severe needs.</i></p>
b

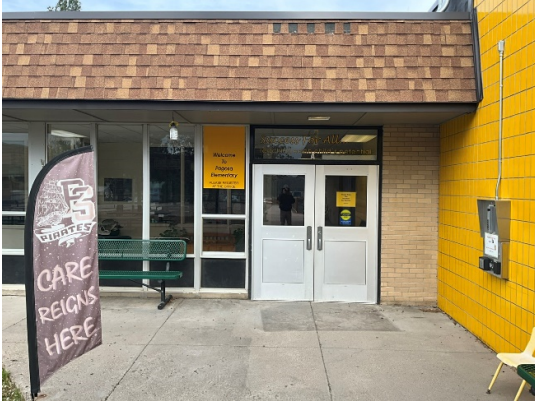
<p><i>There is electrified hardware at the main entry, but not a control vestibule.</i></p>
c

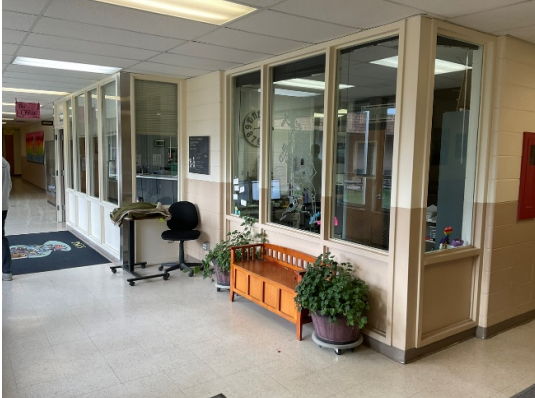
<p><i>-A secure vestibule does not exist. The administration/receptionist is buried within the building and does not have a line of sight to the main entry doors.</i></p> <p><i>-The nurse area is remote from office.</i></p>

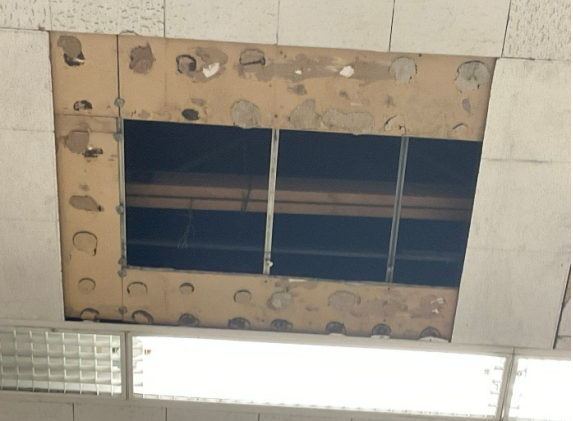
<p><i>Damage was observed in several areas on Interior ceilings and light fixtures.</i></p>
b

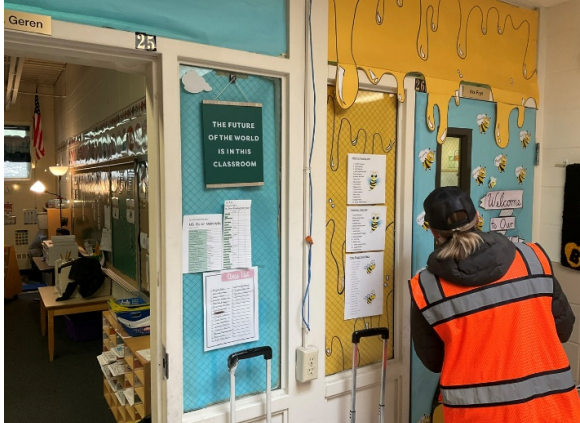
<p><i>There are opportunities for visual connections to the corridor, but the windows have been covered with blinds or paper.</i></p>
c

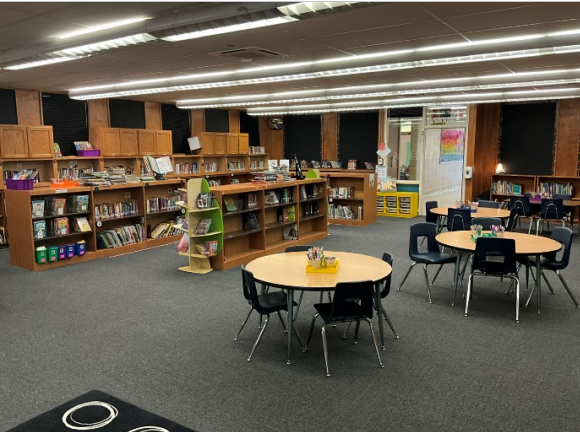
<p><i>The library and furniture are "traditional", fixed to the wall or difficult to move and reconfigure.</i></p>

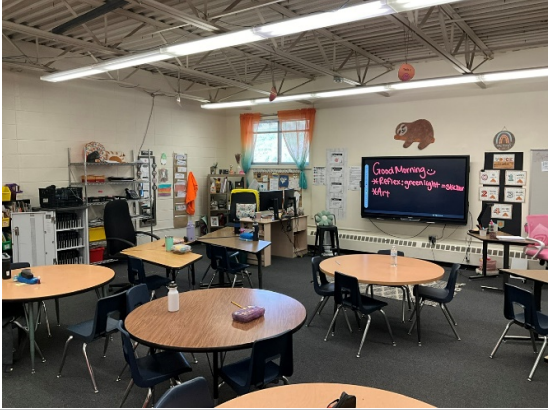
<p><i>Classrooms have "traditional" furniture and are difficult to reconfigure. There was a lack of variety.</i></p>
b

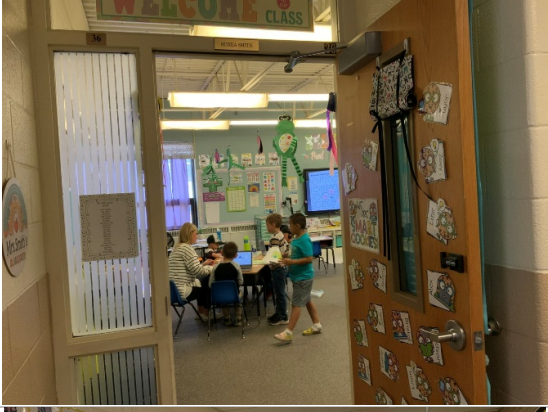
<p><i>Most of the views on door windows have a direct view to adjacent interior spaces were obstructed.</i></p>
c

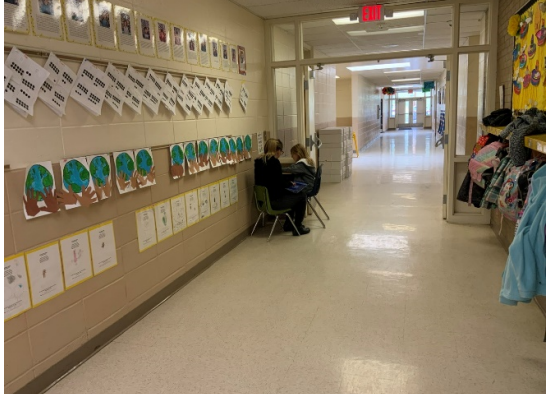
<p><i>There are not teaming areas for students to collaborate outside of the classroom, but several desks in the hallway which demonstrate the need.</i></p>
