IGNACIO SCHOOLS ADMINISTRATION BUILDING

Retro-Commissioning Report_DRAFT September 2024

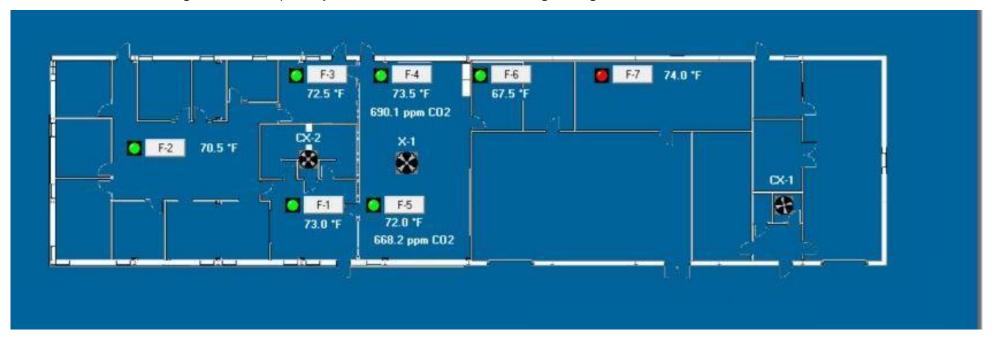
The DDC system reflects the furnaces and exhaust fans. The DDC system is dated, but functional. The control points are linked and operational. Trend and energy data is not accessible from the BAS. CO2 levels are reflected for the furnaces that serve the conference space on the north side of the building. The BAS does not reflect data from electrical or plumbing systems.

The snow melt boilers are not reflected on the administration building pages of the BAS. The boilers have been reported to be enabled during the summer .

The furnaces and A/C coils are listed in the BAS, but individual graphics do not exist in the system. Recommend adding individual furnace graphics to simplify diagnosing issues during operation.

It is suspected that no occupancy schedule is functional within the building with respect to the furnaces and A/C units. It is recommended that an occupancy schedule be implemented to reduce gas and electrical consumption.

Maintenance team is not notified of the snow melt boilers enabling or disabling. As a result, gas is consumed year-round. Adding snow melt boiler plants to the BAS will allow for diagnostics and repairs by the maintenance team to reduce gas usage.

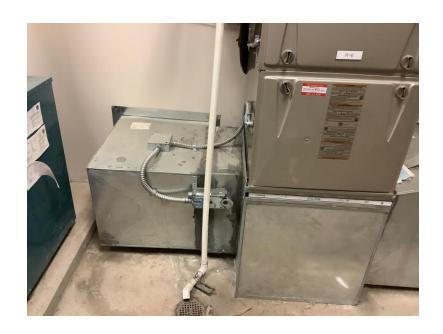
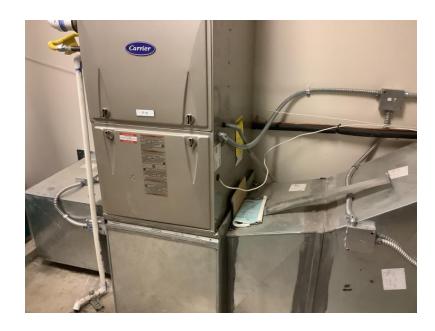
Heating and A/C systems

Overall Condition: Poor (D-)

The HVAC system for the Administration building is a series of gas-fired furnaces with DX A/C coils served by individual, air-cooled condensing units. The furnaces are controlled by individual thermostats wall-mounted in their respective zones. F-4 and F-5 monitor CO2 levels in the main conference room, but implementation of demand control ventilation is unclear.

High mixed air temperatures during the summer indicate that a larger-than-normal rate of outside air is mixed with the return air of the system. This may be the reason for the inordinately high gas consumption of the building, as mixed air temperatures during the winter would be lower-than-normal. Recommend rebalancing of the outside air dampers, confirmation of motorized damper operability, and closure of dampers during unoccupied hours.

Insulation of the outside air ductwork was not observed. Recommend installing duct insulation with a minimum rating of R-12 on all outside air ductwork.

Implement demand control ventilation sequence and confirm outside air and return air dampers operate inversely with each other.

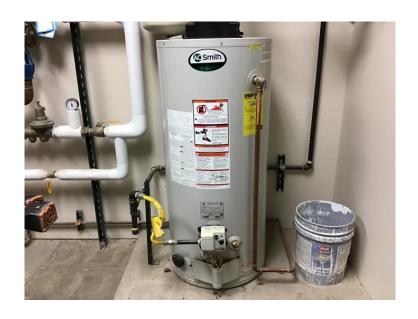
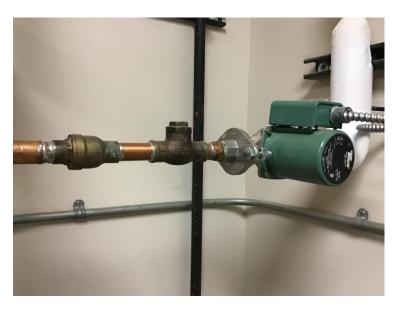
Overall Condition: Good (A)

The domestic hot water (DHW) system consists of a 200 btu/h 96% efficient gas fired water heater with 100 gallons of storage. It is in mechanical room A117 and was installed in 2013. The DHW has Point-Of-Use thermostatic mixing valves set at 105 deg F for non-kitchen plumbing fixtures, cold water 50 deg F and hot water at 120 deg F. Recirculation of the 120 deg F and 105 deg F system is accomplished through DHW circulators controlled by aquastats.

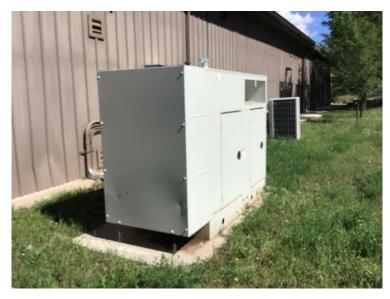
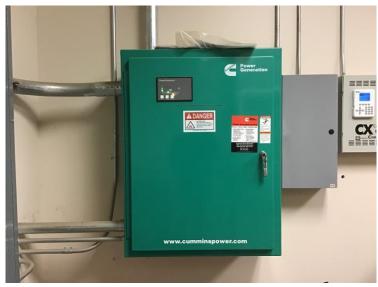
Overall Condition: Good (A-)

The electrical distribution system has 1 utility transformer feeding into an 800 Amp Disconnect which serves multiple interior panels. Those 208V panels are used for the small mechanical and plumbing loads, task lighting and receptacle loads. Panel A, a 600 Amp MLO transfers power to an overhead line, serves a Quonset Hut Building (Woodshop) to the north of the main building. There is a 240V, 35kW generator that backups the electrical systems for these facility's served by a 200 Amp Automatic Transfer Switch. According to the maintenance team, the generator is tested monthly for functionality.

We recommend that the electrical panels be thermally scanned and that all feeders be re-torqued.

Perform routine electrical maintenance on all disconnects check movement of disconnects as lubricate/exercise as needed, tighten all conductors which land on lugs - entering and exiting the disconnects.

Test batteries of all interior and exterior emergency fixtures.

It is recommended that the ATS be thoroughly tested to comply with all operating requirements. At a minimum, test the switch under load for proper operation, check all connections and remove all dust and debris. Inspect or test for evidence of overheating and excessive contact erosion. Verify system controls will operate as intended. It is recommended that the generator is tested to comply with all operating requirements. At a minimum, test the generator under load for proper operation, checking all connections. Test the on-board circuit breaker and the EPO button. It is also recommended that the load bank be tested at 25% of total KW load for 30 minutes, 50% KW load for 30 minutes, and at 75% of nameplate KW for 1-hour.

Add a surge protection device to protect the building from outages during severe lighting storms.
