# IGNACIO ELEMENTARY SCHOOL

Retro-Commissioning Report\_DRAFT 2

November 2024

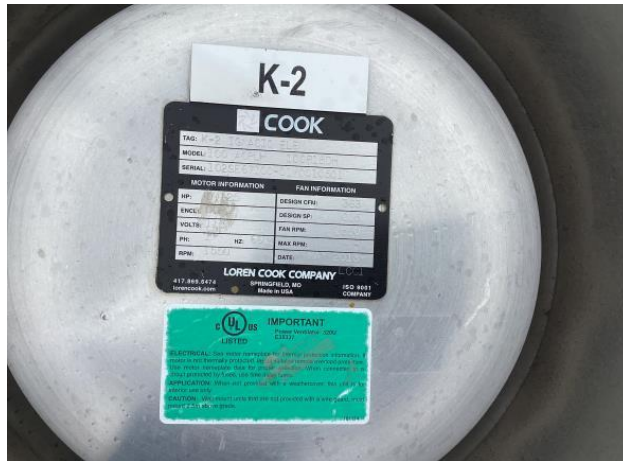
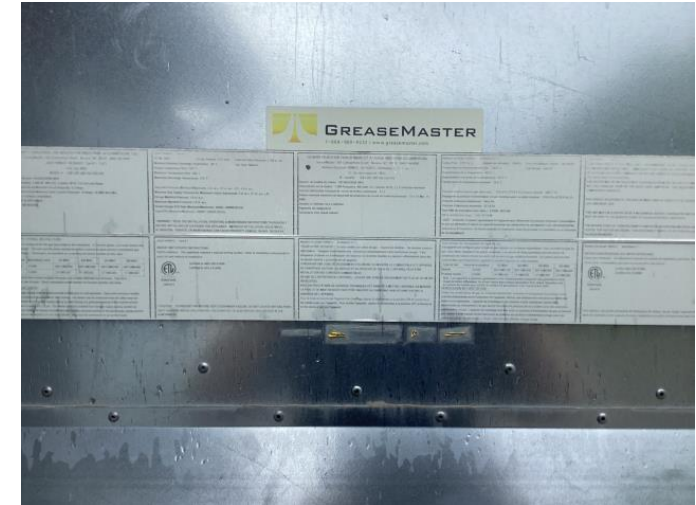
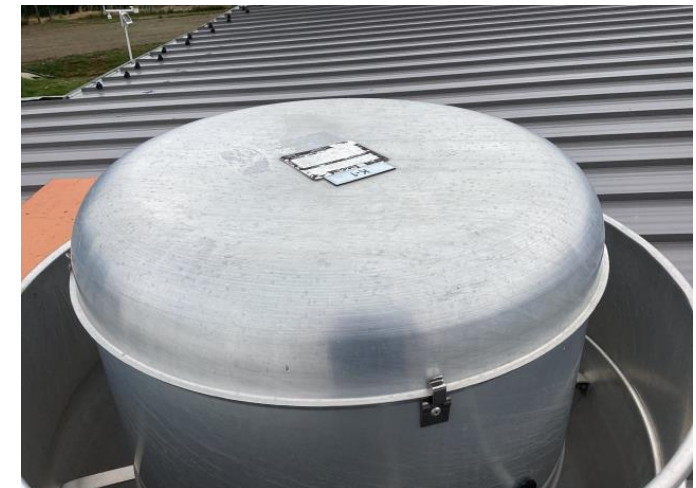
The hood and dishwasher exhaust fans are operable. The GreaseMaster MAU is not operable. The exhaust fan VFD increases the fan speed when additional burners enable.

Check belt tensions/alignment, routine cleaning of grease hood and ductwork. Range hood and dishwasher exhaust and makeup air system is not displayed or operated through the graphical user interface. Recommend integrating kitchen controls with BAS for operability by maintenance team.

Reznor MAU specified in 2013 design drawings was never installed. Recommend replacing existing MAU as soon as possible.

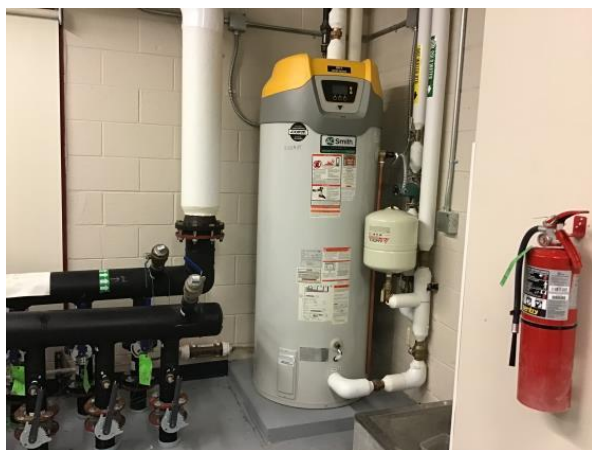
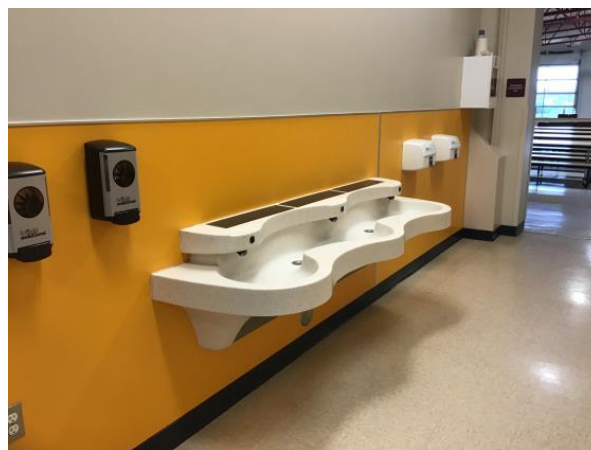
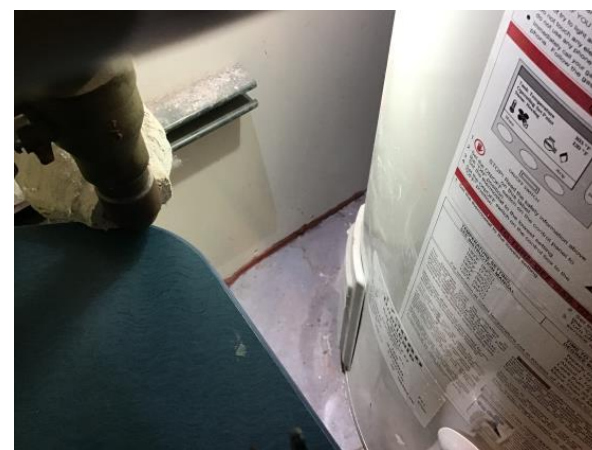
A test to run hot water from a fixture furthest from the domestic hot water heater failed. Gang sinks in the 1st grade wing took longer than 2 minutes to produce hot water. Circuit setters in other areas of the building may be reset in order to allow for domestic hot water to flow to these fixtures. Further investigation will be conducted upon a follow-up visit to determine if there is a cross-connection between domestic hot and cold water.

There is a sewer smell coming from the fifth-grade wing. The odor only occurs during the spring and fall when classes are in session. Order goes away when building is vacant. Recommend investigating. Lower access panel on WH-1 is turned facing the wall with less than a minimum of 20- inch clearance.
