# IGNACIO HIGH SCHOOL

Retro-Commissioning Report\_DRAFT 2

November 2024

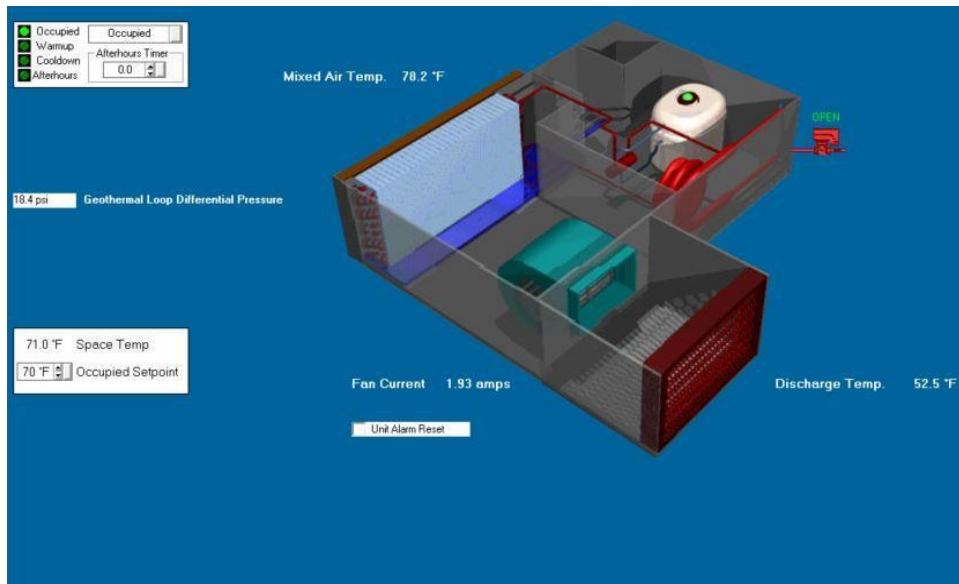
- Add fan and compressor failure/alarm points to all heat pump graphics for diagnostics.
- Distribution pumps are in alarm. Recommend controls contractor investigate and clear alarms.

*Typical Heat Pump graphic*

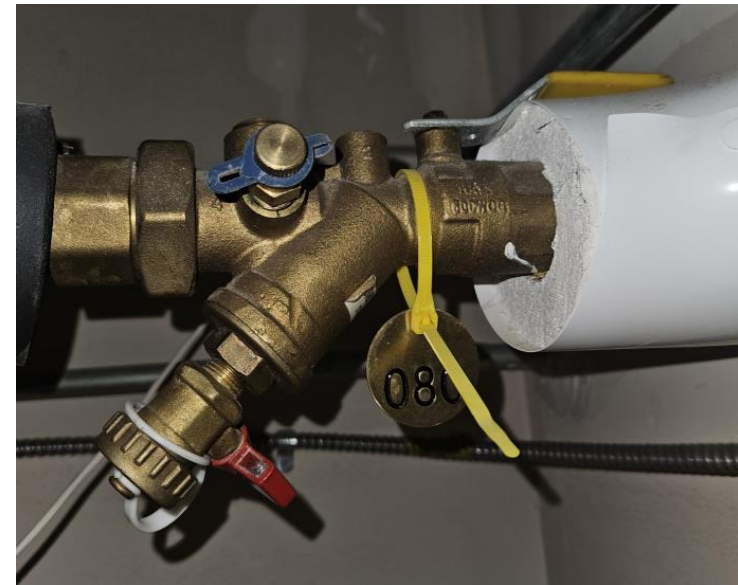
*Typical strainer – clean out twice per year*

- Re-program pump sequence to run pumps in a lead/lag configuration and reset hydronic loop differential pressure setpoint from 17 psi to 6-8psi.
- Clean all strainers in the hydronic system twice per year.

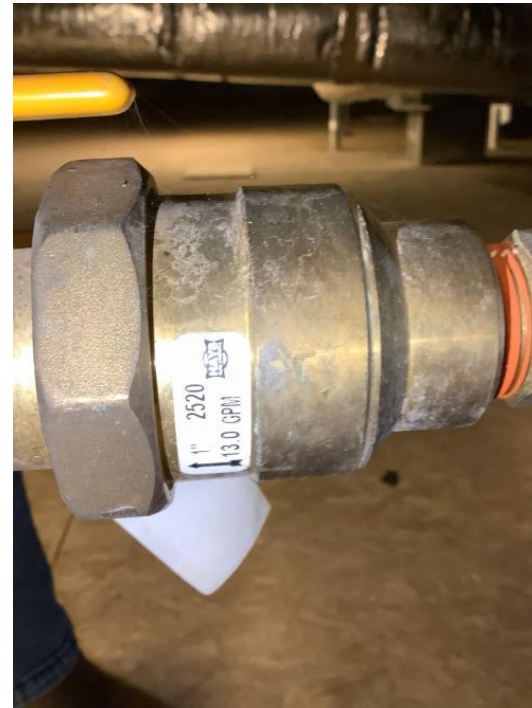
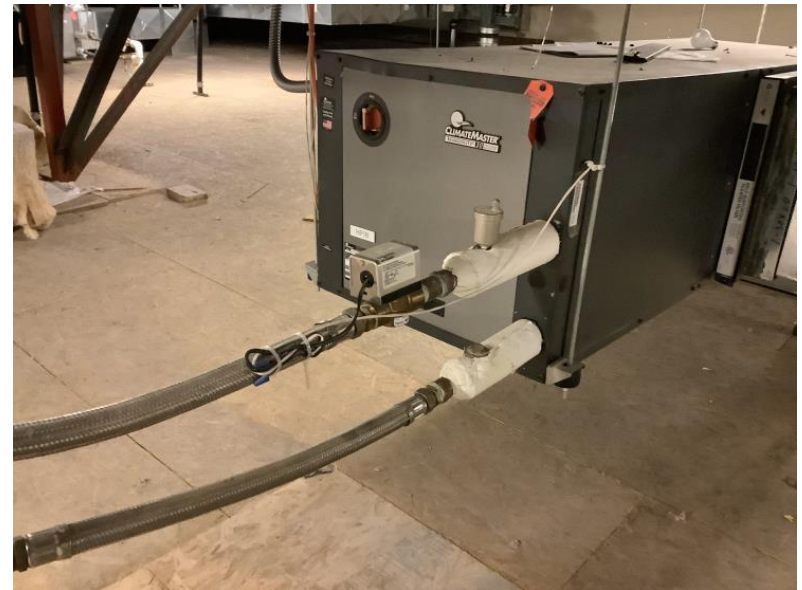
Several heat pumps show signs of corrosion and degradation at coil connections.

Several HP have failed compressors. On 7/9/24, HP-33 failed resulting in several heat pumps to discharge 90 °F air when in a call for cooling.

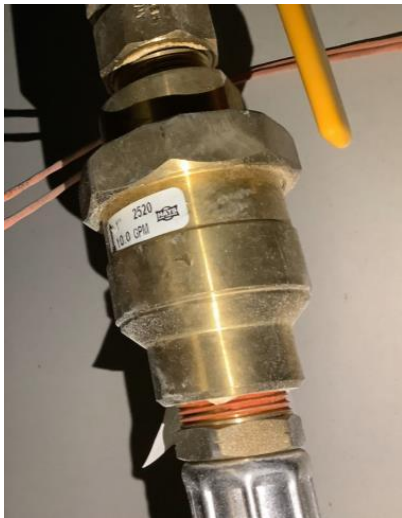
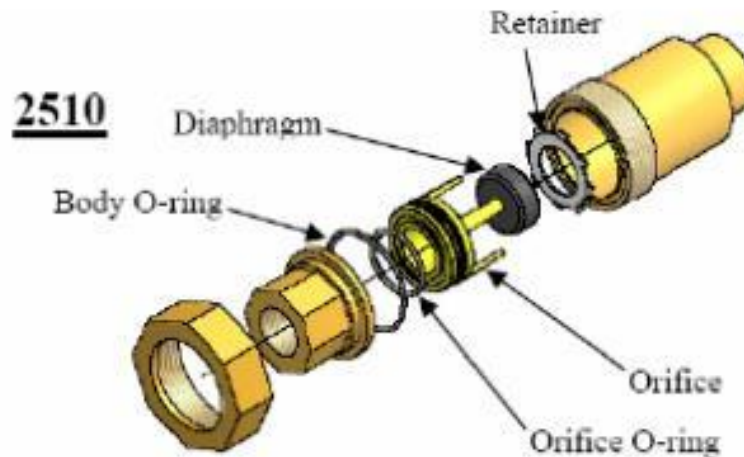
The scheduled flow rate for the heat pumps appears to be based on the calculated cooling capacity. The installed heat pump in most cases is a nominal size larger than the calculated capacity. Many of the heat pump flow rates are less than 3 gpm/ton. Increasing the flow rate to each individual heat pump will improve reliability, function, and equipment durability.

See figure below. The flow to each heat pump is limited by a Hays autoflow valve. The diaphragm and orifice are set from the factory to the designated flow rate. To increase the flow output of each valve the diaphragm and orifice can be replaced by a new factory set cartridge at the higher flow rate. Farnsworth Group recommends increasing the flow rate to all heat pumps by replacing the flow cartridge to the recommended flow rate listed in the Appendix.

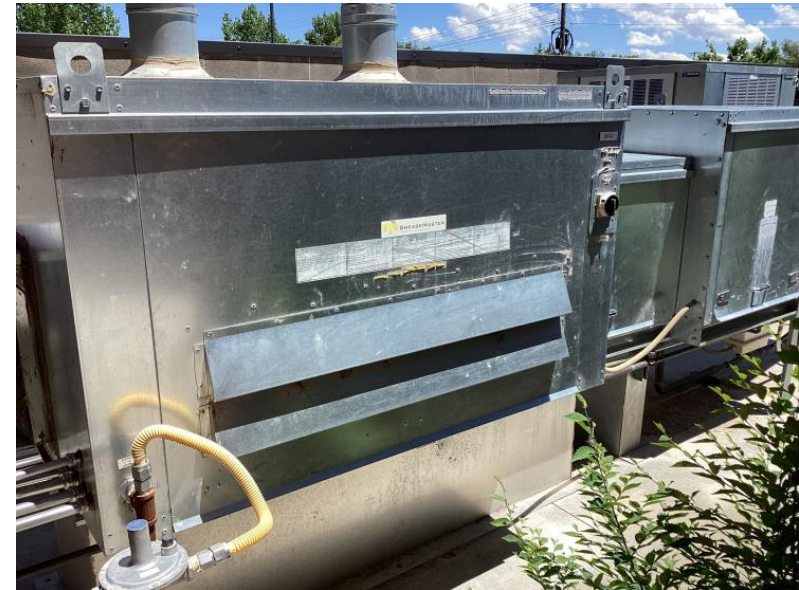
Kitchen MAU is in relatively poor condition. Reznor MAU specified in 2013 design drawings was never installed. Recommend replacing MAU within five years.

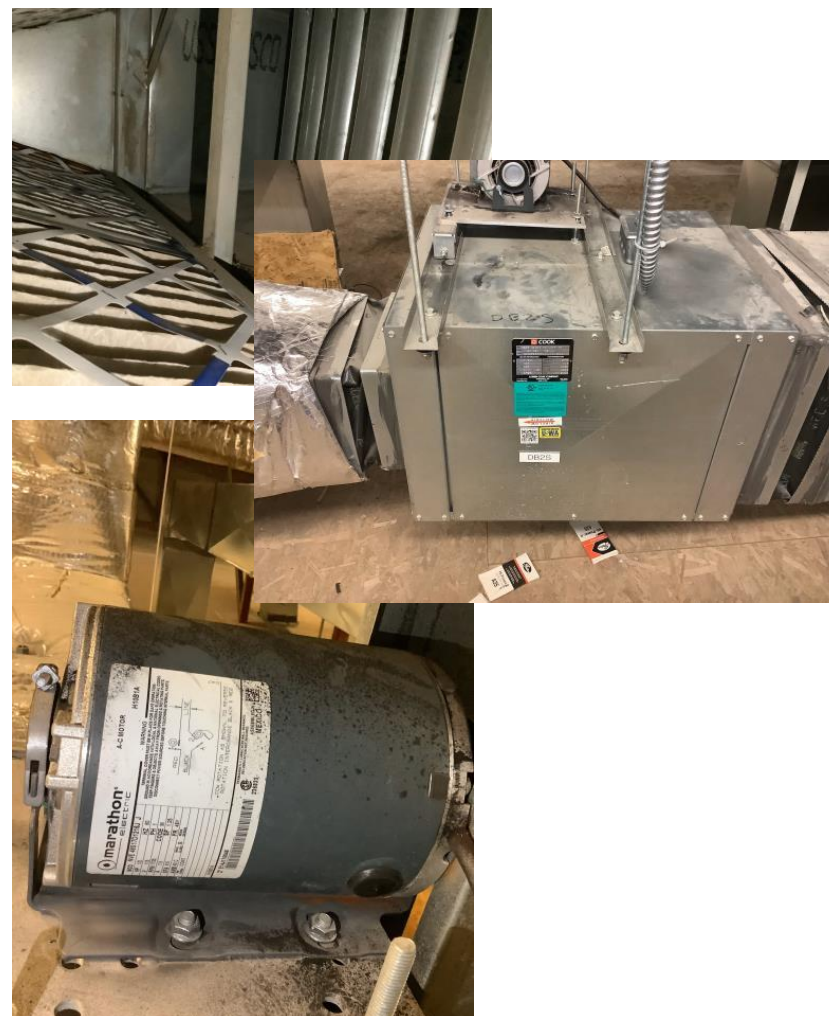
Access is a problem to most equipment, causing filter replacements to be labor intensive. Recommend replacing the ERV filters more frequently to lesson filter loading on HPs downstream.

Many of the supply fan and exhaust fans were in alarm due to difficult access.

The ERVs were not on an occupancy schedule and appear to operate 24/7. Recommend putting ERVs on a schedule to disable during unoccupied hours. This will result in fan energy savings.

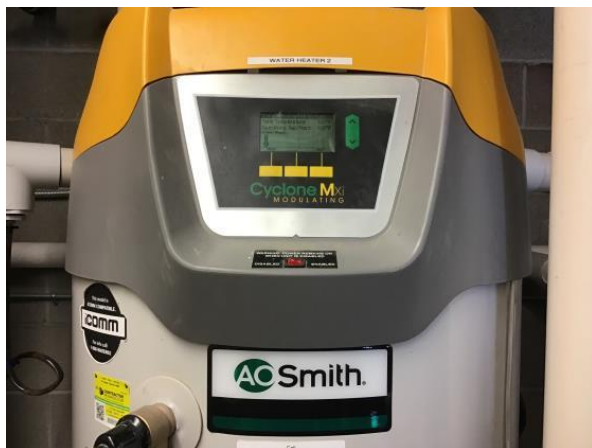
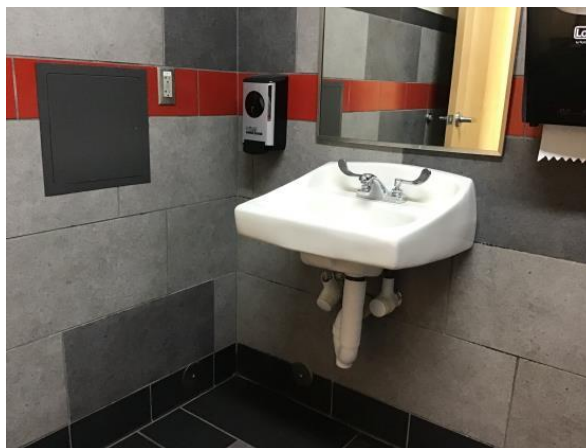
A test to run hot water from a fixture furthest from the domestic hot water heater failed. Shower water in the boys locker room did not heat up after two minutes of continual running. Circuit setters in other areas of the building may be reset in order to allow for domestic hot water to flow to these fixtures. Further investigation will be conducted upon a follow-up visit to determine if there is a cross-connection between domestic hot and cold water.
