IGNACIO MIDDLE SCHOOL

Retro-Commissioning Report_DRAFT 2

November 2024

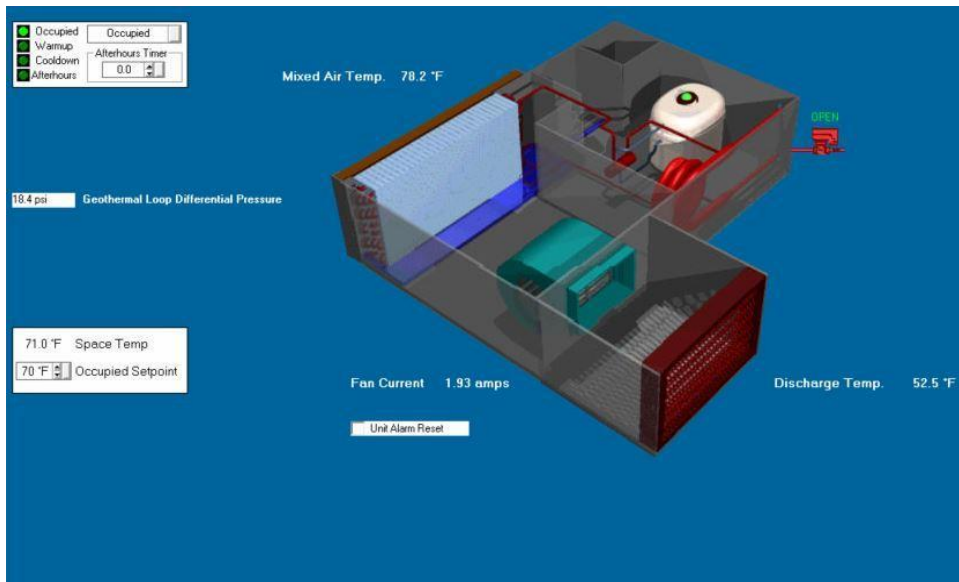
Typical Heat Pump graphic

- Add position points for all hydronic heating and cooling 3-way valves on the heating hot water system graphic
- Add fan and compressor failure/alarm points to all heat pump graphics for diagnostics

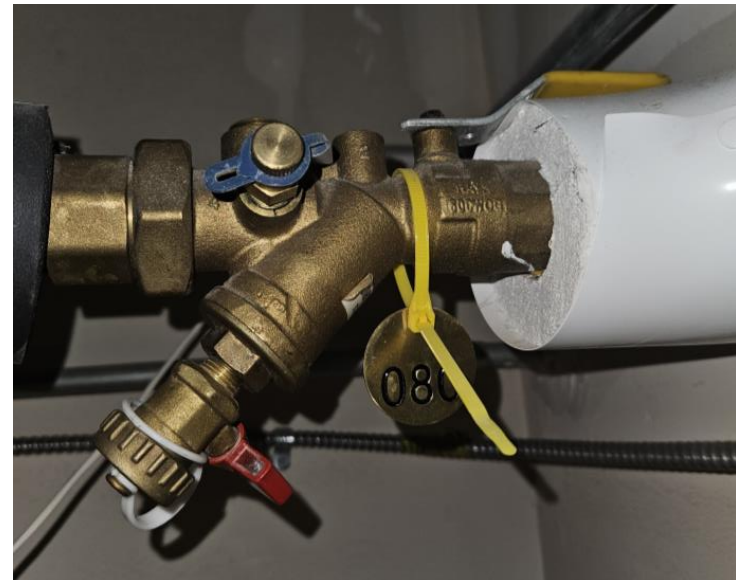
Typical strainer – clean out twice per year

- Clean all strainers in the hydronic system twice per year.
- Implement occupied/unoccupied building schedule in BAS ERVs. Eliminate night setbacks of space temperature setpoints.

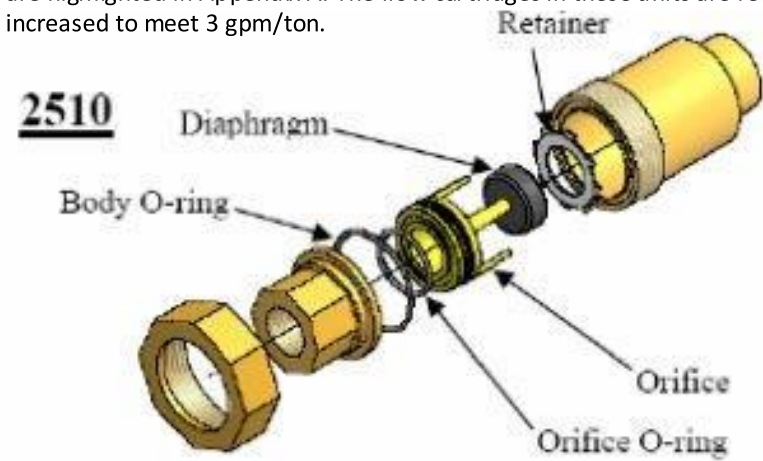
See figure below. The flow to each heat pump is limited by a Hays autoflow valve. The diaphragm and orifice are set from the factory to the designated flow rate. To increase the flow output of each valve the diaphragm and orifice can be replaced by a new factory set cartridge at the higher flow rate. Farnsworth Group recommends increasing the flow rate to heat pumps that are less than 2 gpm/ton. The system operates with far less issues than the elementary school and high school. Replacing all flow cartridges across the entire school is not recommended. The units that are currently operating at less than 2 gpm/ton are highlighted in Appendix A. The flow cartridges in these units are recommended to be increased to meet 3 gpm/ton.

The scheduled flow rate for the heat pumps appears to be based on the calculated cooling capacity. The installed heat pump in most cases is a nominal size larger than the calculated capacity. Many of the heat pump flow rates are less than the optimal 3 gpm/ton. Increasing the flow rate to each individual heat pump will improve reliability, function, and equipment durability.

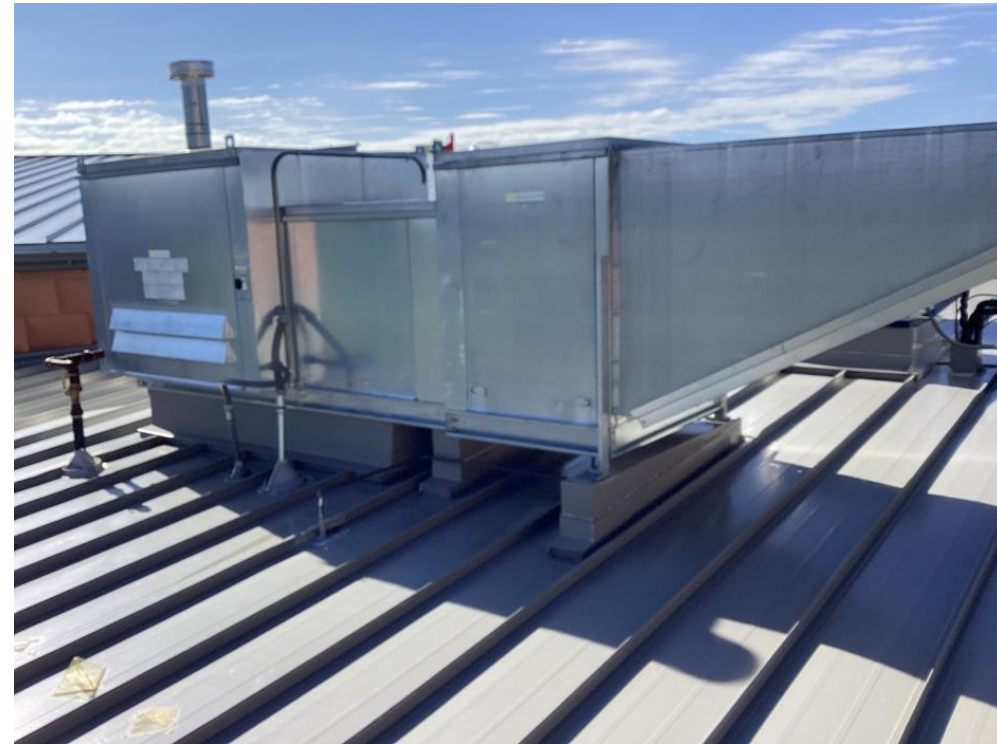
Kitchen pressurization was tested with a manometer. Kitchen exhaust and ventilation air system produce a net positive pressurization of the kitchen if fewer than four gas range burners are on. Recommend re-sequencing exhaust fan to operate at 100% capacity any time range is enabled.

Design makeup air ventilation rate is 3900 cfm, design exhaust flow is ~4100 cfm. Actual exhaust airflow reading is ~2000 cfm, creating positive pressure in space. Hood exhaust increases as additional burners enable, but makeup airflow is relatively constant. Recommend sequencing kitchen hood exhaust fan to enable at 100% with the enabling of any range burner to avoid positive pressurization of kitchen while cooking.

Kitchen MAU is in fair condition. Reznor MAU specified in 2013 design drawings was never installed. Recommend replacing MAU within ten years.

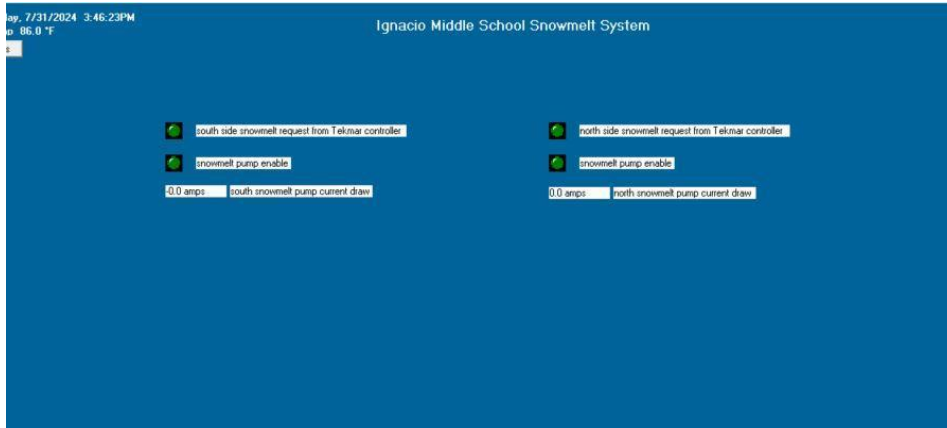
Kitchen exhaust fans are not on the kitchen MAU graphics. Recommend adding kitchen hood exhaust fan and dishwasher exhaust fans to the MAU graphics for ease of use. Slab temperature is not on the snow melt BAS graphics. Recommend adding slab temperature point. We recommend that the snow-melt pump status alarm be added to the BAS graphics to notify the maintenance team. This will allow for the maintenance team to be notified if the slab temperature sensor is not calling for snow melt system enable during a snow event.

Snow-melt graphics – points noted, no display.

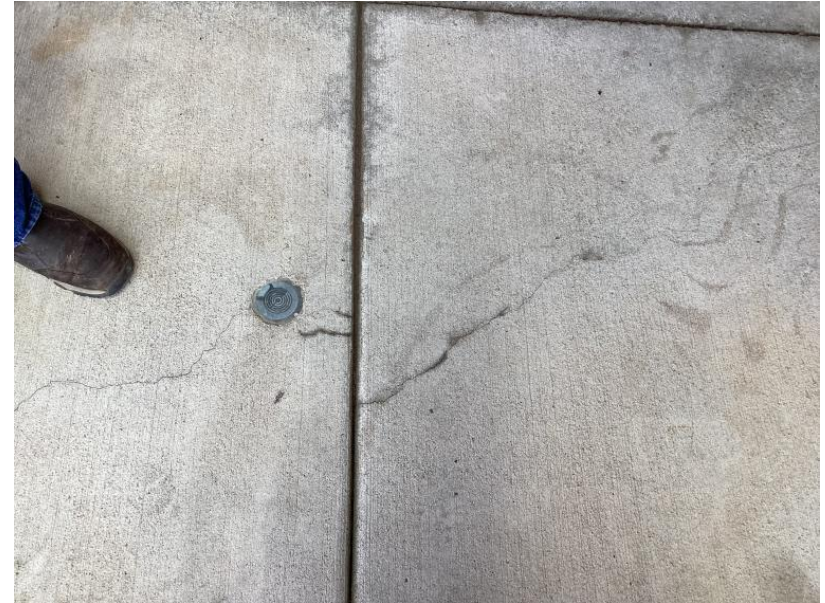
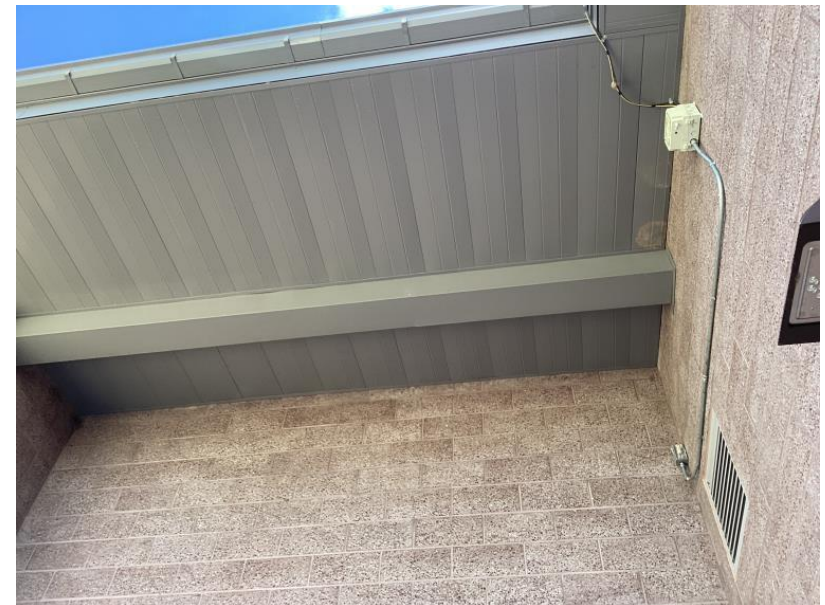
Snow-melt temperature sensor installed under roof overhang.

Snow melt system enable slab sensor is located under the roof overhang. We recommend moving the sensor out from under the overhang such that it enables during snow events without intervention by the maintenance team.
