Centennial Middle School

**1100 South 5th.
Montrose, CO 81401**

3.2 Condition Analysis Matrix

Condition Photo Documentation

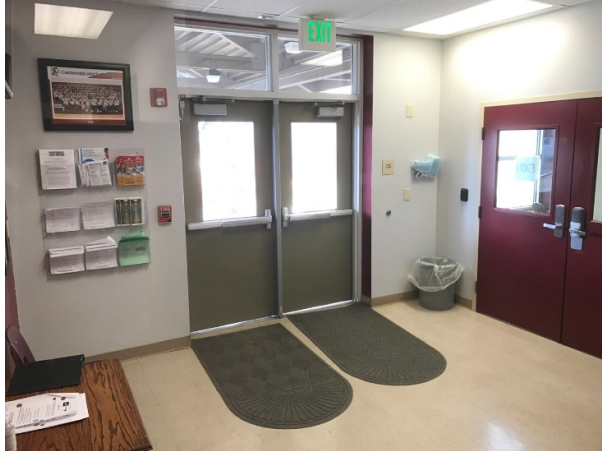
Replace wire glass on exterior door

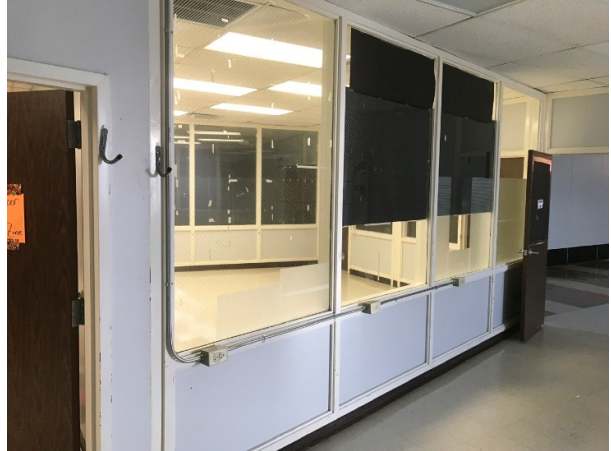
Replace single pane wired glass all locations

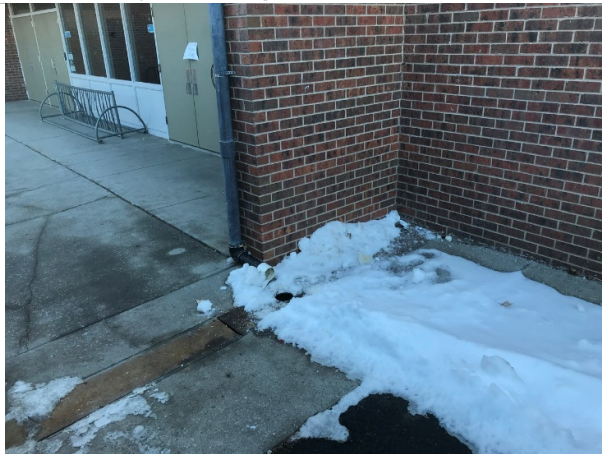
Reroute downspout at the north entry that cases ice hazards

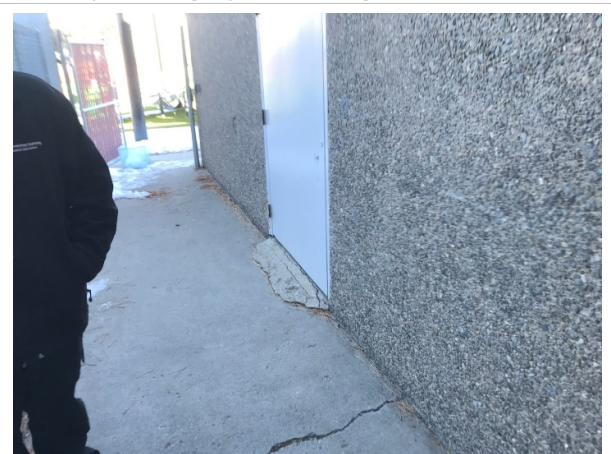
Replace sunken slabs, sidewalks, and stoops

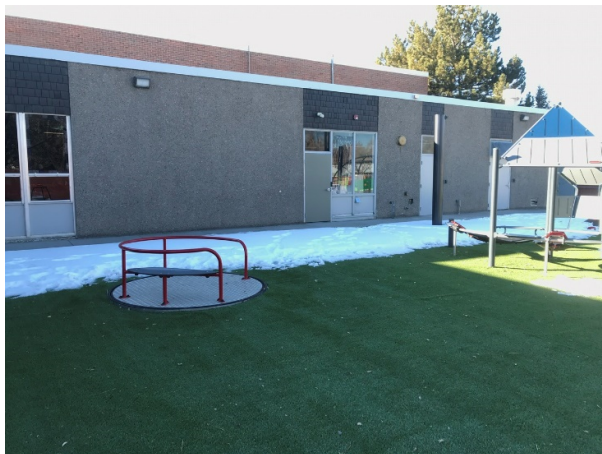
Add snow guards

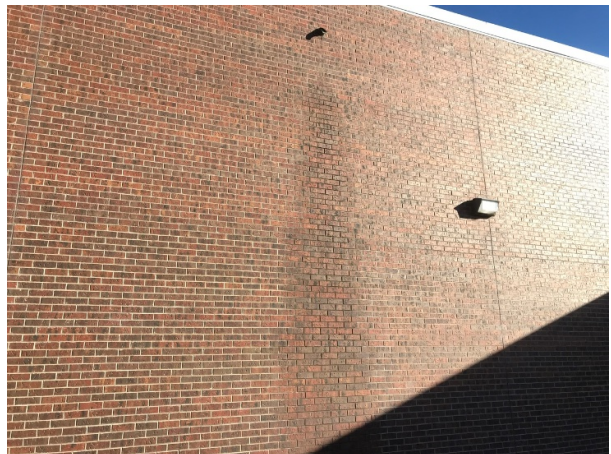
Downspout off of gym leaks on face of brick

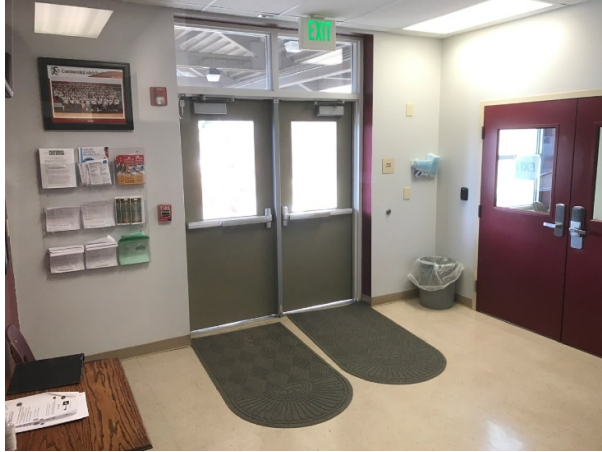
Provide energy vestibules

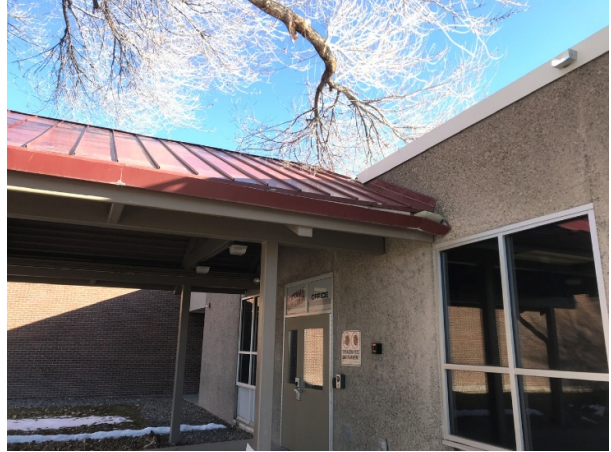
Replace damaged gutter

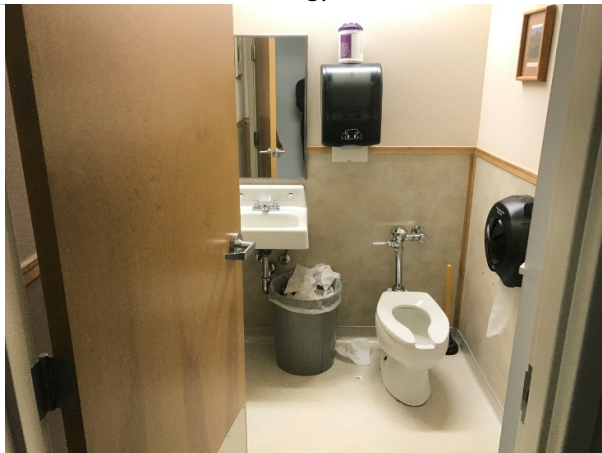
Provide ADA compliant toilets

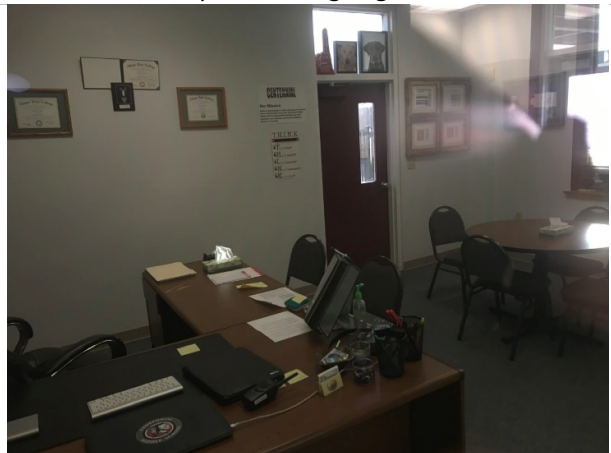
South side door in principal's office has non-compliant door hardware

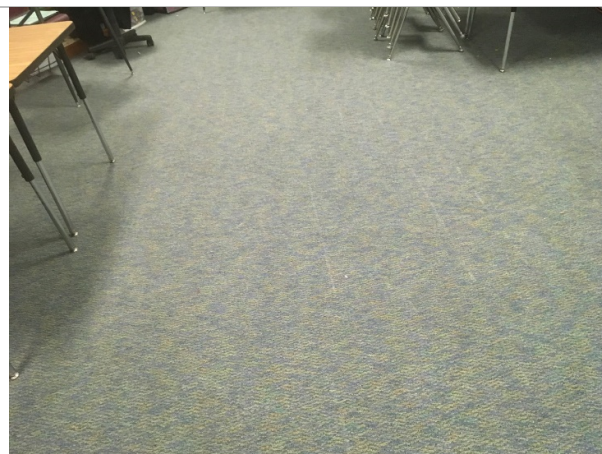
Replace outdated carpet

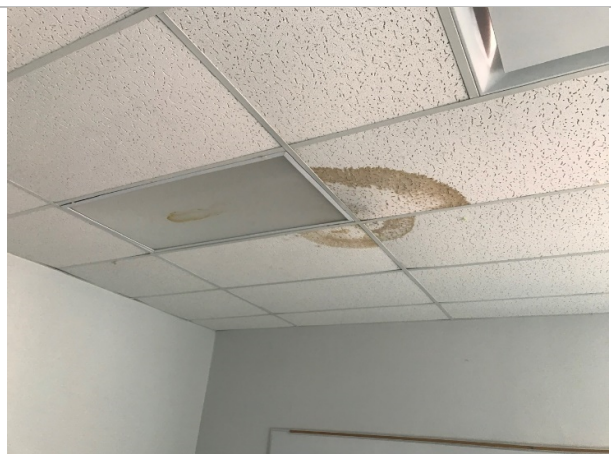
Replace ceiling tiles that are outdated
