Johnson Elementary School

**13820 6700 Rd.
Montrose, CO 81401**

3.2 Condition Analysis Matrix

Project: Montrose County School District
 Facility: **Johnson Elementary School (JES)**
 Date: 2/7/2022
 Date of last addition: NA
 Year round start date: _____

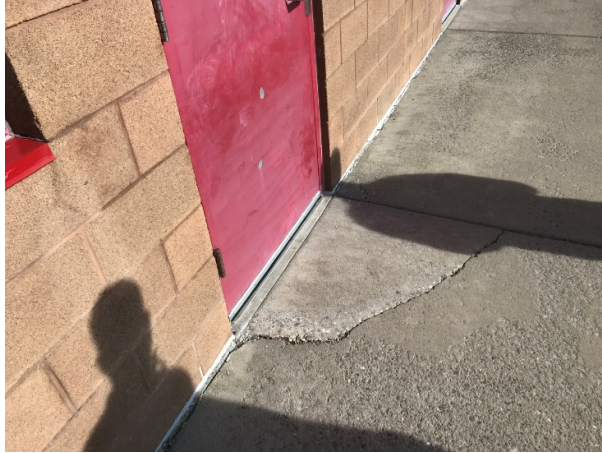
Replace displaced sidewalk

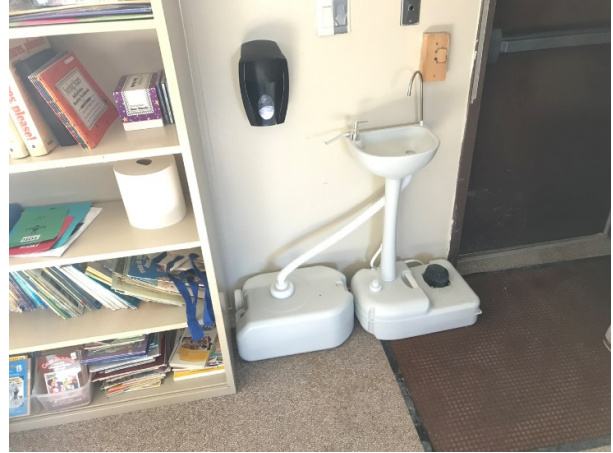
Remove all bubblers

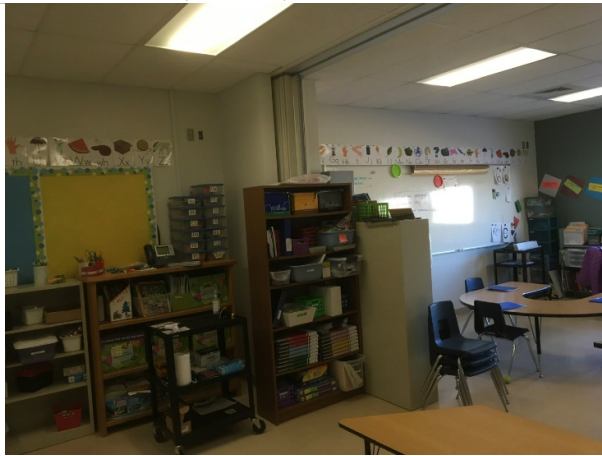
Provide lighting controls

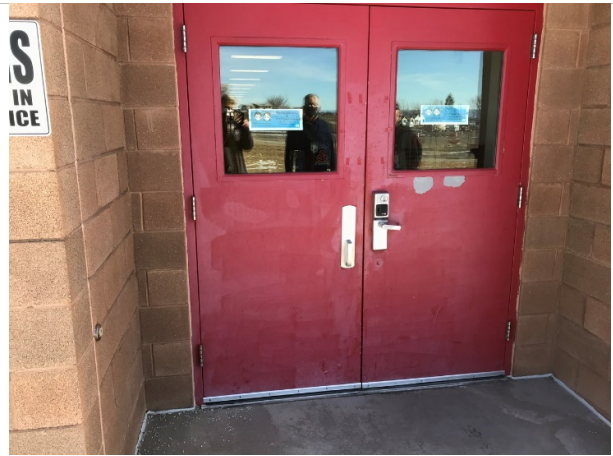
Provide energy vestibules

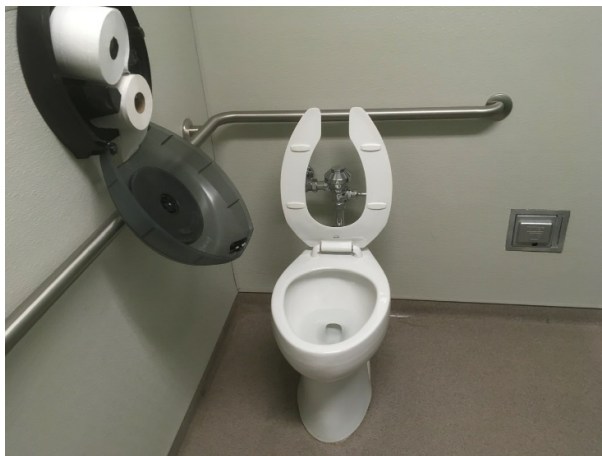
Lower toilet paper dispensers below grab bars

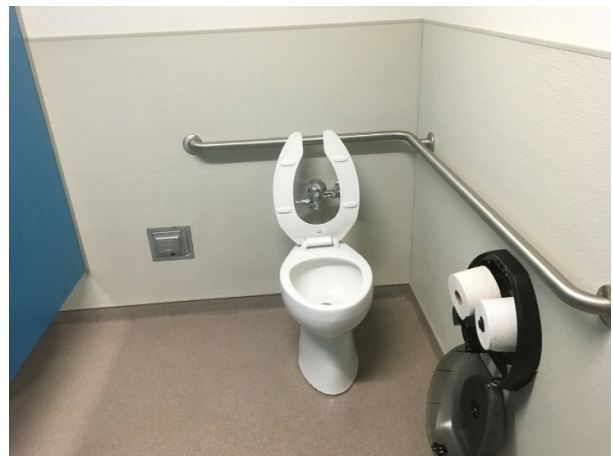
Replace continual grab bars with segmented ones

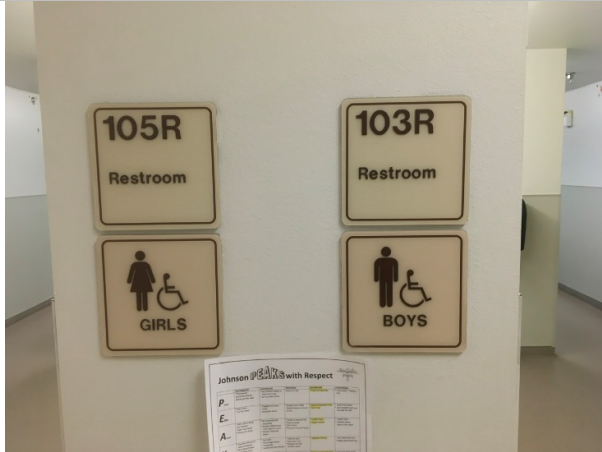
Provide ADA compliant signage

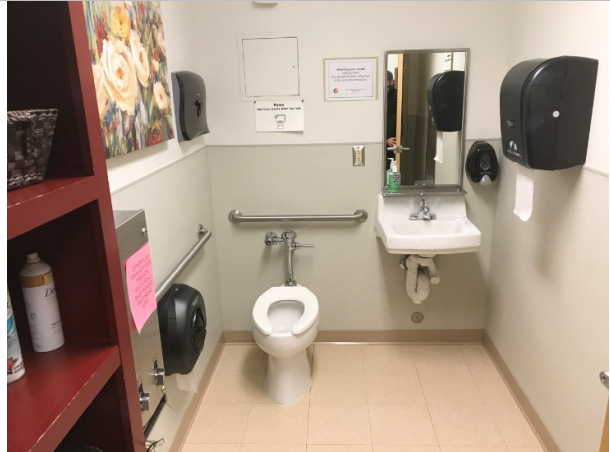
Provide vertical grab bars

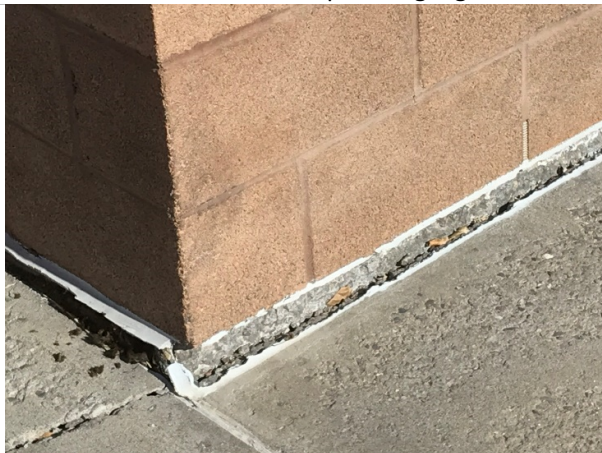
Replace Caulking at site hardscapes

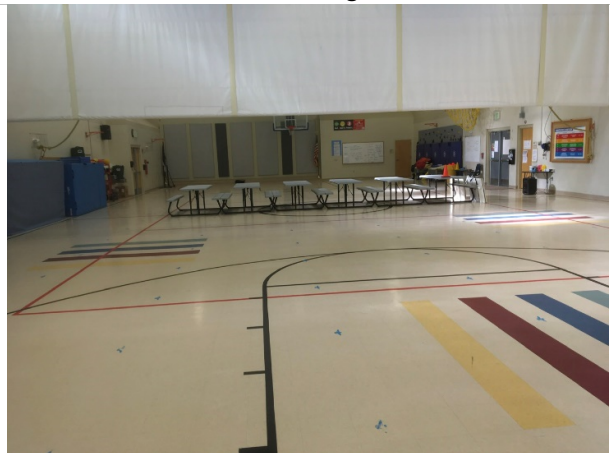
Replace flooring in gym

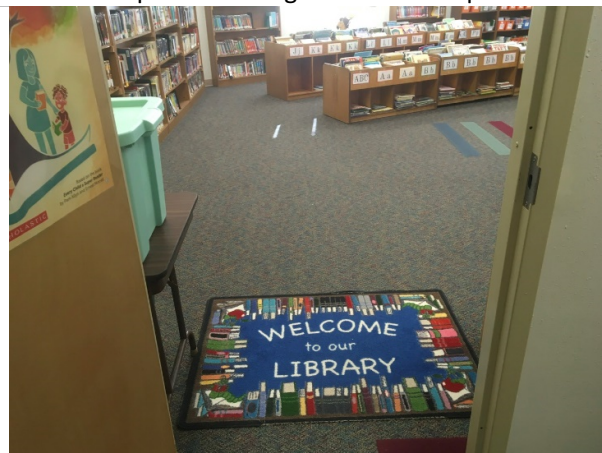
Replace carpet in Rooms 301, 308, 309, 310, 311, office, and library

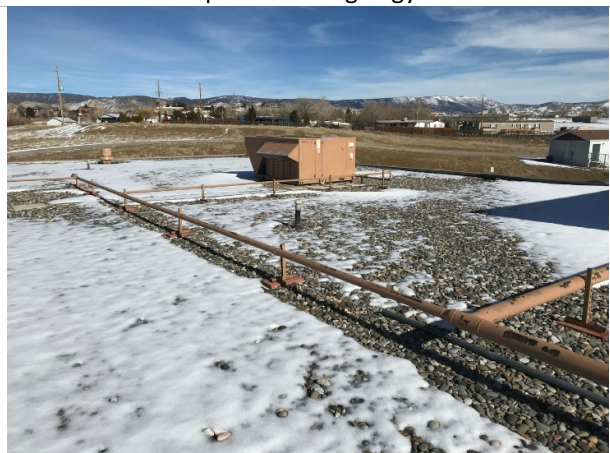
The mechanical system is a series of packaged rooftop units that are original to the building, and have reached the end of their service life. It is recommended that they are replaced within the next five years. The interior lighting system throughout the building was identified as fluorescent and should be replaced or retrofitted with LED fixtures to improve energy efficiency, maintenance costs, and quality of indoor spaces. Given the age of the building, it is expected that there are several areas noted with worn or deteriorated floor finishes, including the high-trafficked multi-purpose gymnasium/cafeteria.

Out of date rooftop mechanical systems
