Northside Elementary School

**528 North Uncompahgre
Montrose, CO 81401**

3.2 Condition Analysis Matrix

Project: Montrose County School District
 Facility: **Northside Elementary School (NES)**
 Date: 2/7/2022
 Date of last addition: NA
 Year round start date: _____

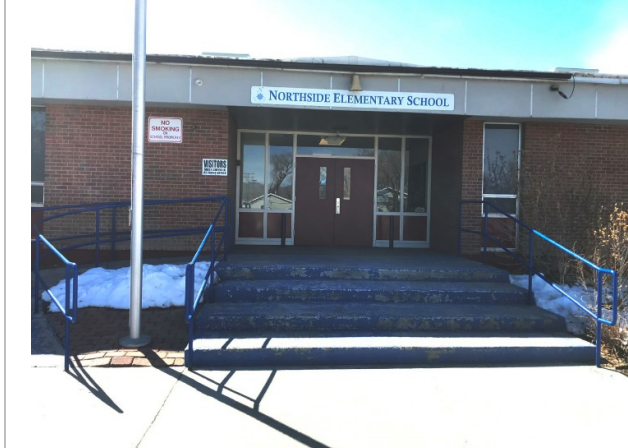
| ITEM # | FACILITY | LOCATION | ITEM DESCRIPTION | CONSULTANT | ITEM CATEGORY | FAIL TIMING | CAT | CONSQ | FINAL RANK | REMAINING LIFE (YEARS) | COST (Direct Cost) (no soft costs) | COST (w/ Fees & GC's) (no soft costs) | TOTAL COST (w/ soft costs) | TOTAL COST (w/ contingency) |
|---|---|---|---|---|---|---|---|---|---|---|---|--|---|---|
| 10 | NES | EXT | Replace single pane wire glass at main entry | RTA | Window System | 1 | 1 | 1 | 1 | | \$ 7,000 | \$ 8,050 | \$ 9,660 | \$ 10,867.50 |

Replace single pane wire glass at main entry

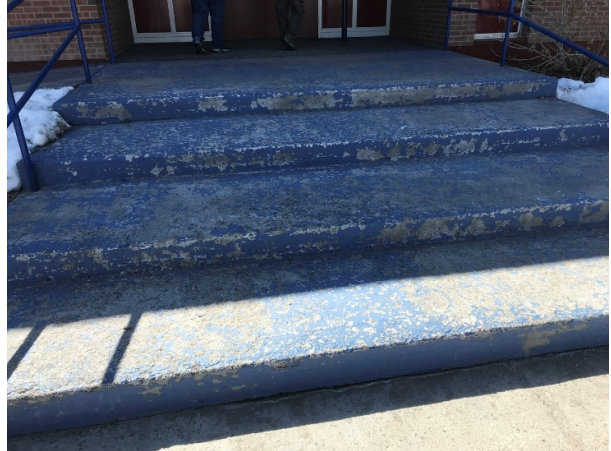
| ITEM # | FACILITY | LOCATION | ITEM DESCRIPTION | CONSULTANT | ITEM CATEGORY | FAIL TIMING | CAT | CONSQ | FINAL RANK | REMAINING LIFE (YEARS) | COST (Direct Cost) (no soft costs) | COST (w/ Fees & GC's) (no soft costs) | TOTAL COST (w/ soft costs) | TOTAL COST (w/ contingency) |
|---|---|---|---|---|---|---|---|---|---|---|---|--|---|---|
| 21 | NES | EXT | Main sidewalk concrete is deteriorated and is hazardous | RTA | Pavement System | 1 | 1 | 1 | 1 | | \$ 45,024 | \$ 51,778 | \$ 62,133 | \$ 69,899.76 |

Main sidewalk concrete is deteriorated and is hazardous

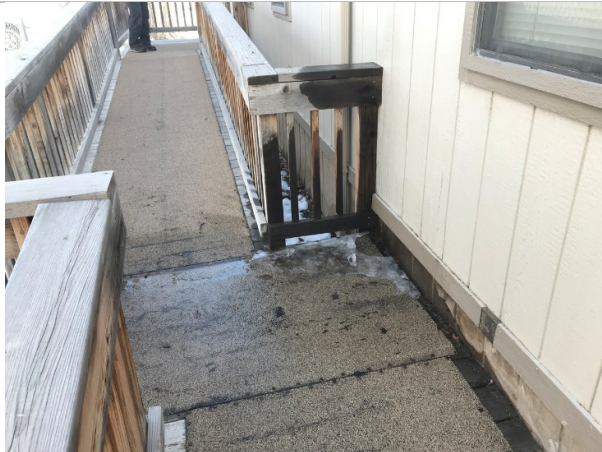
| ITEM # | FACILITY | LOCATION | ITEM DESCRIPTION | CONSULTANT | ITEM CATEGORY | FAIL TIMING | CAT | CONSQ | FINAL RANK | REMAINING LIFE (YEARS) | COST (Direct Cost) (no soft costs) | COST (w/ Fees & GC's) (no soft costs) | TOTAL COST (w/ soft costs) | TOTAL COST (w/ contingency) |
|---|---|---|---|---|---|---|---|---|---|---|---|--|---|---|
| 23 | NES | PORT | Wooden ramp back side of building has roof drain leaking, ice hazard | RTA | Roofing System | 1 | 1 | 1 | 1 | | \$ 82,326 | \$ 94,675 | \$ 113,610 | \$ 127,811.12 |

Wooden ramp back of building has roof drain leaking

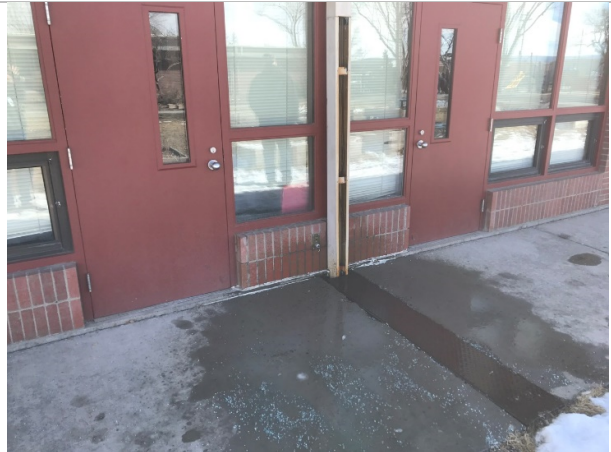
| ITEM # | FACILITY | LOCATION | ITEM DESCRIPTION | CONSULTANT | ITEM CATEGORY | FAIL TIMING | CAT | CONSQ | FINAL RANK | REMAINING LIFE (YEARS) | COST (Direct Cost) (no soft costs) | COST (w/ Fees & GC's) (no soft costs) | TOTAL COST (w/ soft costs) | TOTAL COST (w/ contingency) |
|---|---|---|---|---|---|---|---|---|---|---|---|--|---|---|
| 25 | NES | PORT | Roof dripping on sidewalk in front of classroom doors, ice hazard | RTA | Roofing System | 1 | 1 | 1 | 1 | | \$ - | \$ - | \$ - | \$ - |

Roof dripping on sidewalk in front of classroom doors

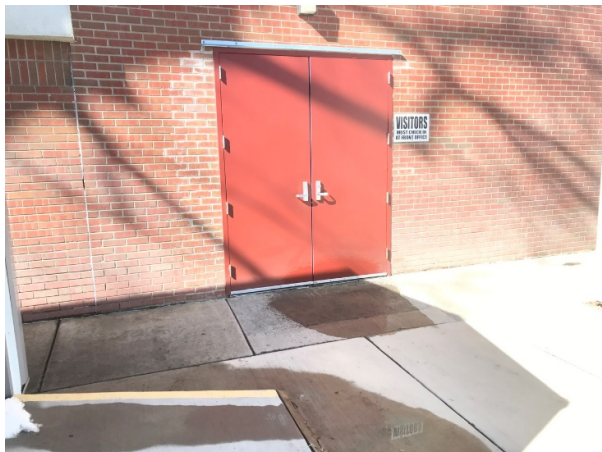
| ITEM # | FACILITY | LOCATION | ITEM DESCRIPTION | CONSULTANT | ITEM CATEGORY | FAIL TIMING | CAT | CONSQ | FINAL RANK | REMAINING LIFE (YEARS) | COST (Direct Cost) (no soft costs) | COST (w/ Fees & GC's) (no soft costs) | TOTAL COST (w/ soft costs) | TOTAL COST (w/ contingency) |
|---|---|---|---|---|---|---|---|---|---|---|---|--|---|---|
| 27 | NES | PORT | Gutter leaking in front of gym exit, ice hazard | RTA | Roofing System | 1 | 1 | 1 | 1 | | \$ - | \$ - | \$ - | \$ - |

Gutter leaking in front of gym

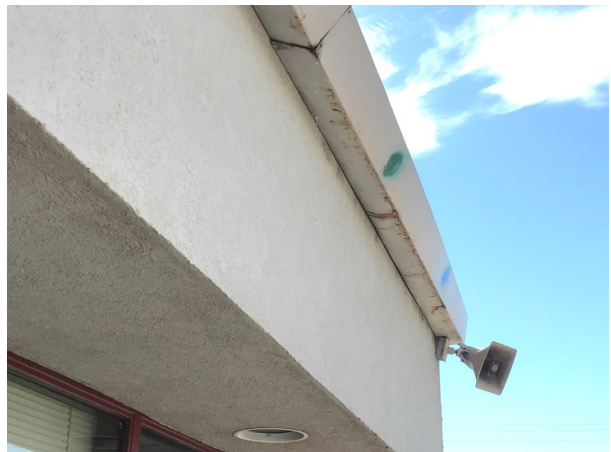
| ITEM # | FACILITY | LOCATION | ITEM DESCRIPTION | CONSULTANT | ITEM CATEGORY | FAIL TIMING | CAT | CONSQ | FINAL RANK | REMAINING LIFE (YEARS) | COST (Direct Cost) (no soft costs) | COST (w/ Fees & GC's) (no soft costs) | TOTAL COST (w/ soft costs) | TOTAL COST (w/ contingency) |
|---|---|---|---|---|---|---|---|---|---|---|---|--|---|---|
| 15 | NES | EXT | Replace leaking gutters. Possible soffit damage | RTA | Roofing System | 1 | 2 | 3 | 6 | | \$ - | \$ - | \$ - | \$ - |

Replace leaking gutter. Possible soffit damage

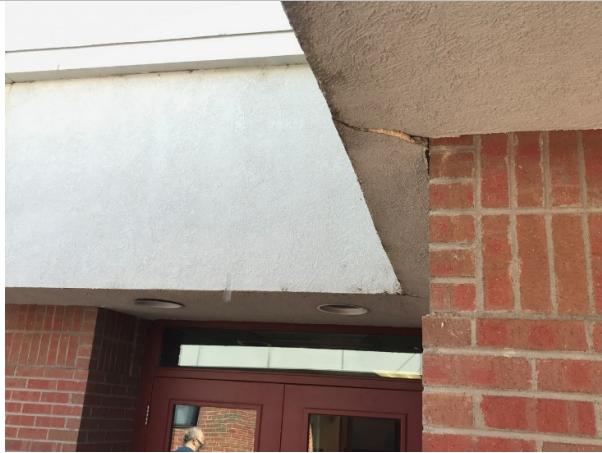
| ITEM # | FACILITY | LOCATION | ITEM DESCRIPTION | CONSULTANT | ITEM CATEGORY | FAIL TIMING | CAT | CONSQ | FINAL RANK | REMAINING LIFE (YEARS) | COST (Direct Cost) (no soft costs) | COST (w/ Fees & GC's) (no soft costs) | TOTAL COST (w/ soft costs) | TOTAL COST (w/ contingency) |
|---|---|---|---|---|---|---|---|---|---|---|---|--|---|---|
| 16 | NES | EXT | Caulking needs to be redone around windows and control joints | RTA | Other | 1 | 2 | 3 | 6 | | \$ 6,750 | \$ 7,763 | \$ 9,315 | \$ 10,479.38 |

Caulking needs to be redone around windows and control joints

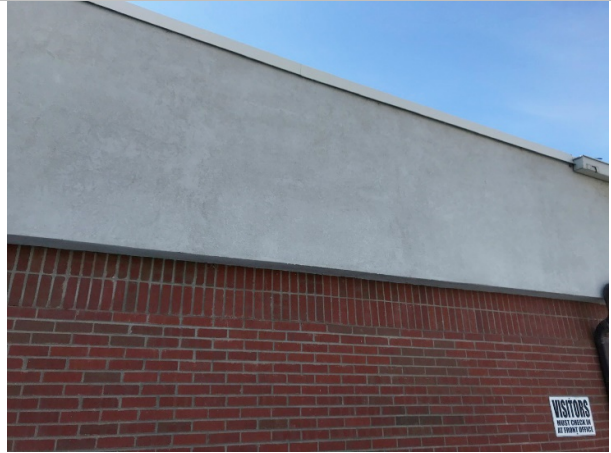
| ITEM # | FACILITY | LOCATION | ITEM DESCRIPTION | CONSULTANT | ITEM CATEGORY | FAIL TIMING | CAT | CONSQ | FINAL RANK | REMAINING LIFE (YEARS) | COST (Direct Cost) (no soft costs) | COST (w/ Fees & GC's) (no soft costs) | TOTAL COST (w/ soft costs) | TOTAL COST (w/ contingency) |
|---|---|---|---|---|---|---|---|---|---|---|---|--|---|---|
| 18 | NES | EXT | Provide missing roof gutters | RTA | Roofing System | 1 | 2 | 3 | 6 | | \$ - | \$ - | \$ - | \$ - |

Provide missing roof gutters

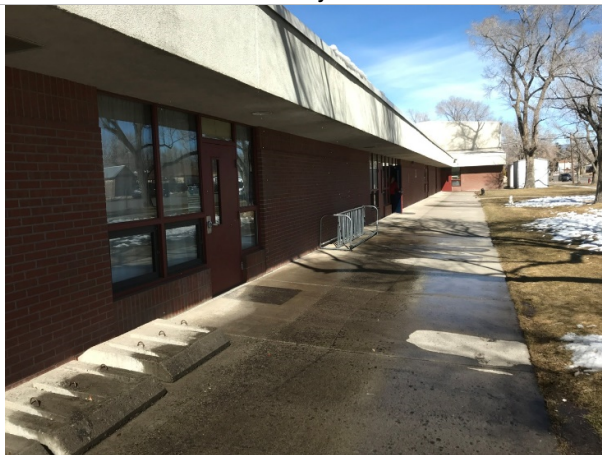
| ITEM # | FACILITY | LOCATION | ITEM DESCRIPTION | CONSULTANT | ITEM CATEGORY | FAIL TIMING | CAT | CONSQ | FINAL RANK | REMAINING LIFE (YEARS) | COST (Direct Cost) (no soft costs) | COST (w/ Fees & GC's) (no soft costs) | TOTAL COST (w/ soft costs) | TOTAL COST (w/ contingency) |
|---|---|---|---|---|---|---|---|---|---|---|---|--|---|---|
| 2 | NES | INT | Replace single pane window in old building | RTA | Code/ADA | 1 | 3 | 4 | 12 | | \$ 38,400 | \$ 44,160 | \$ 52,992 | \$ 59,616.00 |

Replace single pane window in old building

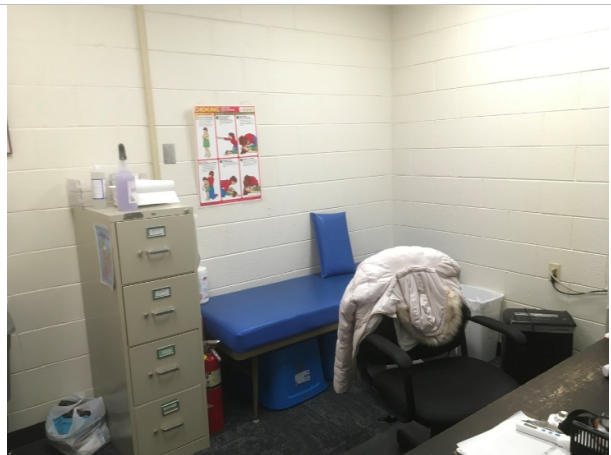
| ITEM # | FACILITY | LOCATION | ITEM DESCRIPTION | CONSULTANT | ITEM CATEGORY | FAIL TIMING | CAT | CONSQ | FINAL RANK | REMAINING LIFE (YEARS) | COST (Direct Cost) (no soft costs) | COST (w/ Fees & GC's) (no soft costs) | TOTAL COST (w/ soft costs) | TOTAL COST (w/ contingency) |
|---|---|---|---|---|---|---|---|---|---|---|---|--|---|---|
| 4 | NES | INT | Provide privacy curtain in nurse's office | RTA | Code/ADA | 1 | 3 | 4 | 12 | | \$ 1,500 | \$ 1,725 | \$ 2,070 | \$ 2,328.75 |

Provide privacy curtain in nurse's office

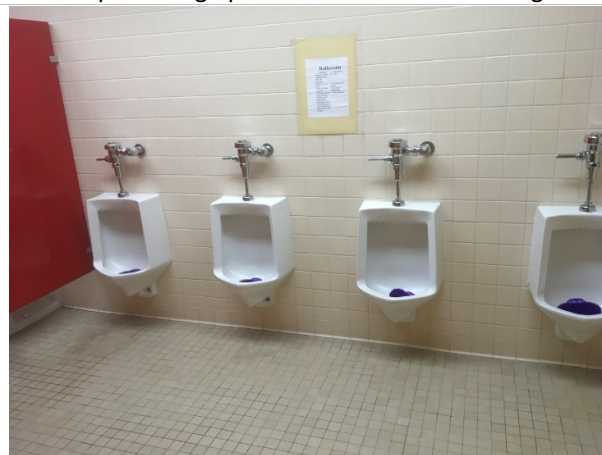
| ITEM # | FACILITY | LOCATION | ITEM DESCRIPTION | CONSULTANT | ITEM CATEGORY | FAIL TIMING | CAT | CONSQ | FINAL RANK | REMAINING LIFE (YEARS) | COST (Direct Cost) (no soft costs) | COST (w/ Fees & GC's) (no soft costs) | TOTAL COST (w/ soft costs) | TOTAL COST (w/ contingency) |
|---|---|---|---|---|---|---|---|---|---|---|---|--|---|---|
| 5 | NES | INT | Provide urinal screens | RTA | Code/ADA | 1 | 3 | 4 | 12 | | \$ 2,700 | \$ 3,105 | \$ 3,726 | \$ 4,191.75 |

Provide urinal screens

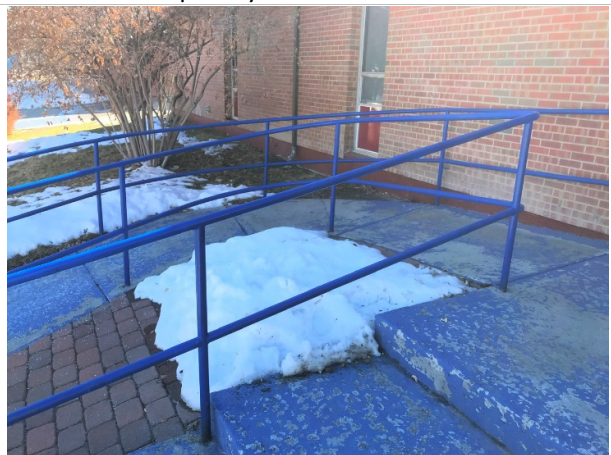
| ITEM # | FACILITY | LOCATION | ITEM DESCRIPTION | CONSULTANT | ITEM CATEGORY | FAIL TIMING | CAT | CONSQ | FINAL RANK | REMAINING LIFE (YEARS) | COST (Direct Cost) (no soft costs) | COST (w/ Fees & GC's) (no soft costs) | TOTAL COST (w/ soft costs) | TOTAL COST (w/ contingency) |
|---|---|---|---|---|---|---|---|---|---|---|---|--|---|---|
| 11 | NES | EXT | Handicap ramp does not meet ADA requirements | RTA | Code/ADA | 1 | 5 | 4 | 20 | | \$ 10,000 | \$ 11,500 | \$ 13,800 | \$ 15,525.00 |

Handicap ramp does not meet ADA requirements
