## Oak Grove Elementary School

**62100 Oak Grove  
Montrose, CO 81403**

### 3.2 Condition Analysis Matrix

# Condition Photo Documentation

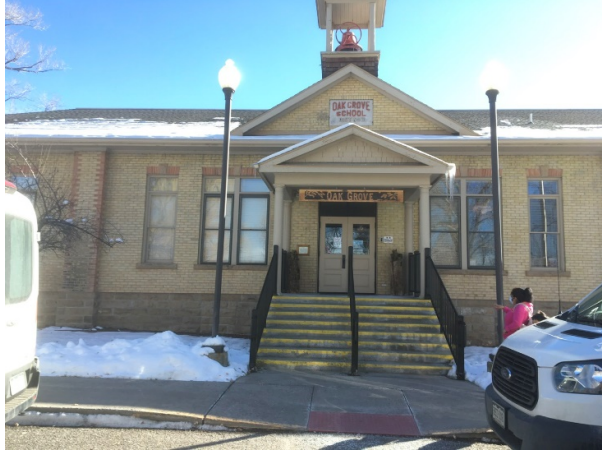
Replace front entry stairs that are deteriorating from freeze and thaw

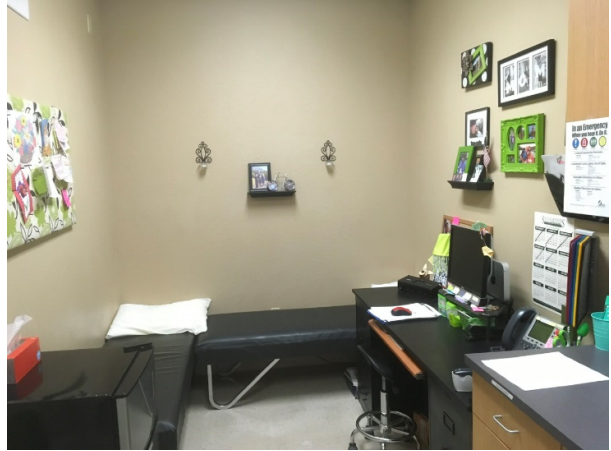
Provide privacy curtain in nurse's office

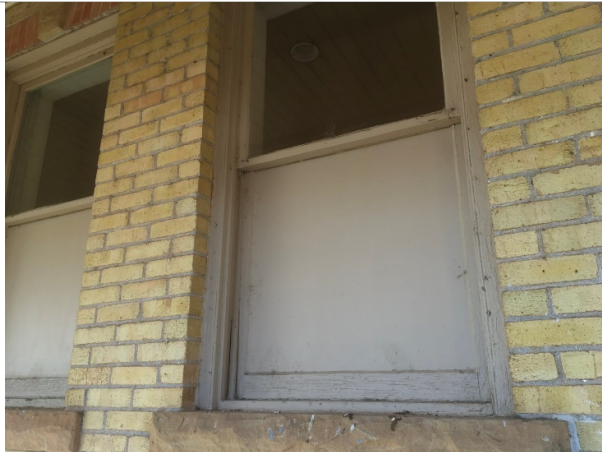
Replace windows in bathroom, library, 400 wing, and original building

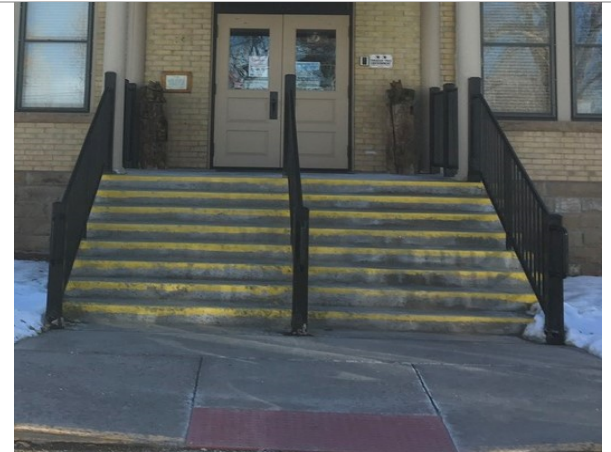
Replace rusted and broken handrail at main entry

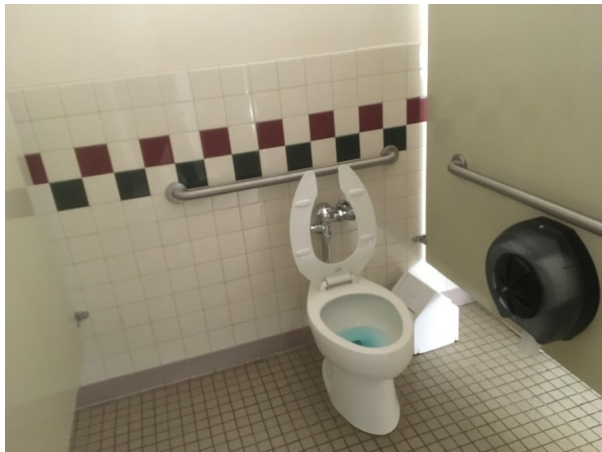
Provide vertical grab bars

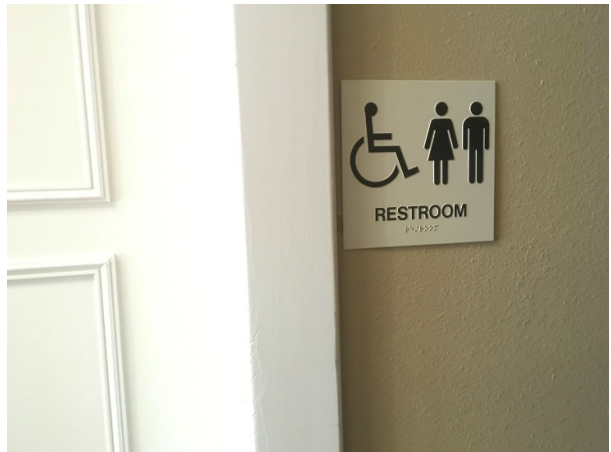
Provide ADA compliant door signage

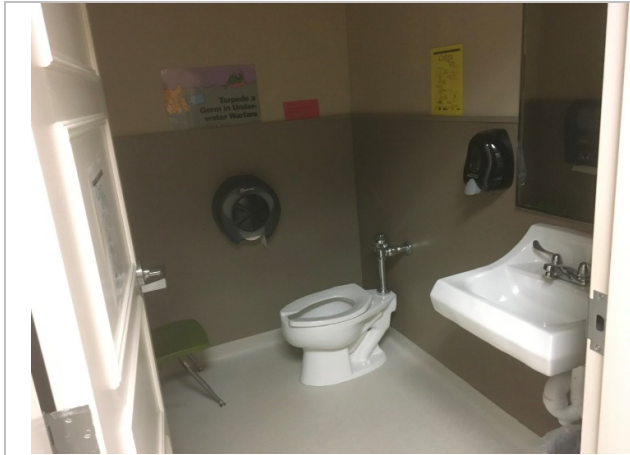
Provide ADA compliant toilets

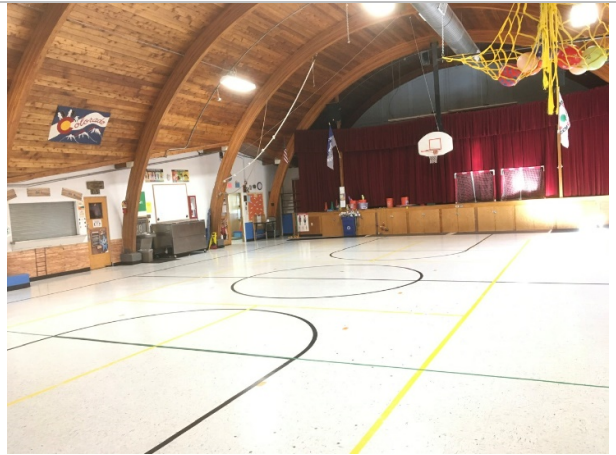
Provide ADA access to stage

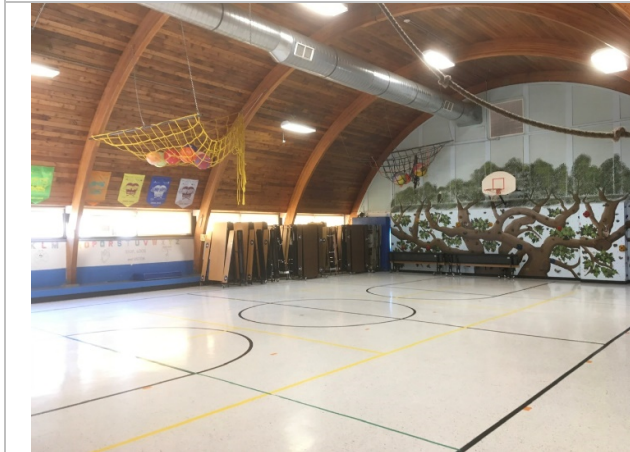
Replace rotten wood on multi-colored wall at north of gym

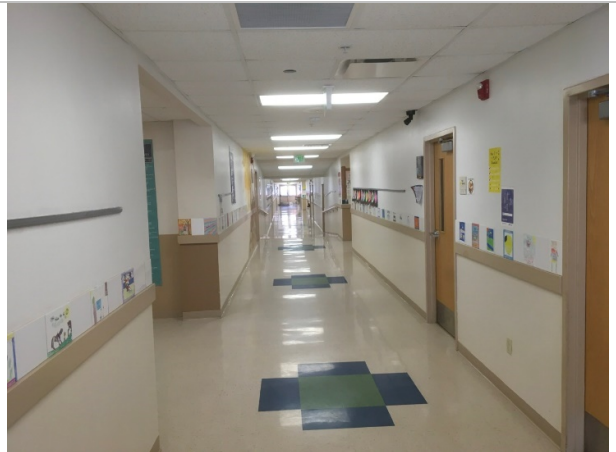
The corridors and classrooms have fluorescent lighting

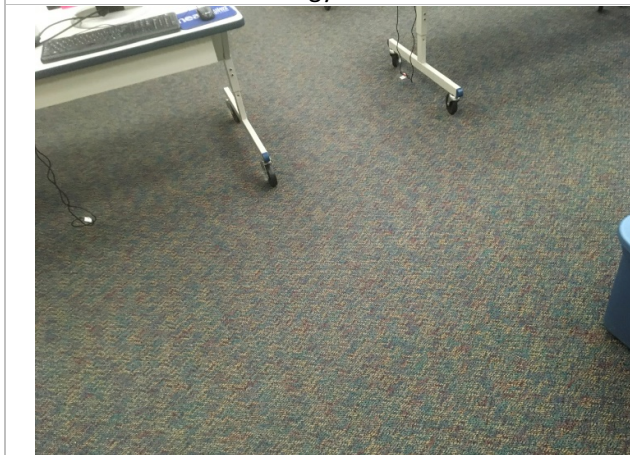
Replace carpeting in 5-10 years

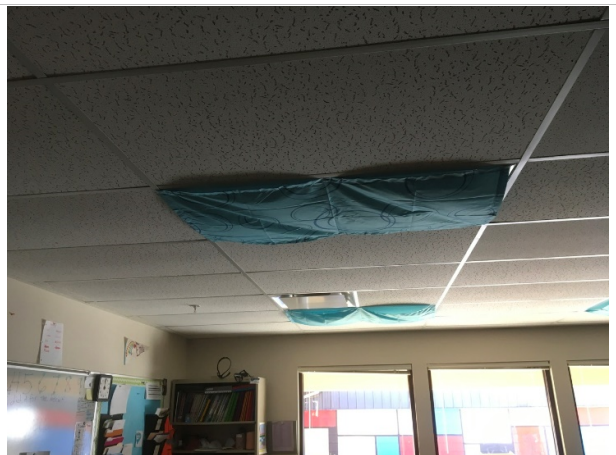
Replace deteriorates ceiling tiles
