## Olathe Elementary School

**326 North 3rd Street  
Olathe, CO 81425**

### 3.2 Condition Analysis Matrix

# Condition Photo Documentation

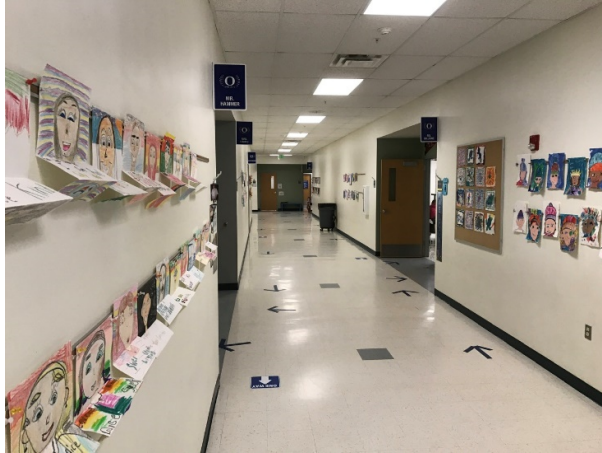
Flourescent lighting in hallways

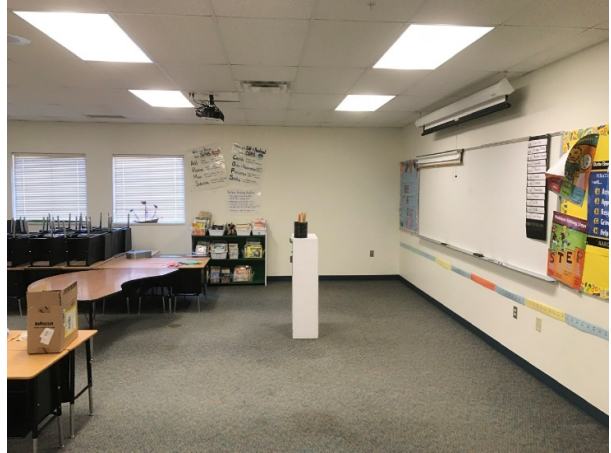
Flourescent lighting in classrooms

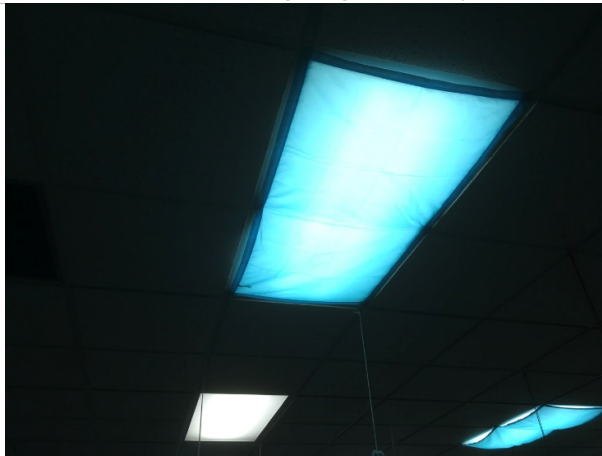
Flourescent lighting cover due to undesirable light output

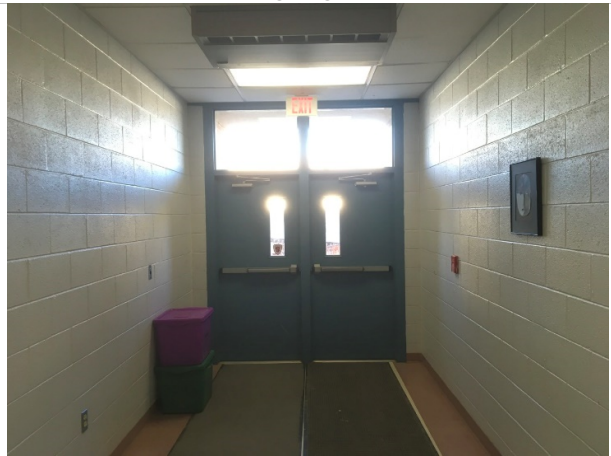
Heavily used exterior doors with out energy vestibule

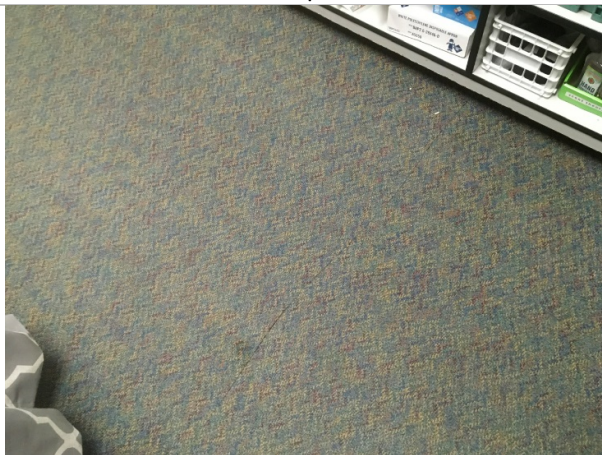
Deterriorated carpet in Media Center & Administration

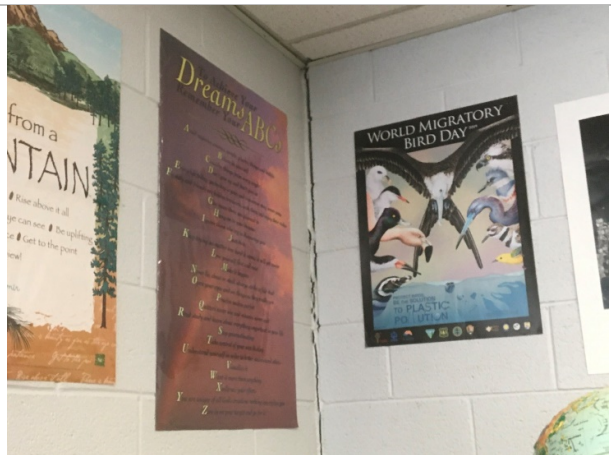
Settlement cracks in interior CMU walls

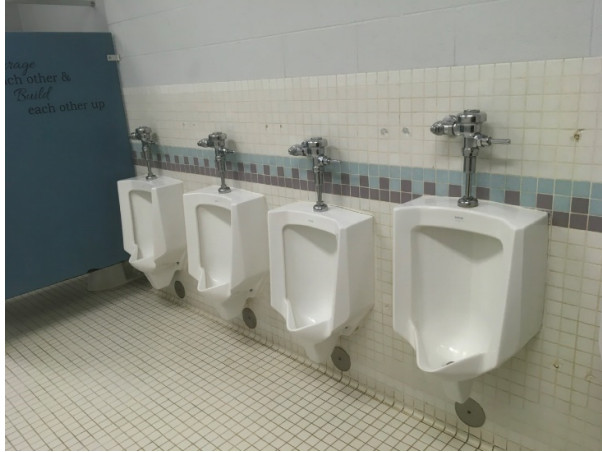
Lack of screening in main restrooms

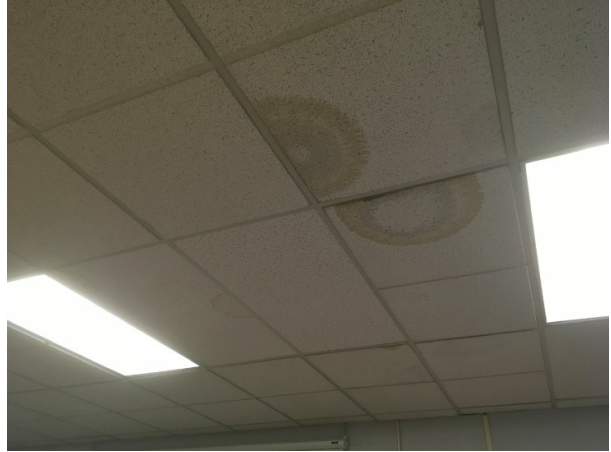
Water damage in interior ceiling tiles

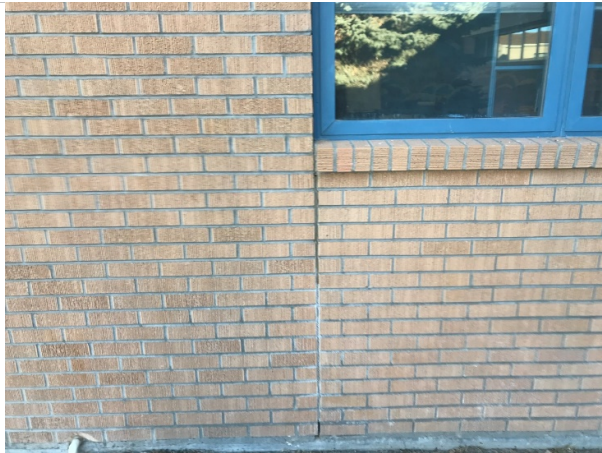
Deteriorated caulk joints

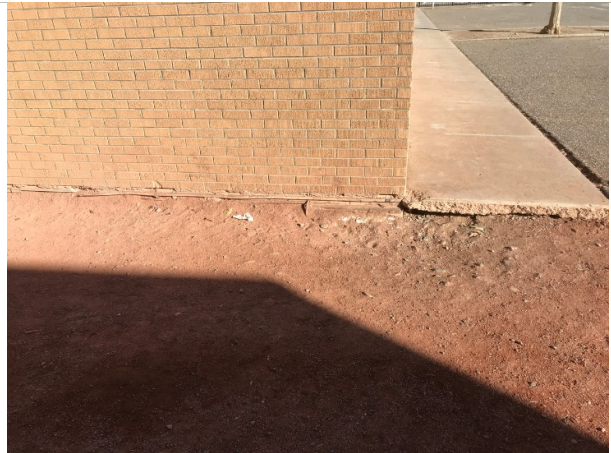
Broken sidewalk and deteriorated brick

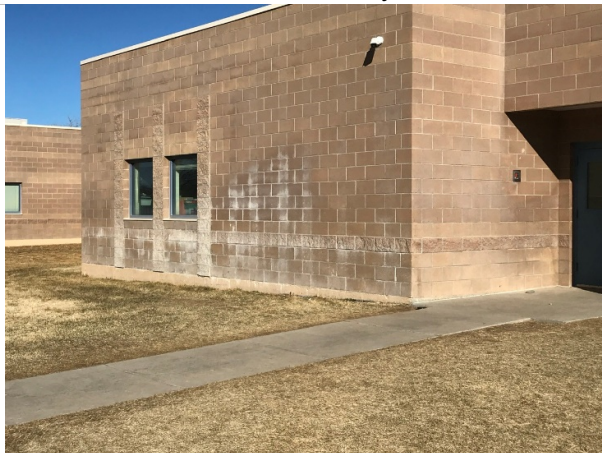
Effervescent on exterior wall

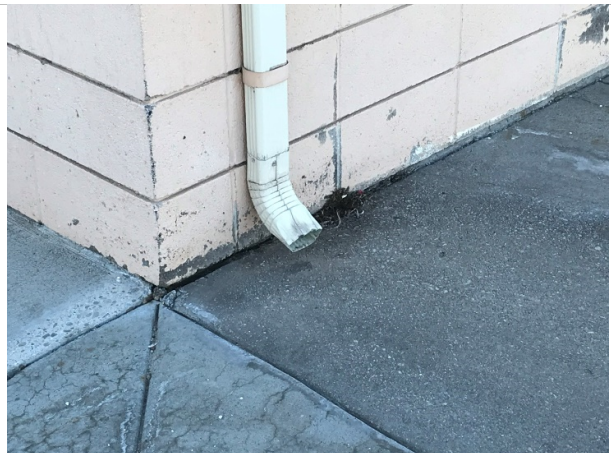
Downspout at sidewalk / icing issues

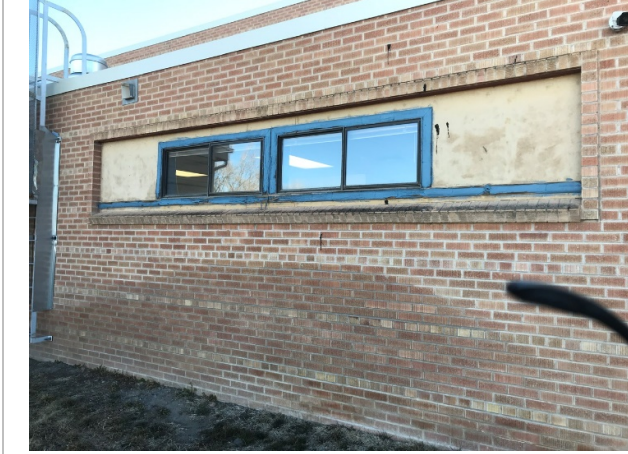
Deteriorated wood at exterior windows

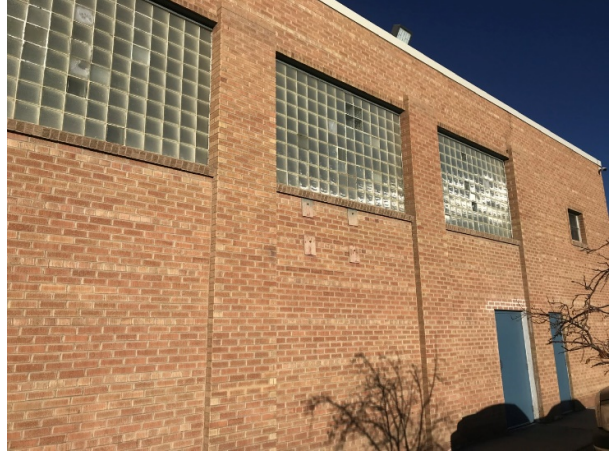
Inefficient glass block openings
