RTA Architects
Archuleta School District 50JT
K-8 School Due Diligence

Archuleta School District 50JT K-8 School Due Diligence

SGM Project 2025-345.001

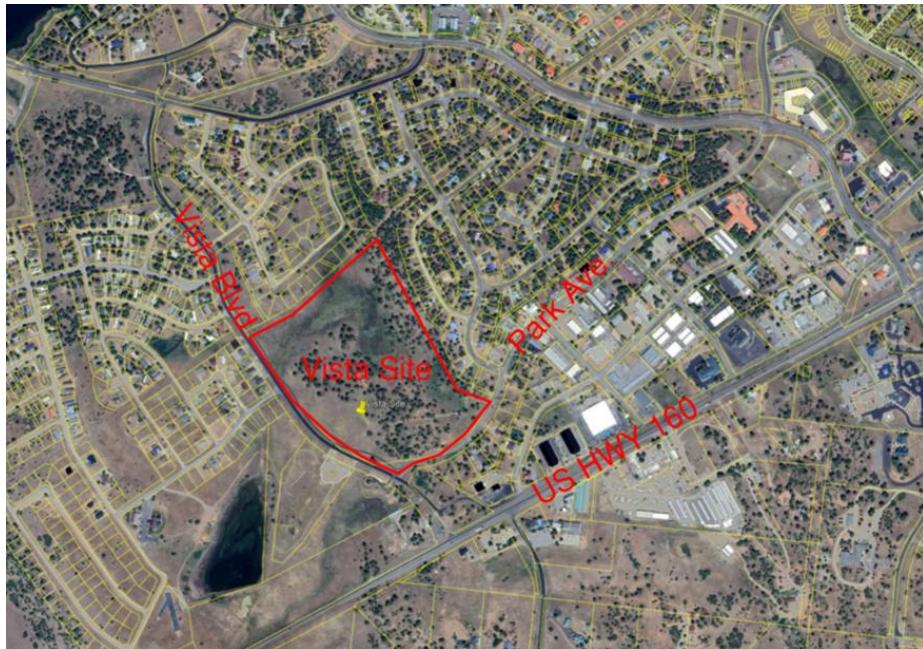
Figure 1: Vista Site Location

The Vista parcel consists of a mix of wetland meadows and ponderosa pine woodlands. The property is adjacent to Vista Blvd. and Park Ave. Typical access to the property is from the junction of Hwy 160 and Vista Blvd.

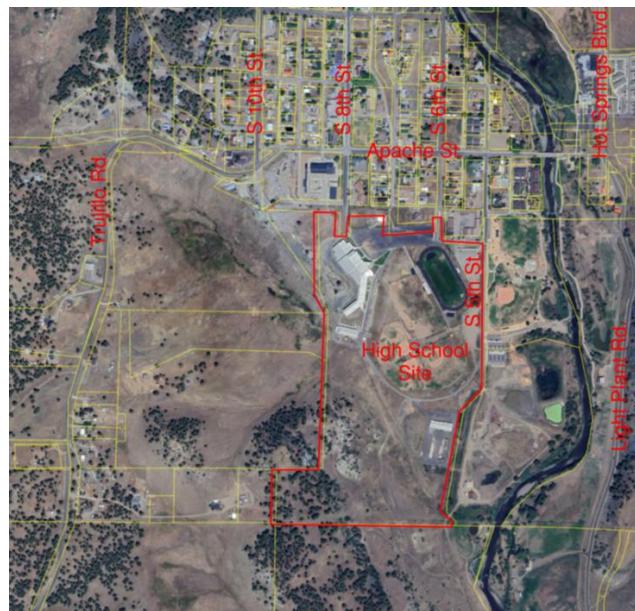
Figure 2: High School / Trujillo Site Location

The High School parcel is mostly school buildings, facilities, and a bus barn. There is a segment of undeveloped land on the property, located on the southwest corner, that is being evaluated for feasibility. This area would be accessed off South 5th St.

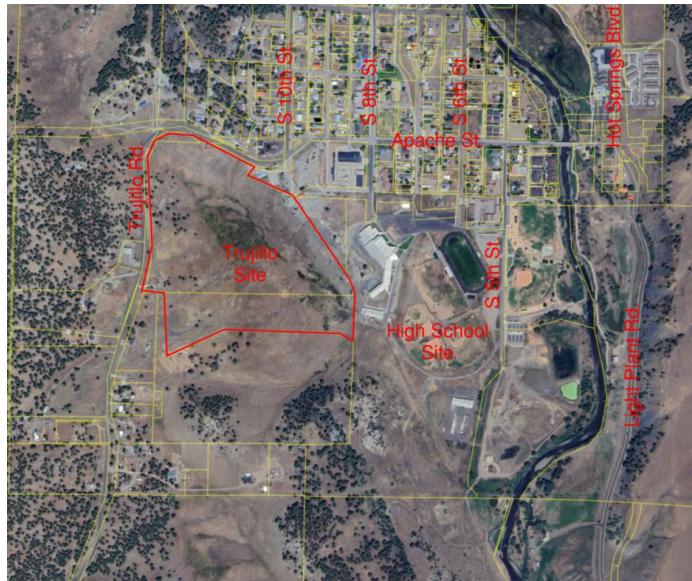
Figure 3: Trujillo Site Location

The Trujillo parcel consists of a mix of wetland and moderately sloping meadows with some ponderosa pine on the western side of the property. The property is adjacent to Trujillo Road.

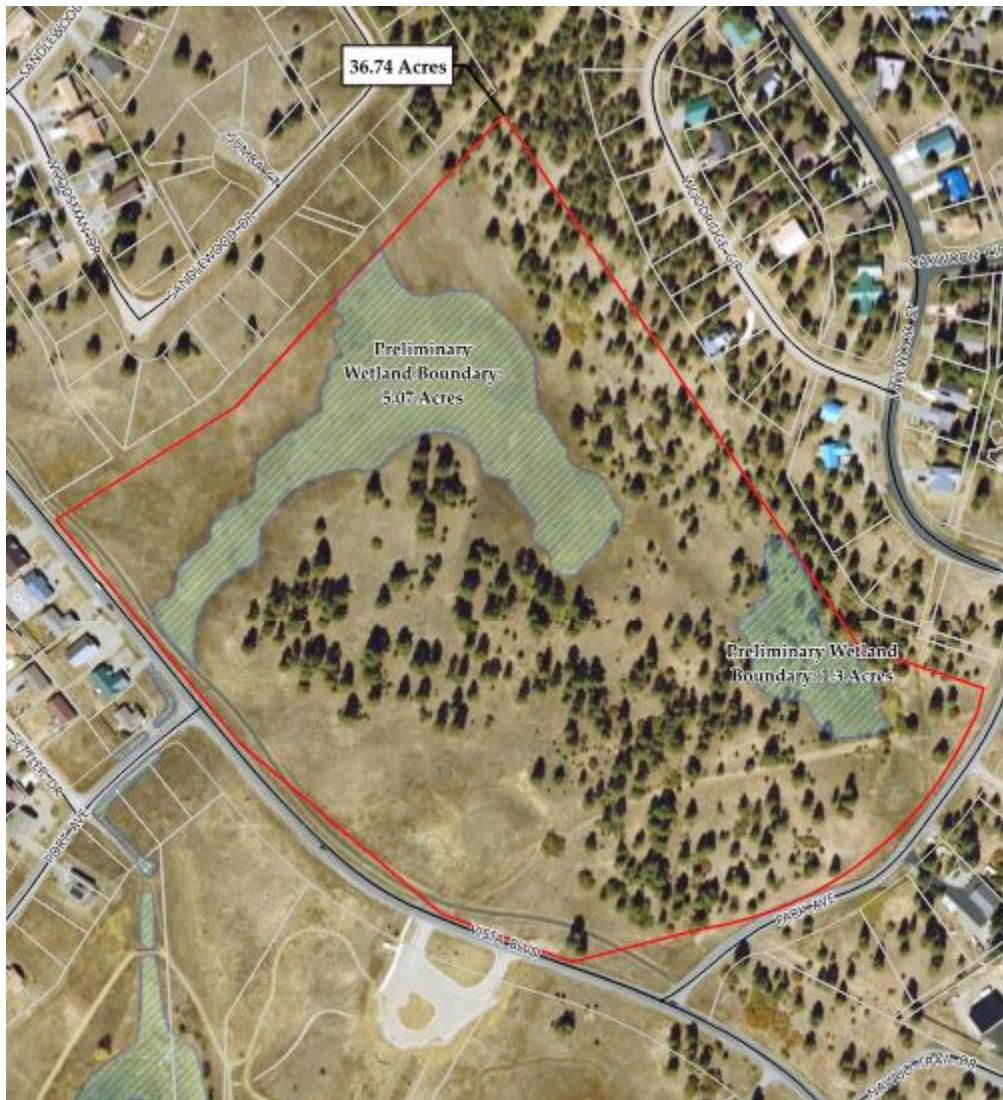
Figure 4: Vista Site Wetland

meadow located on the Vista parcel has a surface connection to the reservoir located southwest of the project area. Therefore, wetlands on the Vista parcel are under the jurisdiction of the US Army Corps of Engineers and would require permitting any proposed disturbances.

Due to drought conditions, vegetation within the project area was in very poor condition for September. However, there was sufficient plant material to determine the presence of wetlands on the Vista parcel. Wetland vegetation was dominated by Baltic Rush (*Juncus balticus*) and a rush species (*Carex* spp.). Both are common wetland plant species in Southwest Colorado.

Soil samples were color scored within and adjacent to wetland areas. Samples in wetlands met the Army Corps hydric soil color criteria. Review of NRCS soil survey maps identified Tottles clay loam in wetland areas, which is on the national hydric soil list, and testing confirmed this within the project area. Saturated soils or surface inundations were lacking for almost the entire site, which is not unusual in September. However, soil saturation and inundation were observed adjacent to the Vista Blvd culvert as well as the southeast corner of the parcel, where water

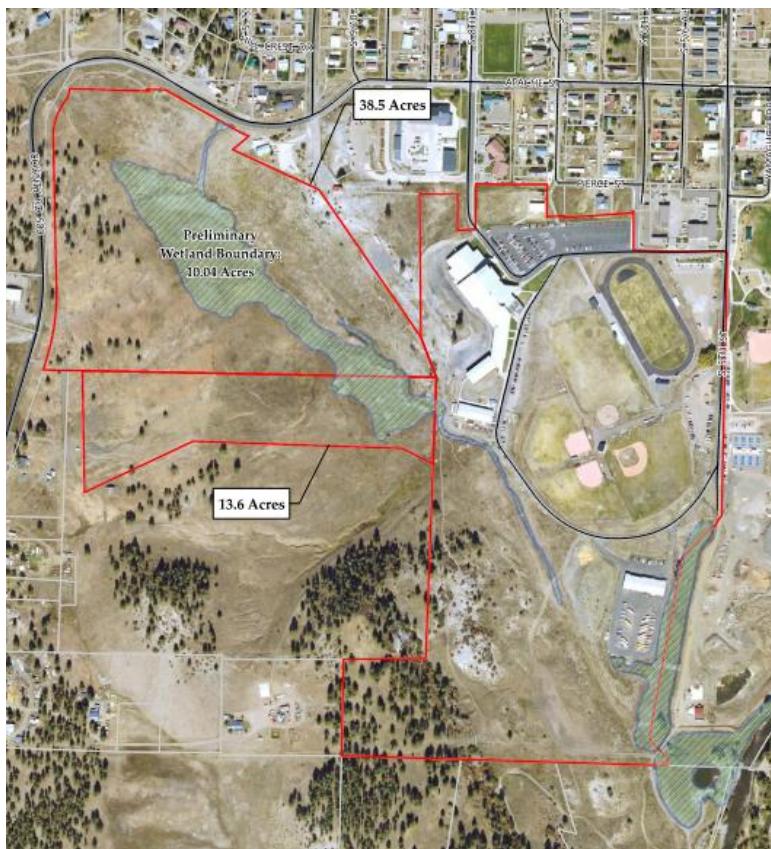
Figure 5: HS/Trujillo Site Wetland

Approximately 10.04 acres of the 52.1+ acre parcel were identified within the project area, and the approximate boundaries are illustrated in Figure 5 and Appendix C. The majority of the wetlands were located on the Trujillo property but continued across the high school property.

Due to the drought conditions, vegetation within the project area was in very poor condition for September. However, there was sufficient plant material to determine that wetlands begin two-thirds of the way up the slope towards Trujillo Road, where water likely emerges/seeps from the hillside. The wetland proceeds downslope towards the southern end of the high school building complex, draining into a sizable naturally occurring swale. Wetland vegetation was dominated by Baltic Rush (*Juncus balticus*) and a spike rush species (*Eleocharis spp*). Both are common wetland plant species in Southwest Colorado.

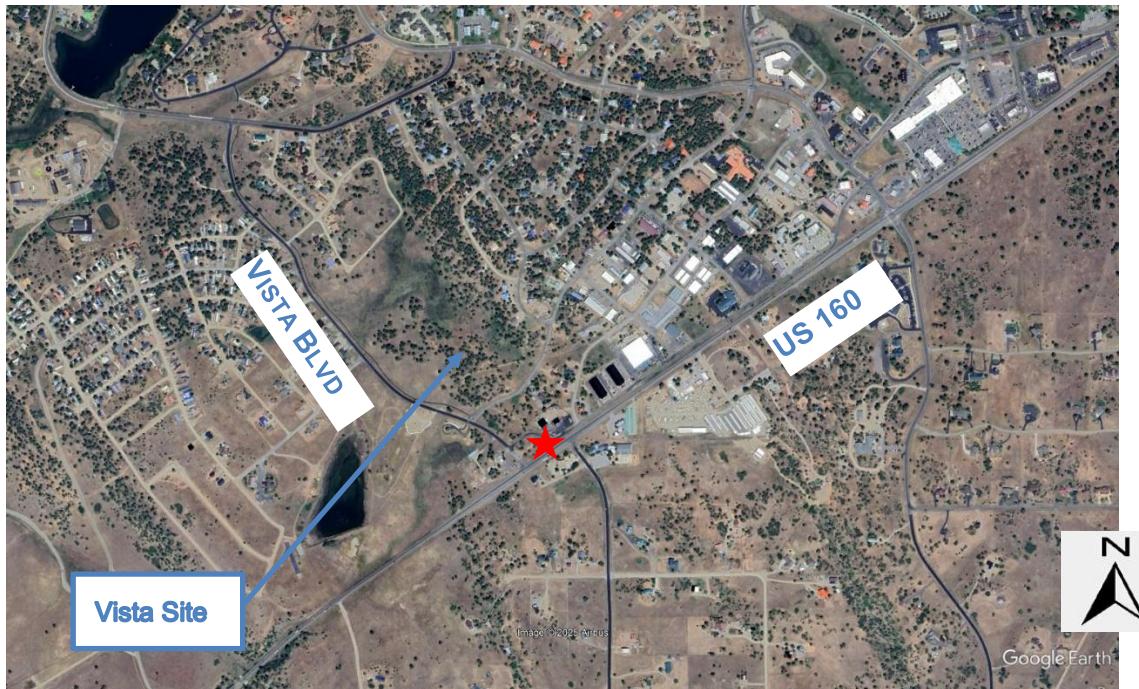
Figure 6: Vista Site Location Map

This Traffic Analysis is generally prepared using the guidelines for a Colorado Department of Transportation (CDOT) Level Two Auxiliary Turn Lane Assessment (TLA). The analysis is being completed to provide a feasibility analysis for the Vista and High School / Trujillo sites shown in Figure 6 and Figure 7.

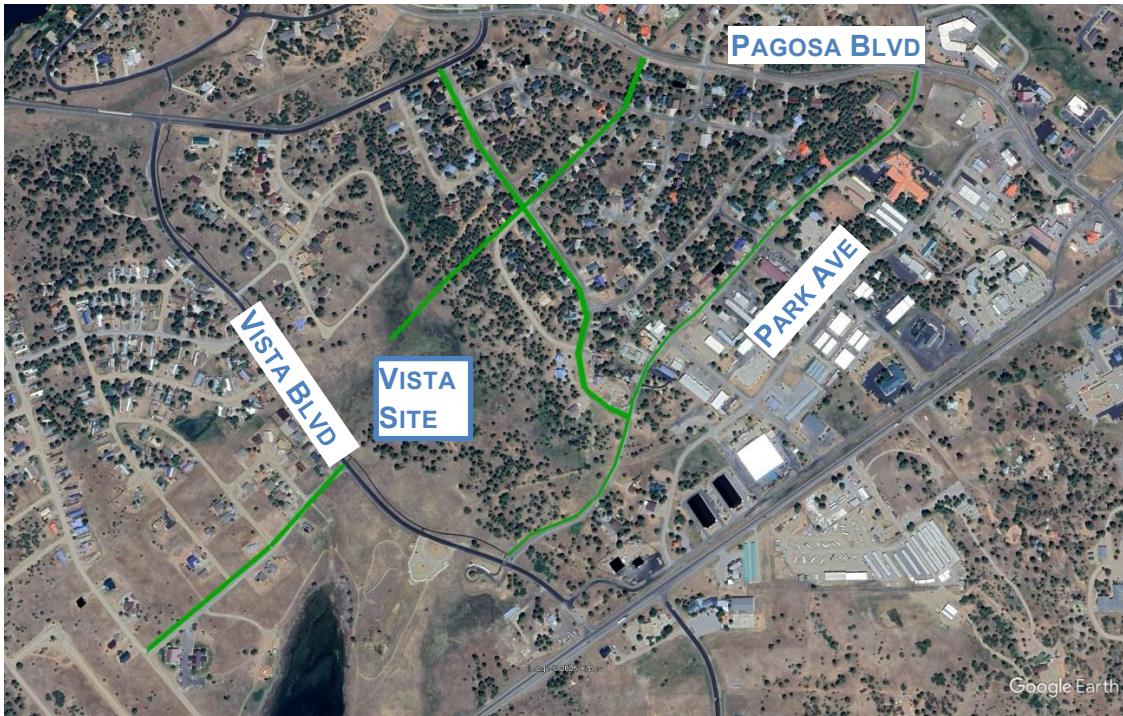
Figure 10: Vista Site Potential Pedestrian Routes

The existing sidewalk infrastructure in the Vista area within a $\frac{1}{2}$ to 1 mile radius of the proposed site is generally lacking. Capital investment to expand multimodal infrastructure would be recommended to provide the same level of accessibility provided around the downtown site. The green lines represent potential routes in Figure 3 (~10,000 linear feet). Specific improvements for the final location and crossings would need to be studied and implemented. The scope of this study does not consider the effect the relocation of the Elementary and Middle Schools to the Vista site would impact the bus system efficiency or cost. It is possible these capital improvements are outside the scope of the School District to construct but should be a stakeholder in the community for these investments to be built.

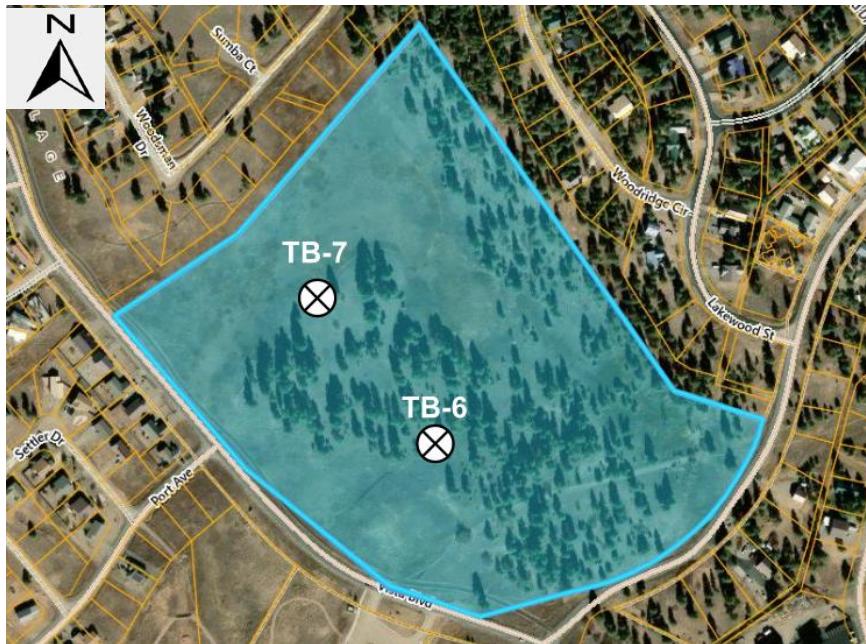
Figure 15: Geotechnical Engineering Study Boring Location Map

compacted structural fill. The foundations could support a multistory building up to three stories without concern.

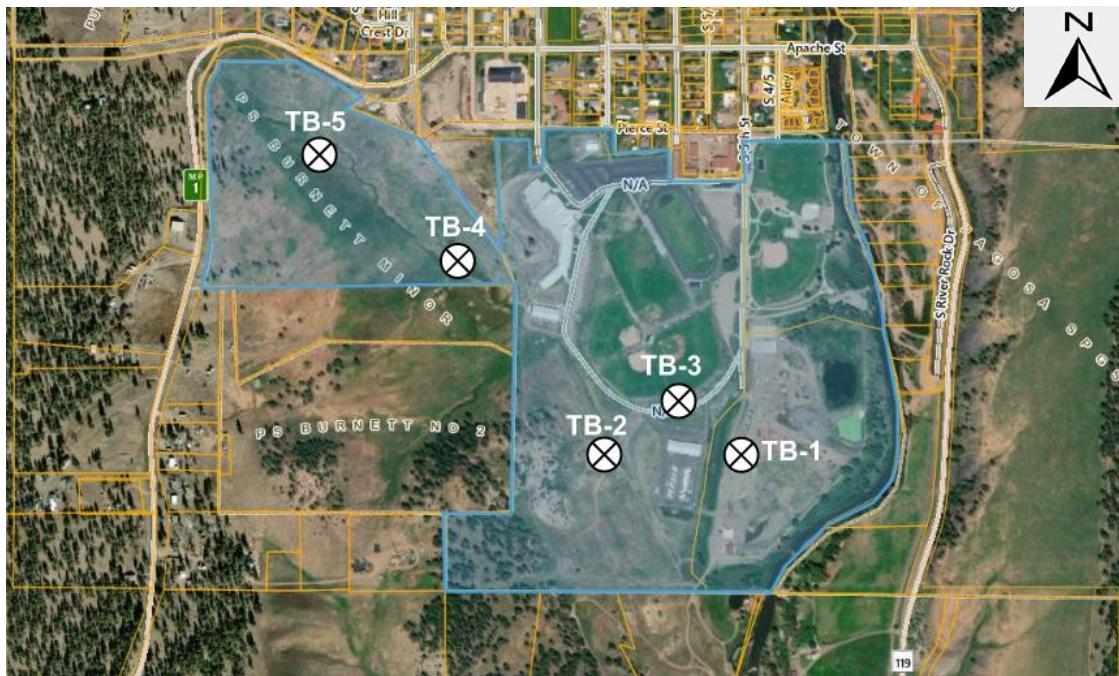
Figure 22: Geotechnical Engineering Study - High School/Trujillo Site Boring Location Map

Trautner Geotech performed three (3) borings named TB-1 through TB-3 at the High School Site, as presented in Figure 22.

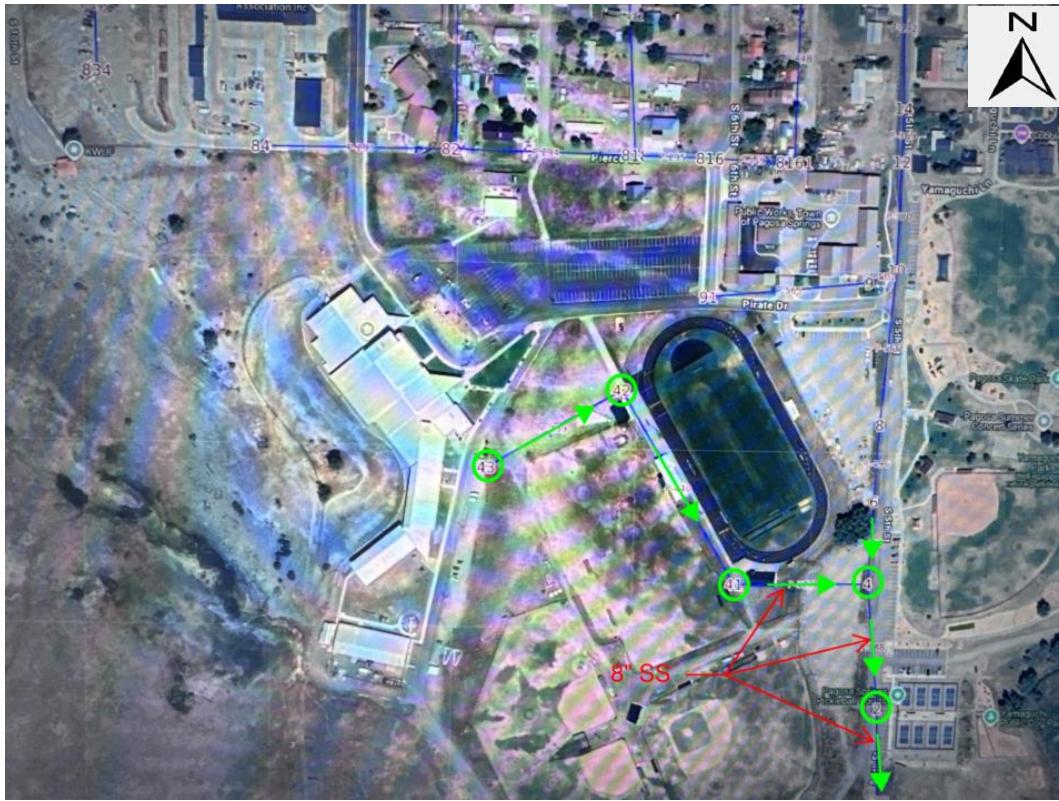
Figure 24: Pagosa Sanitary Sewer General Improvement District – Trujillo Site Sanitary Sewer Map

The Trujillo site is within the Pagosa Sanitary Sewer General Improvement District (PSSGID) and would be subject to sewer connection with this district—an 8" gravity main runs along the east side of S 5th Street. Depending on building placement, the Trujillo property would require 3,000 feet to 4,000 feet of sewer extension to connect to the gravity sewer on South 5th Street. The sewer map of the area provided by the utility is presented in Figure 24.

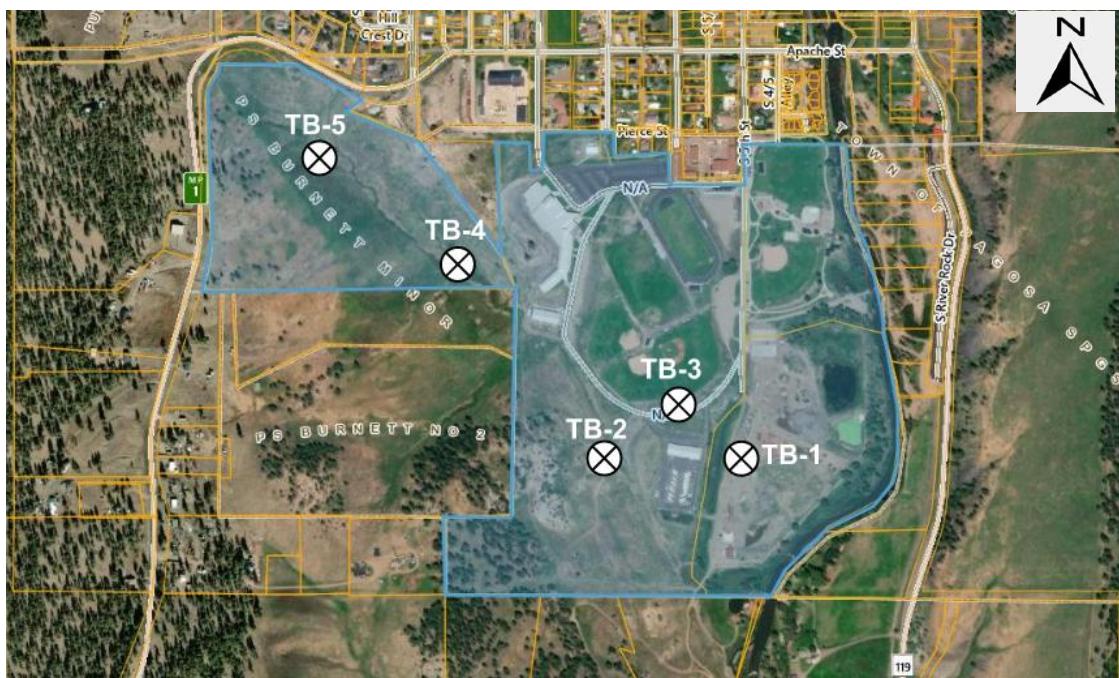
Figure 27: Geotechnical Engineering Study - High School/Trujillo Site Boring Location Map

Trautner Geotech performed two (2) borings named TB-4 and TB-5 at the Trujillo Site, as presented in Figure 27.

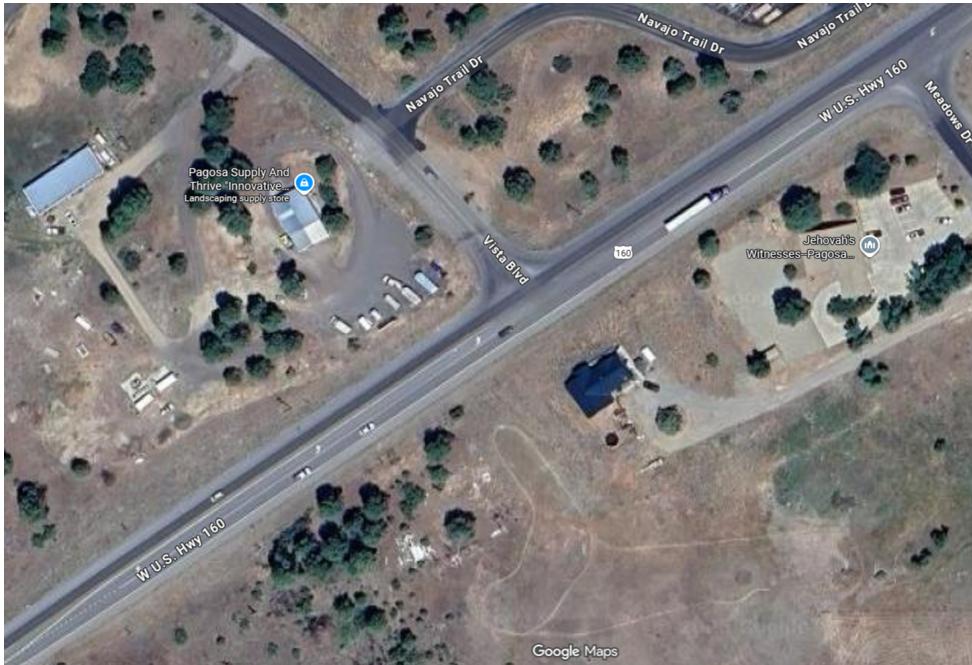
CATEGORY NR-A - Non-Rural Principal Highway

Auxiliary Lane Requirements

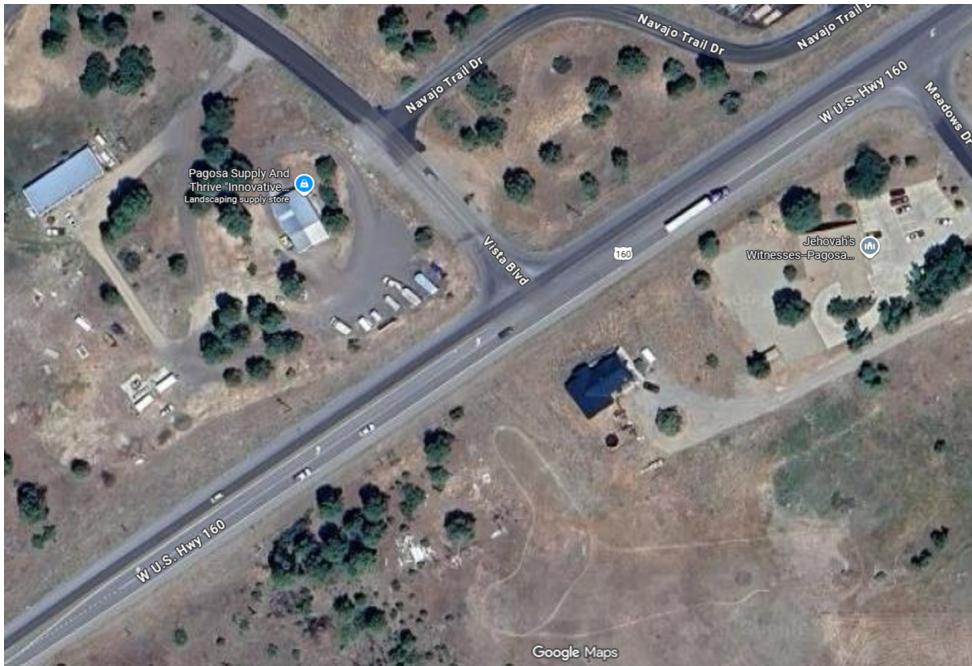
CATEGORY NR-A - Non-Rural Principal Highway

Auxiliary Lane Requirements
