Condition Photo Documentation

Pagosa Springs Middle School

09/26/2024

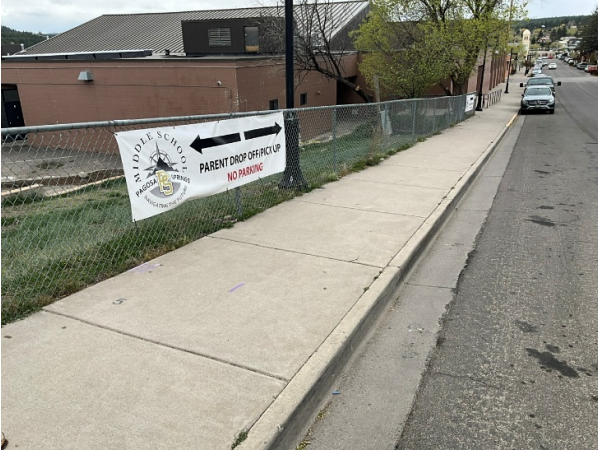
<p><i>There was only one instance of signage designating on-street parent drop-off and pick-up observed.</i></p>
b

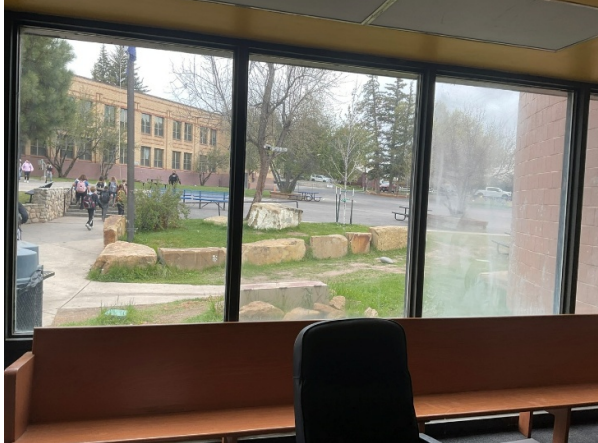
<p><i>The entries to the school property are not easily surveilled from the main entry/ administration offices.</i></p>
c

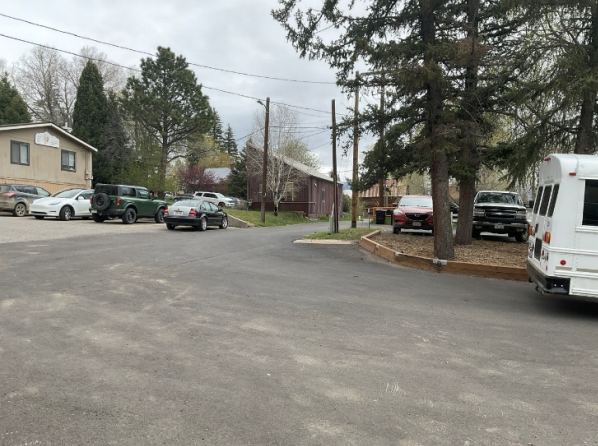
<p><i>Parking lot entrances and exits are NOT clearly marked and delineated for students, staff and visitors.</i></p>

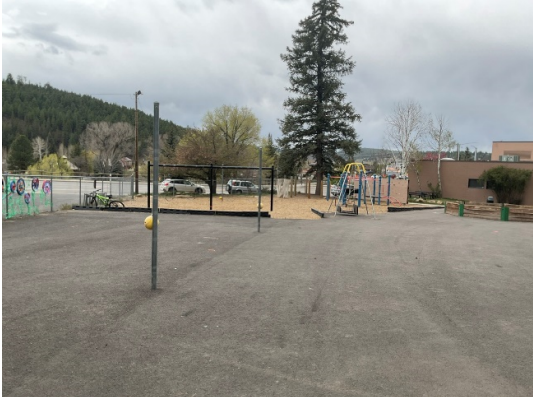
<p><i>The minimal playground equipment offered is dated, weathered and in disrepair.</i></p>
b

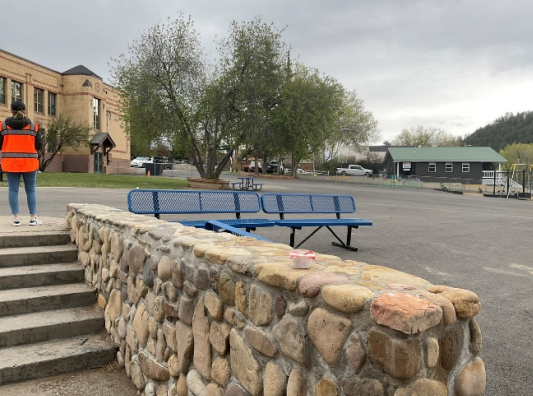
<p><i>There are no playfields offered at this school due to site constraints. They utilize the town park across the street.</i></p>

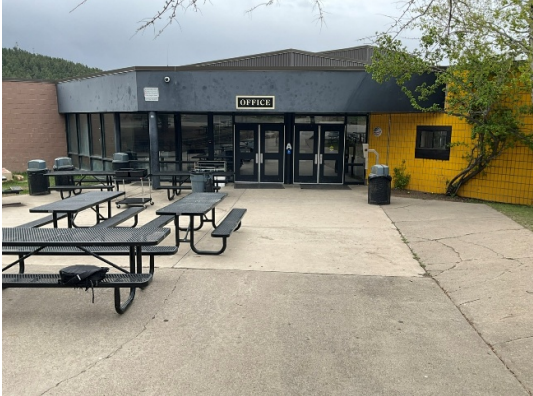
<p><i>There are NO vehicular barriers (bollards, concrete benches, etc.) at the main entry that are integrated into the design.</i></p>
b

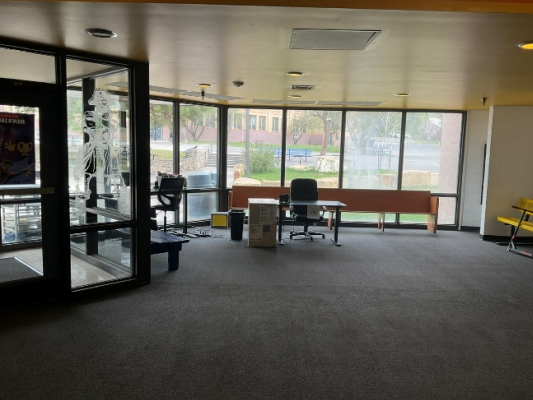
<p><i>MS 5-6 has 2 separate doors with no secure entries and stands separate from MS 7-8. MS 7-8 has the ability to be a secure vestibule but controlled at exterior doors only.</i></p>
c

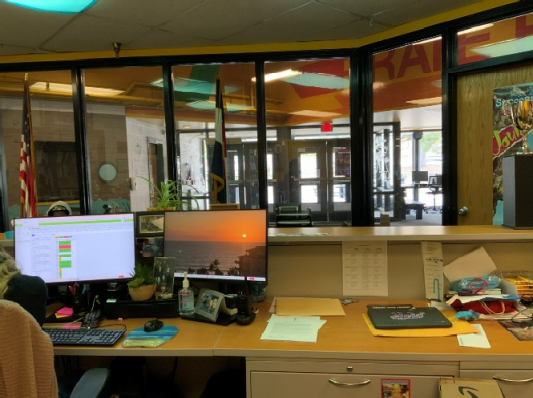
<p><i>Administration is buried internally and does NOT have direct connection to the vestibule via a transaction window.</i></p>

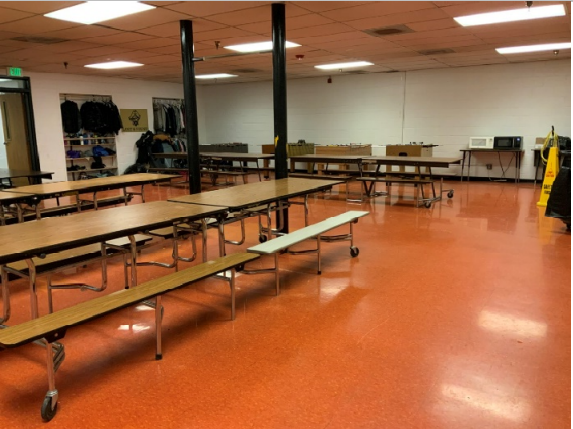
<p><i>-The cafeteria is NOT located adjacent to playgrounds or other outdoor recreation space for students to use during lunch.</i></p> <p><i>-There is NOT enough seating options provided (regular table and chair, high-tops, or booths, etc.)</i></p>
b

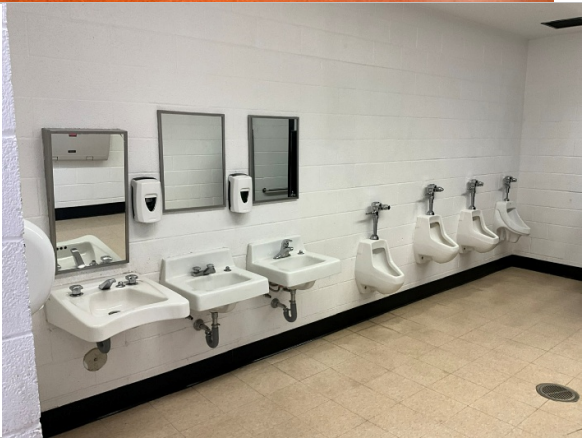
<p><i>Restrooms are NOT well distributed across the building, in various stages of disrepair and finishes are in poor condition.</i></p>
c

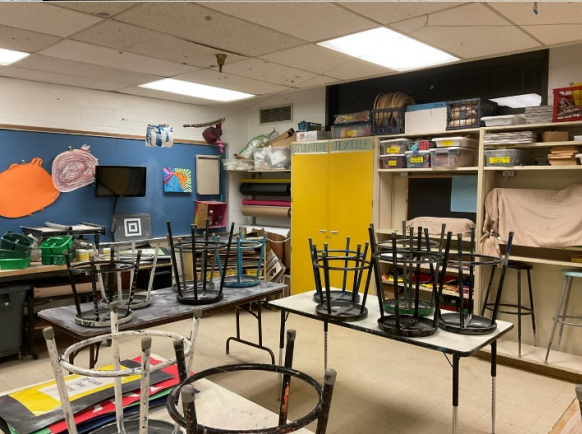
<p><i>The Art Room(s) lack of natural light or a connection to outdoors.</i></p>

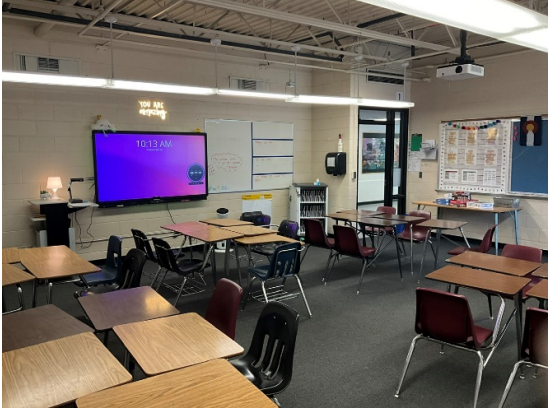
<p><i>Classrooms do NOT have flexible furniture that can be adapted to support different modes of instruction and Rotational Learning (lecture, group discussion, seminar, activity centers, etc.) that are appropriate to the age group they serve.</i></p>
b

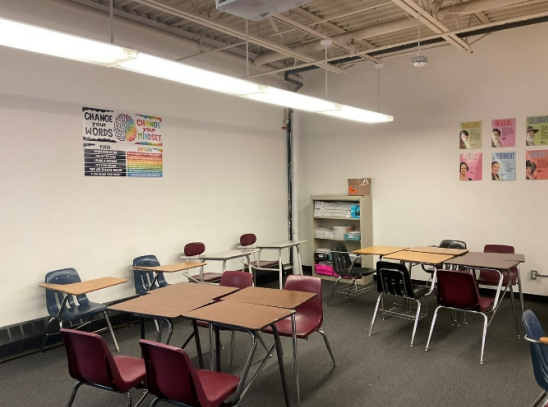
<p><i>Many classrooms in the 7th-8th building are without windows due to multiple additions.</i></p>
c

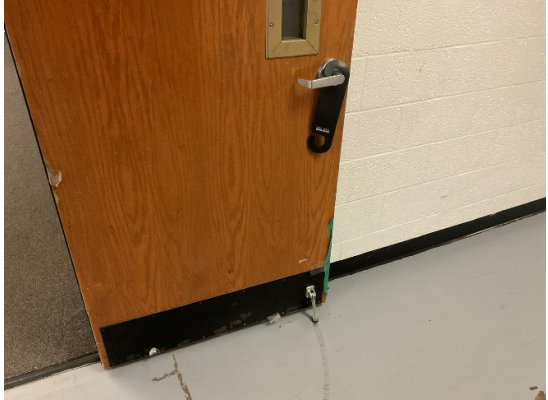
<p><i>Classroom door hardware does NOT meet the state requirement for lockability / function</i></p>
