# **OLATHE MIDDLE HIGH SCHOOL**

#### 3.2 Condition Analysis Matrix

Project: Montrose County School District Facility: Olathe Middle High School (OMHS)
Date: 2/7/2022

# **Condition Photo Documentation**

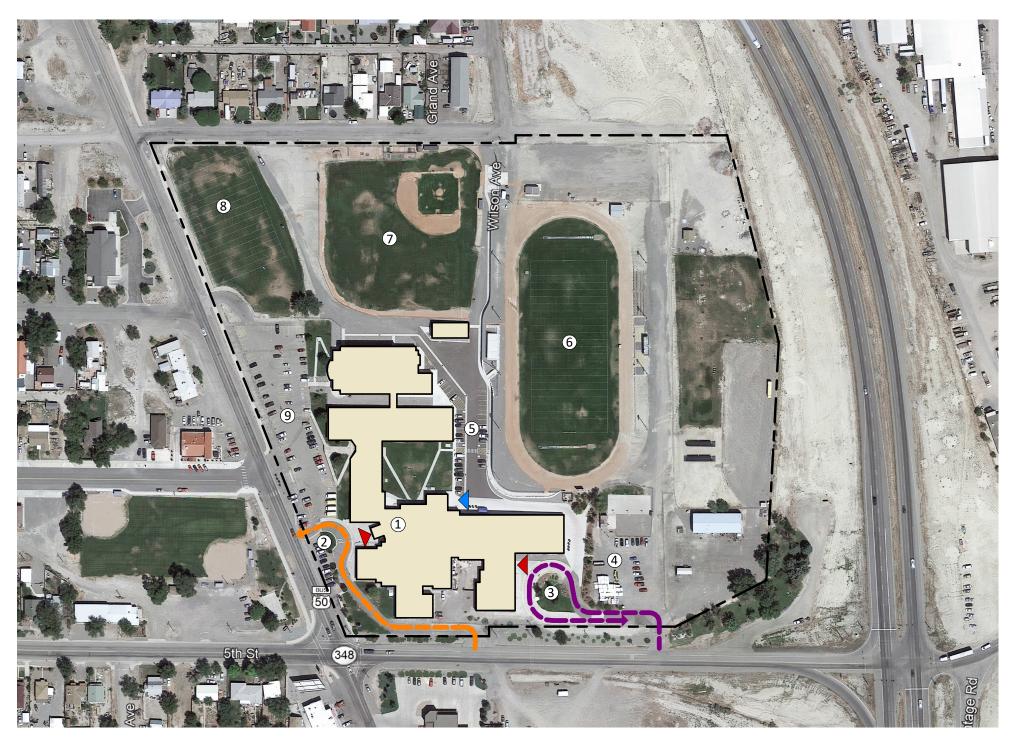
The campus lies on the east side of Business Route 50 between 2<sup>nd</sup> and 5<sup>th</sup> Streets east of the heart of Olathe with easy access to Hwy 50. The interconnected buildings and most parking are located on the southwest portion of the site, with athletic fields, service access and additional parking to the east and north. The traffic flow appears to work fairly well, although some parking at the main entrance accesses directly from Bus, Route 50 near its intersection with 5<sup>th</sup> Street.

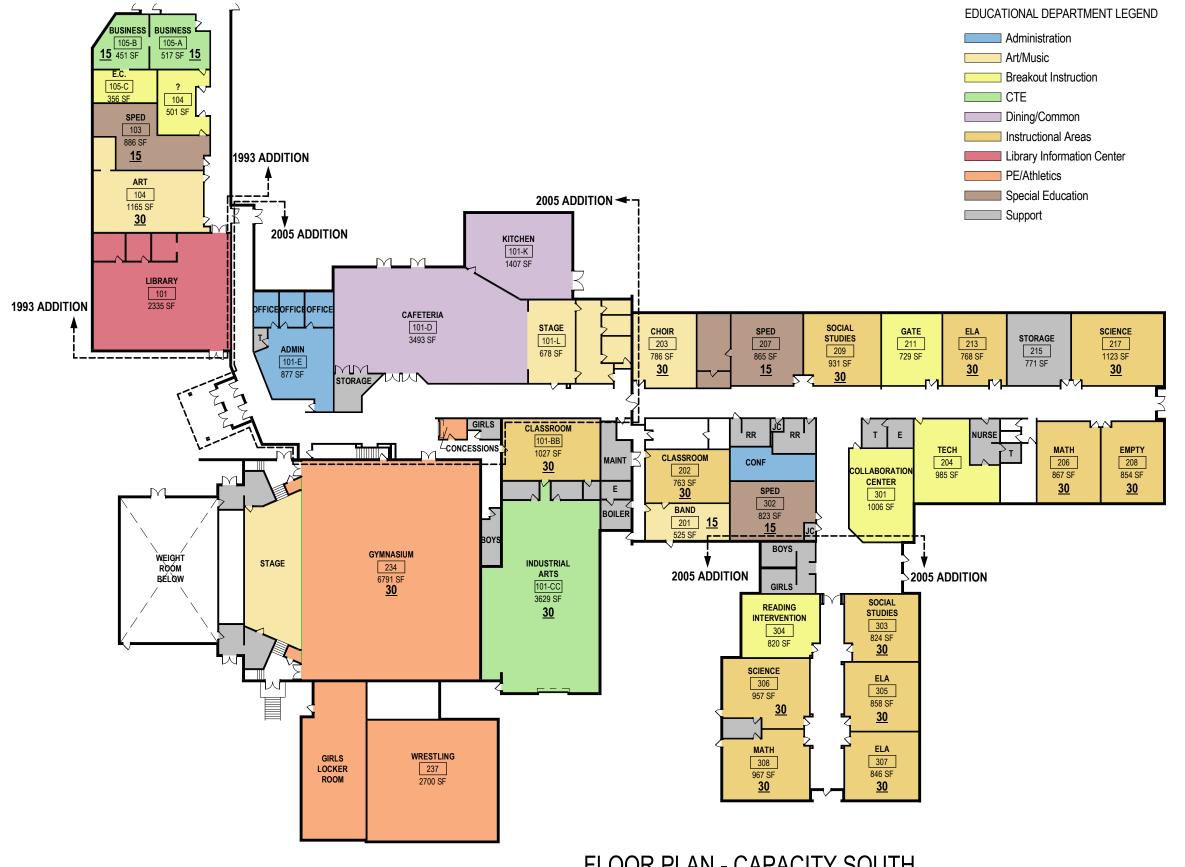
# FLOOR PLAN - CAPACITY SOUTH

#### **CLASSROOM CAPACITY**

Special Education				
SPED	103	886 SF	1	15
SPED	123	653 SF	1	15
SPED	207	865 SF	1	15
SPED	302	823 SF	1	15
GRAND TOTAL: 41		53190 SF	41	975

75% Utilization

732 students
