Ridgway School District R-2 Facilities Master Plan

December 14, 2020

1.0 Executive Summary

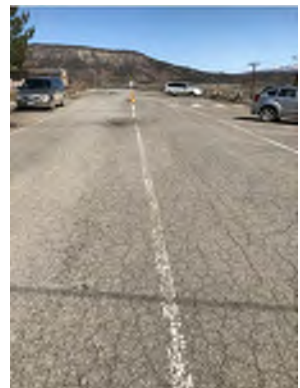
System Description:

Parking lot and roadway flexible pavement (bituminous) includes a 12" thick gravel base course for large paved areas.

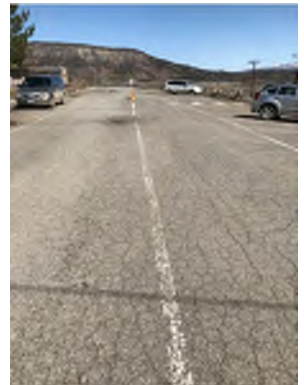
Auto generated renewal for Parking Lot and Roadway Flexible Pavement - Intermediate Course. System Description: Parking lot and roadway flexible pavement includes a 3" thick bituminous intermediate binder course for large paved areas. Years remaining have been increased because the system is currently functioning, however the system is beyond its useful life and should be budgeted for repair/replacement.

Cost:	\$69,972	Priority:	3 - Due within 5 Years of Inspection
Action Date:	3/25/24	Prime Sys:	Bases and Sub-Bases
		Action:	Parking Lot and Roadway Flexible Pavement - Intermediate Course Renewal

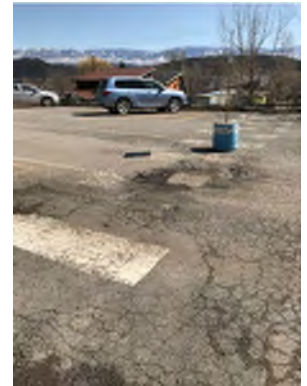
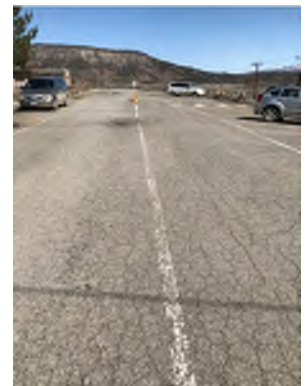
System Description:

Parking lot and roadway flexible pavement includes a 2" thick bituminous wearing surface course for large paved areas. This system is failing and should be budgeted for repair/replacement.

Auto generated renewal for Parking Lot and Roadway Flexible Pavement - Surface Course. System Description: Parking lot and roadway flexible pavement includes a 2" thick bituminous wearing surface course for large paved areas. This system is failing and should be budgeted for repair/replacement.

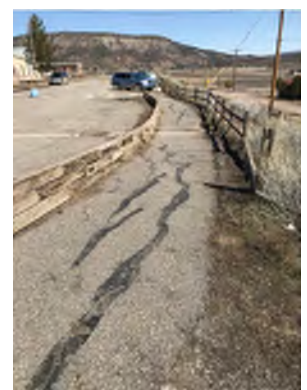
System Description:

Site development includes wood fencing with 4"x 4" posts. Years remaining have been increased because the system is currently functioning, however the system is beyond its useful life and should be budgeted for repair/replacement.

Site Development - Fencing - Wood - 1996 Renewal

Cost:	\$6,562	Priority:	3 - Due within 5 Years of Inspection
Action Date:	3/25/24	Prime Sys:	Fences and Gates
		Action:	Site Development - Fencing - Wood - 1996 Renewal

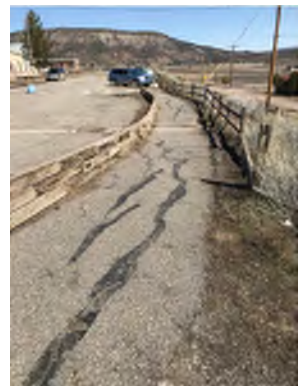
System Description:

Site development includes 4' high wood split rail fencing with post. Years remaining have been increased because the system is currently functioning, however the system is beyond its useful life and should be budgeted for repair/replacement.

Site Development - Fencing - Split Rail Renewal

Cost: \$12,350 **Priority:** 3 - Due within 5 Years of Inspection
Action Date: 3/25/22 **Prime Sys:** Fences and Gates
Action: Site Development - Fencing - Split Rail Renewal

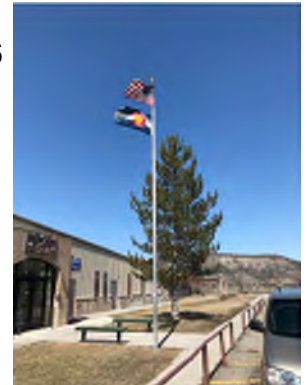
System Description:

Site development includes aluminum flagpoles. Years remaining have been increased because the system is currently functioning, however the system is approaching the end of its useful life and should be budgeted for repair/replacement.

Site Development - Flagpoles - Aluminum Renewal

Cost: \$8,670	Priority: 3 - Due within 5 Years of Inspection
Action Date: 3/25/24	Prime Sys: Flagpoles
	Action: Site Development - Flagpoles - Aluminum Renewal

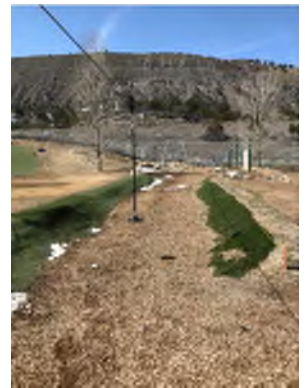
System Description:

The site includes modular play equipment, swings and a zip line.

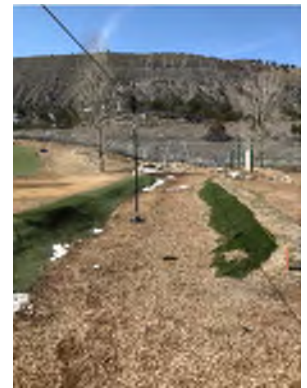
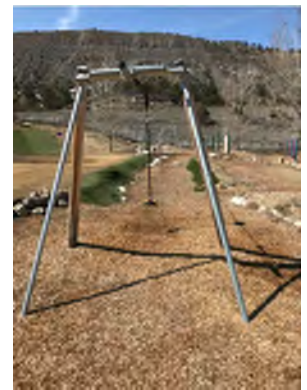
The playground area includes a wood chip protective surface. Years remaining have been increased because the system is currently functioning, however the system is approaching the end of its useful life and should be budgeted for repair/replacement.

Auto generated renewal for Site Development - Playground Protective Surfacing - Wood Chip - Playgrounds. System Description: The playground area includes a wood chip protective surface. Years remaining have been increased because the system is currently functioning, however the system is approaching the end of its useful life and should be budgeted for repair/replacement.

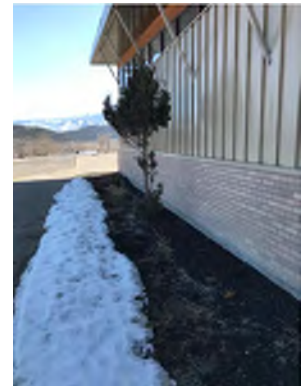
Landscaping includes stone chip over weed barrier. Years remaining have been increased because the system is currently functioning, however the system is beyond its useful life and should be budgeted for repair/replacement.

Auto generated renewal for Landscaping - Mulching - Stone Chips. System Description: Landscaping includes stone chip over weed barrier. Years remaining have been increased because the system is currently functioning, however the system is beyond its useful life and should be budgeted for repair/replacement.

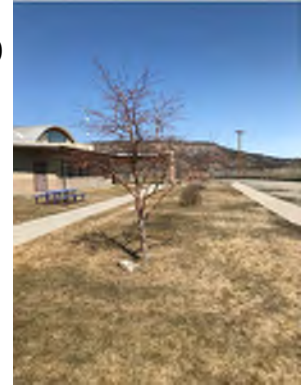
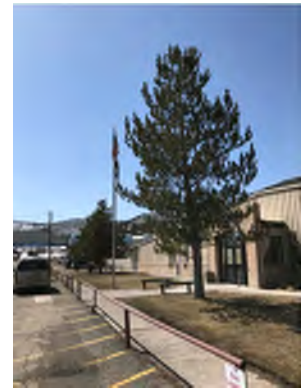
Landscaping includes graded, sodded grass areas. Note - irrigation is a separate system. This system is approaching the end of its useful life and should be budgeted for repair/replacement.

Auto generated renewal for Landscaping - Grass Sodding. System Description: Landscaping includes graded, sodded grass areas. Note - irrigation is a separate system. This system is approaching the end of its useful life and should be budgeted for repair/replacement.

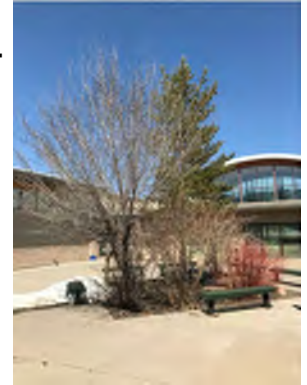
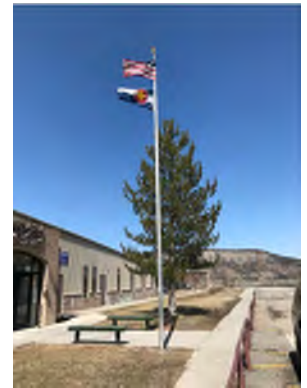
Landscaping includes trees with prepared beds.

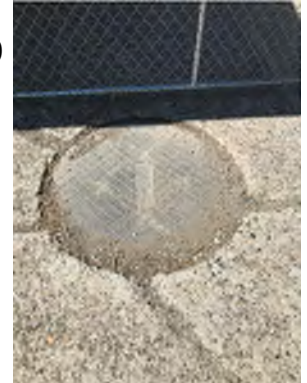
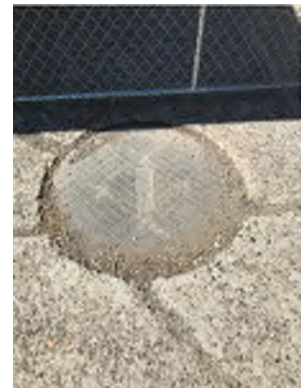
Sanitary sewer includes underground waste water drainage piping. This system is approaching the end of its useful life and should be budgeted for repair/replacement.

Cost:	\$153,678	Priority:	3 - Due within 5 Years of Inspection
Action Date:	3/25/22	Prime Sys:	Piping
		Action:	Sanitary Sewer - Waste Water Piping - 1972 Renewal

Auto generated renewal for Sanitary Sewer - Waste Water Piping - 1972. System Description: Sanitary sewer includes underground waste water drainage piping. This system is approaching the end of its useful life and should be budgeted for repair/replacement.

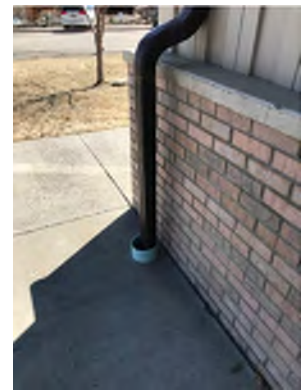
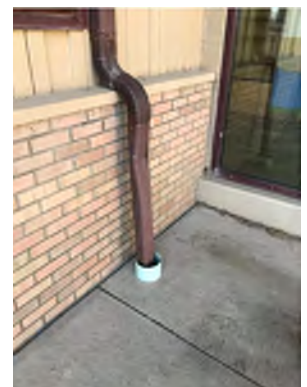
The site storm water system includes RCP (reinforced concrete) and/or PVC (polyvinyl chloride) pipe used to convey storm water.

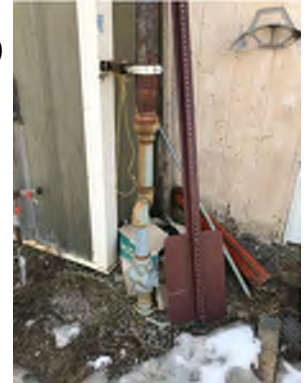
Fuel distribution includes direct buried gas service piping.

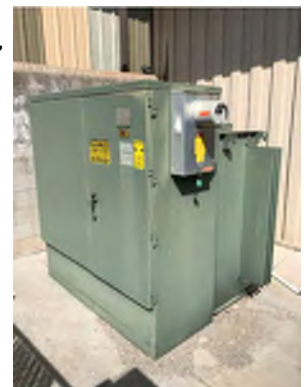
Site electrical distribution includes a pad mounted transformer.

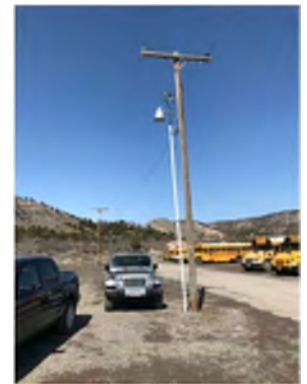
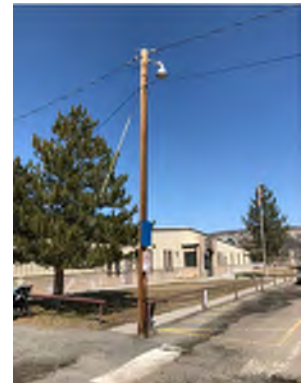
Site lighting includes 400W HID (High-Intensity Discharge) light fixtures for parking/pathway/roadway lighting. Bracket arms are included. Note: circuitry is captured in a separate system. Years remaining have been increased because the system is currently functioning, however the system is beyond its useful life and should be budgeted for repair/replacement.

Auto generated renewal for Site Lighting - Fixtures & Transformers - Parking Lot/Roadway - 400W HID - Single Fixture. System Description: Site lighting includes 400W HID (High-Intensity Discharge) light fixtures for parking/pathway/roadway lighting. Bracket arms are included. Note: circuitry is captured in a separate system. Years remaining have been increased because the system is currently functioning, however the system is beyond its useful life and should be budgeted for repair/replacement.

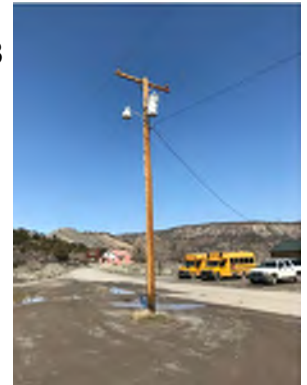
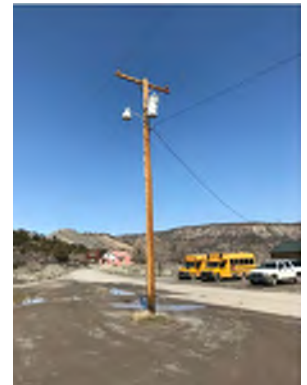
Site lighting includes wood light poles. Light fixtures, bracket arms and circuitry are captured in a separate system. Years remaining have been increased because the system is currently functioning, however the system is beyond its useful life and should be budgeted for repair/replacement.

Cost: \$6,622	Priority: 3 - Due within 5 Years of Inspection
Action Date: 3/25/24	Prime Sys: Poles
	Action: Site Lighting - Poles - Wood Renewal

Auto generated renewal for Site Lighting - Poles - Wood. System Description: Site lighting includes wood light poles. Light fixtures, bracket arms and circuitry are captured in a separate system. Years remaining have been increased because the system is currently functioning, however the system is beyond its useful life and should be budgeted for repair/replacement.

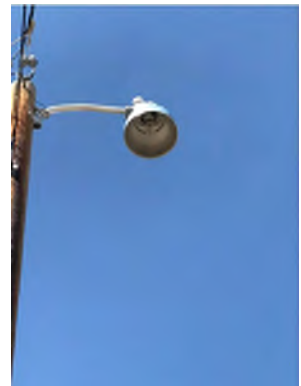
Controls for site lighting include a photocell. Years remaining have been increased because the system is currently functioning, however the system is beyond its useful life and should be budgeted for repair/replacement.

Cost: \$523	Priority: 3 - Due within 5 Years of Inspection
Action Date: 3/25/22	Prime Sys: Site Lighting Controls
	Action: Site Lighting - Site Lighting Controls - Photocell Renewal

Auto generated renewal for Site Lighting - Site Lighting Controls - Photocell. System Description: Controls for site lighting include a photocell. Years remaining have been increased because the system is currently functioning, however the system is beyond its useful life and should be budgeted for repair/replacement.

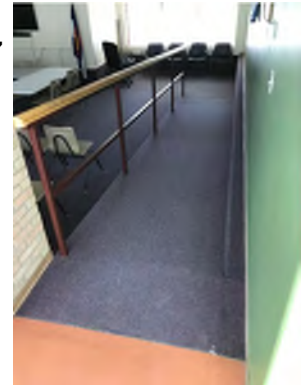
Concrete handicapped ramp with rail.

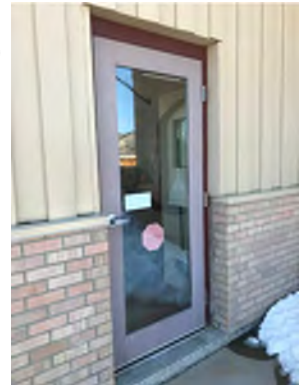
The exterior doors include swinging glazed aluminum storefront leaf plus glazed transom, aluminum frame, hardware including closer.

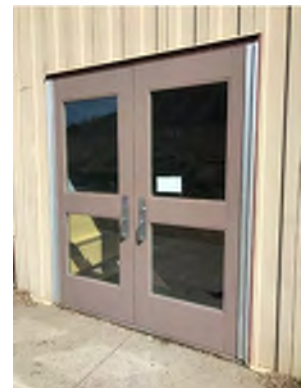
The exterior doors include a pair of 3 x 7 swinging glazed aluminum storefront leafs plus glazed transom, aluminum frame, hardware including closers. Years remaining have been increased because the system is currently functioning, however the system is beyond its useful life and should be budgeted for repair/replacement.

Door Assembly - 6 x 7 Storefront - 1972 Renewal

Auto generated renewal for Door Assembly - 6 x 7 Storefront - 1972. System Description: The exterior doors include a pair of 3 x 7 swinging glazed aluminum storefront leafs plus glazed transom, aluminum frame, hardware including closers. Years remaining have been increased because the system is currently functioning, however the system is beyond its useful life and should be budgeted for repair/replacement.

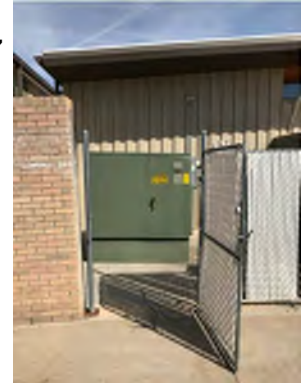
Exterior doors include 3 x 7 steel chain link fence door and steel frame with locking capability. Includes galvanized door and painted frame.

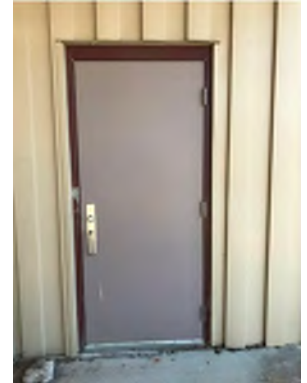
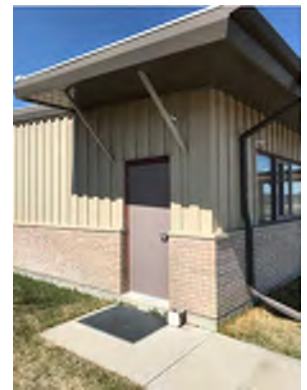
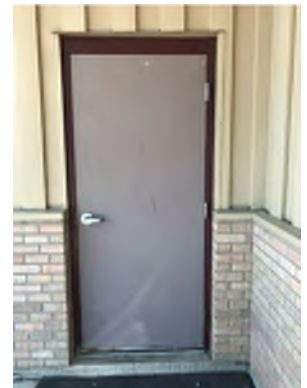
Exterior doors include 3 x 7 HM (Hollow Metal) steel door and steel frame with hinges, lockset, exit hardware and closer. Includes painted door and painted frame.

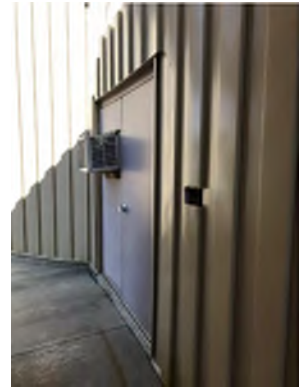
Exterior doors include a pair of 3 x 7 HM (Hollow Metal) steel doors and steel frame with hinges, locksets, exit hardware and closers. Includes painted doors and painted frame.

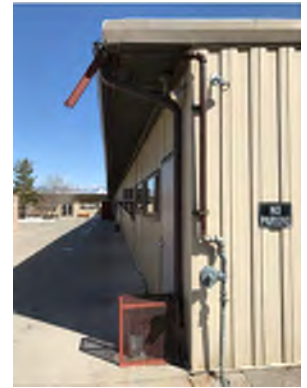
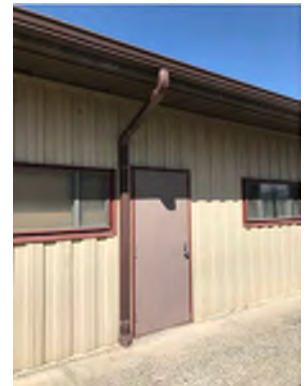
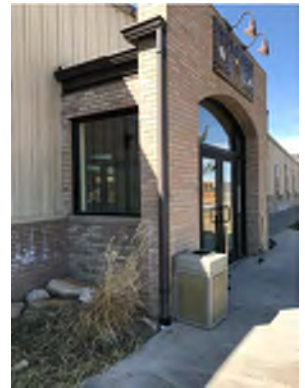
Rain water is removed from the roof by perimeter aluminum gutters, scuppers and downspouts which discharge to the surrounding property. Years remaining have been increased because the system is currently functioning, however the system is beyond its useful life and should be budgeted for repair/replacement.

Auto generated renewal for Gutters and Downspouts - Aluminum - 1972. System Description: Rain water is removed from the roof by perimeter aluminum gutters, scuppers and downspouts which discharge to the surrounding property. Years remaining have been increased because the system is currently functioning, however the system is beyond its useful life and should be budgeted for repair/replacement.

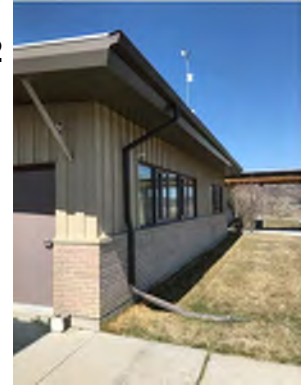
Rain water is removed from the roof by perimeter aluminum gutters, scuppers and downspouts which discharge to the surrounding property. Years remaining have been increased because the system is currently functioning, however the system is approaching the end of its useful life and should be budgeted for repair/replacement.

Auto generated renewal for Gutters and Downspouts - Aluminum - 1996. System Description: Rain water is removed from the roof by perimeter aluminum gutters, scuppers and downspouts which discharge to the surrounding property. Years remaining have been increased because the system is currently functioning, however the system is approaching the end of its useful life and should be budgeted for repair/replacement.

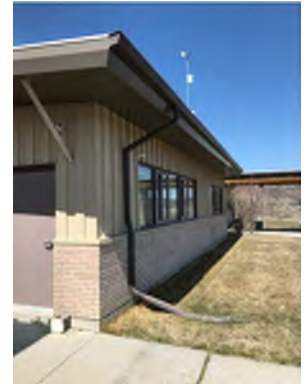
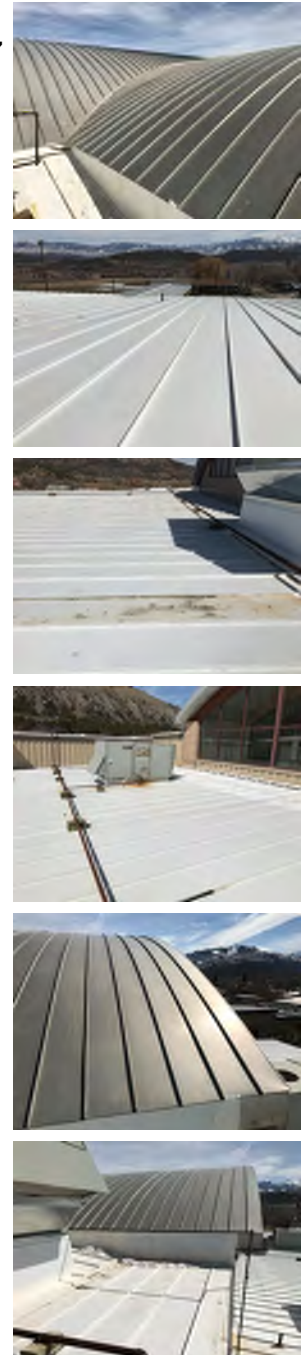
B30 - Roofing

The roof covering is of formed metal roofing, such as standing seam metal.

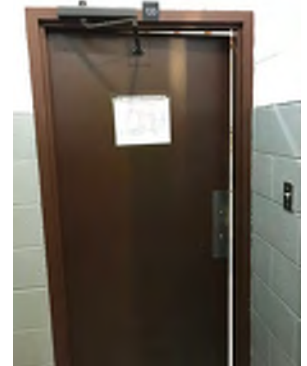
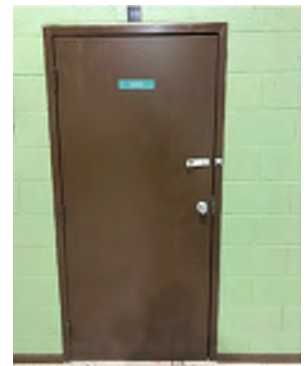
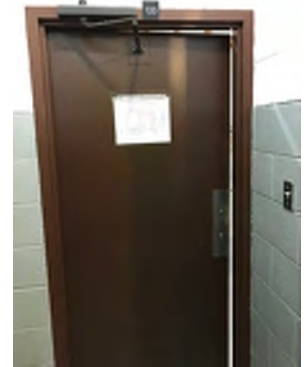
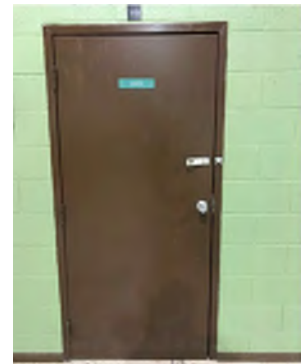
Interior doors include non-rated 3 x 7 Wd (wood) door and frame with hinges, lockset and closer. Includes finished door and frame. This system is approaching the end of its useful life and should be budgeted for repair/replacement.

Auto generated renewal for Swinging Doors - 3 x 7 Wd - 1972. System Description: Interior doors include non-rated 3 x 7 Wd (wood) door and frame with hinges, lockset and closer. Includes finished door and frame. This system is approaching the end of its useful life and should be budgeted for repair/replacement.

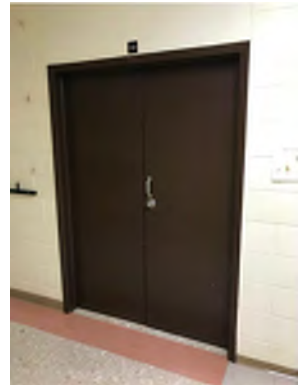
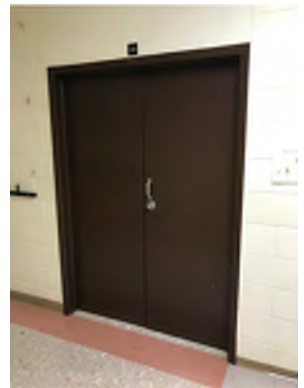
Current Age:	47 years	Year Installed:	1972
Exp. Use. Life:	50 years	Obs. Yrs. Rem:	3 years
Quantity:	2 Each	Unit Cost:	\$5,338.65
Insp. Date:	3/25/19	Inspector:	Mark Hillen

Interior doors include a pair of non-rated 3 x 7 Wd (wood) doors and frame with hinges, locksets and closers. Includes finished doors and frame. This system is approaching the end of its useful life and should be budgeted for repair/replacement.

Cost:	\$13,347	Priority:	3 - Due within 5 Years of Inspection
Action Date:	3/25/22	Prime Sys:	Interior Doors
		Action:	Swinging Doors - Pair - 6 x 7 Wd - 1972 Renewal

Auto generated renewal for Swinging Doors - Pair - 6 x 7 Wd - 1972. System Description: Interior doors include a pair of non-rated 3 x 7 Wd (wood) doors and frame with hinges, locksets and closers. Includes finished doors and frame. This system is approaching the end of its useful life and should be budgeted for repair/replacement.

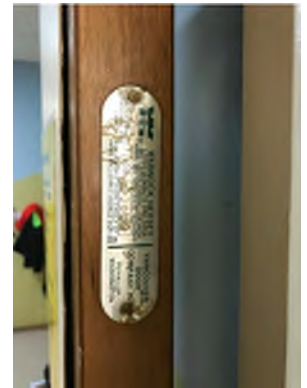
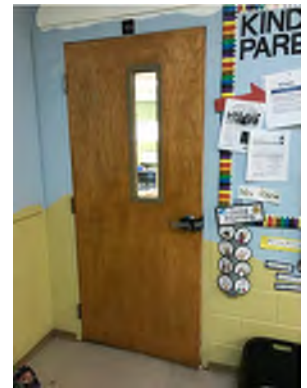
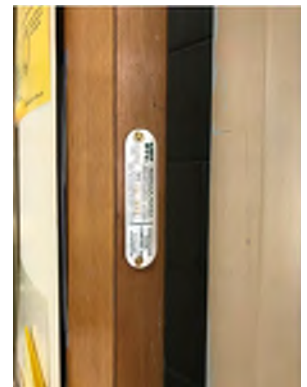
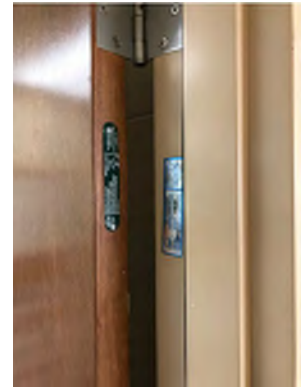
Interior doors include rated 3 x 7 Wd (wood) door and frame with hinges, lockset, hardware and closer. Includes finished door and frame.

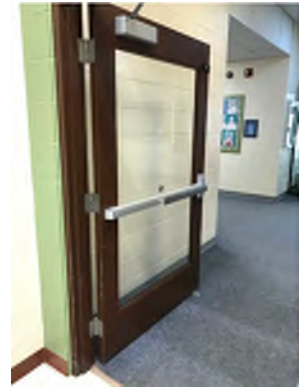
Interior doors include a pair of non-rated 3 x 7 HM (Hollow Metal) steel doors and steel frame with hinges, locksets and closers. Includes painted doors and painted frame.

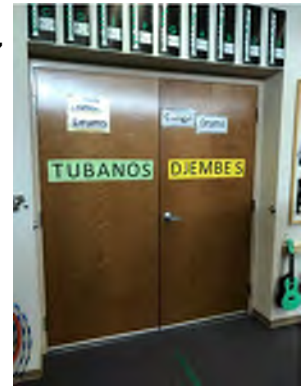
Interior doors include a pair of non-rated 3 x 7 Wd (wood) doors and frame with hinges, locksets and closers. Includes finished doors and frame.

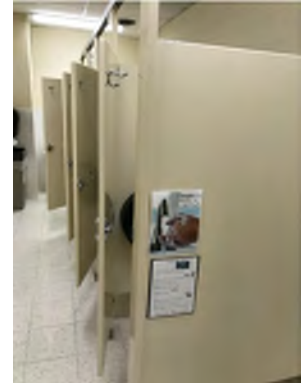
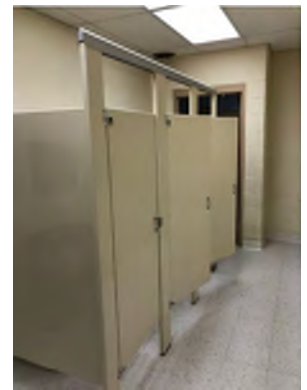
Restrooms are equipped with wall-hung partitions.

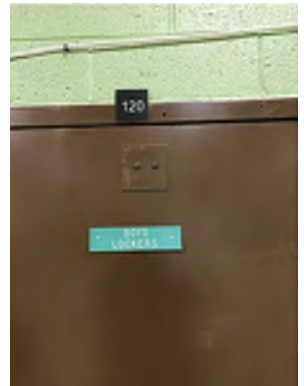
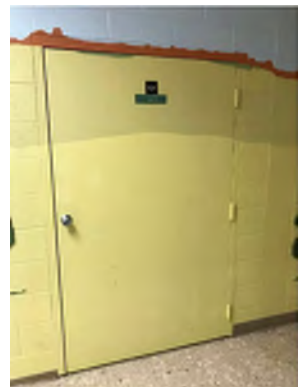
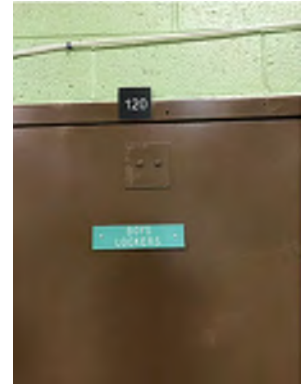
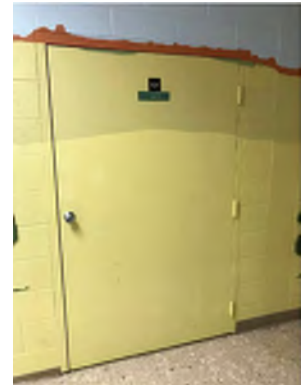
Fittings - Signage - 1972

Current Age:	47 years	Year Installed:	1972
Exp. Use. Life:	10 years	Obs. Yrs. Rem:	5 years
Quantity:	12,000 SF	Unit Cost:	\$0.76
Insp. Date:	3/25/19	Inspector:	Mark Hillen

Finishes include room, door and graphic symbol signs. Years remaining have been increased because the system is currently functioning, however the system is beyond its useful life and should be budgeted for repair/replacement.

Auto generated renewal for Fittings - Signage - 1972. System Description: Finishes include room, door and graphic symbol signs. Years remaining have been increased because the system is currently functioning, however the system is beyond its useful life and should be budgeted for repair/replacement.

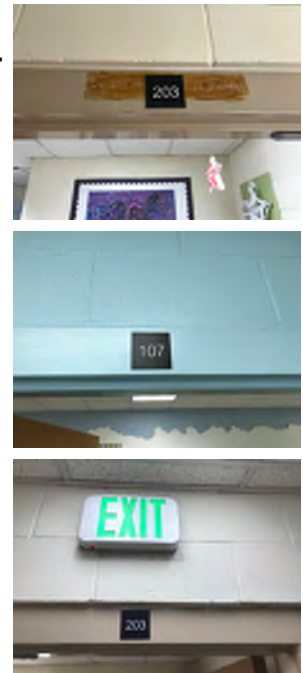
Current Age:	1 years	Year Installed:	2018
Exp. Use. Life:	10 years	Obs. Yrs. Rem:	9 years
Quantity:	45,000 SF	Unit Cost:	\$0.76
Insp. Date:	3/25/19	Inspector:	Mark Hillen

Finishes include room, door and graphic symbol signs.

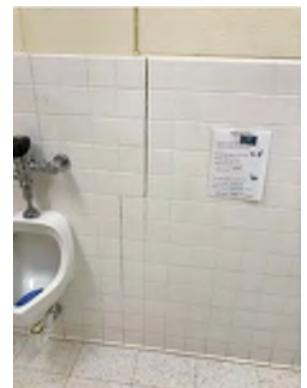
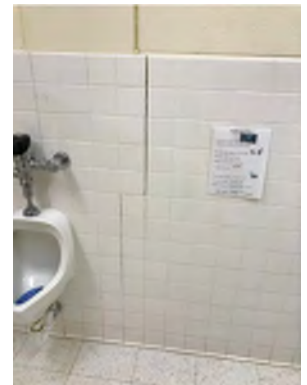
Building wall coverings include 4-in. x 4-in. ceramic tiles. Includes wainscot with bullnose trim. Years remaining have been increased because the system is currently functioning, however the system is approaching the end of its useful life and should be budgeted for repair/replacement.

Auto generated renewal for Ceramic Tile. System Description: Building wall coverings include 4-in. x 4-in. ceramic tiles. Includes wainscot with bullnose trim. Years remaining have been increased because the system is currently functioning, however the system is approaching the end of its useful life and should be budgeted for repair/replacement.

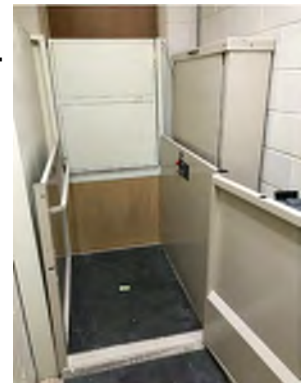
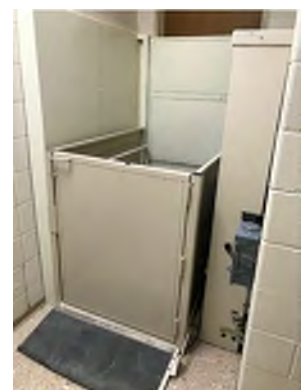
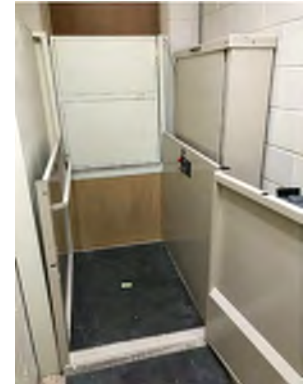
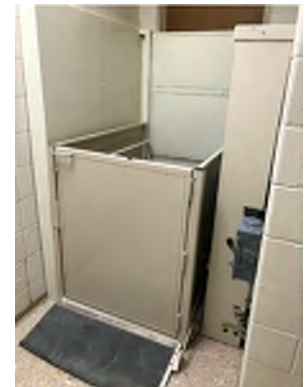
Current Age: 23 years **Year Installed:** 1996
Exp. Use. Life: 25 years **Obs. Yrs. Rem:** 5 years
Quantity: 1 Each **Unit Cost:** \$19,664.42
Insp. Date: 3/25/19 **Inspector:** Mark Hillen

The building includes a wheelchair lift. Years remaining have been increased because the system is currently functioning, however the system is approaching the end of its useful life and should be budgeted for repair/replacement.

Auto generated renewal for Wheelchair Lift. System Description: The building includes a wheelchair lift. Years remaining have been increased because the system is currently functioning, however the system is approaching the end of its useful life and should be budgeted for repair/replacement.

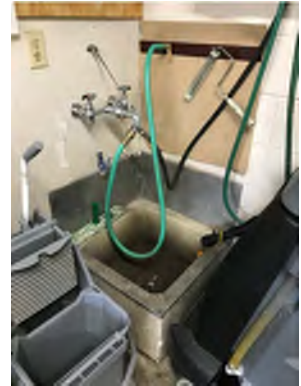
Auto generated renewal for Custodial/Utility Sinks - 1972. System Description: The plumbing fixtures include custodial/utility sinks. Includes rough-in and faucet. Years remaining have been increased because the system is currently functioning, however the system is beyond its useful life and should be budgeted for repair/replacement.

Cost:	\$23,760	Priority:	3 - Due within 5 Years of Inspection
Action Date:	3/25/23	Prime Sys:	Plumbing Fixtures
		Action:	Custodial/Utility Sinks - 1972 Renewal

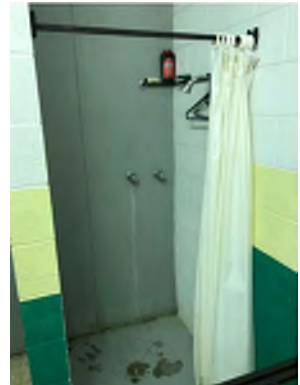
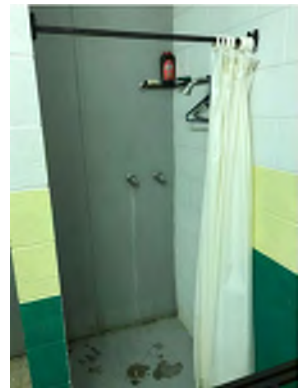
Current Age: 47 years	Year Installed: 1972
Exp. Use. Life: 30 years	Obs. Yrs. Rem: 4 years
Quantity: 1 Each	Unit Cost: \$2,092.03
Insp. Date: 3/25/19	Inspector: Mark Hillen

The restroom fixtures include one individual shower stall. Years remaining have been increased because the system is currently functioning, however the system is beyond its useful life and should be budgeted for repair/replacement.

Cost: \$2,615	Priority: 3 - Due within 5 Years of Inspection
Action Date: 3/25/23	Prime Sys: Plumbing Fixtures
Action:	Restroom Fixtures - Prefab Individual Shower Renewal

Auto generated renewal for Restroom Fixtures - Prefab Individual Shower. System Description: The restroom fixtures include one individual shower stall. Years remaining have been increased because the system is currently functioning, however the system is beyond its useful life and should be budgeted for repair/replacement.

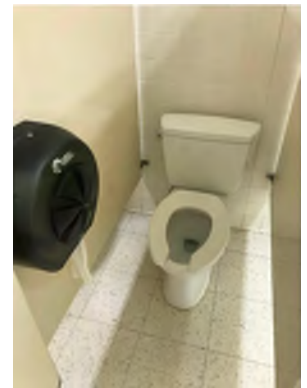
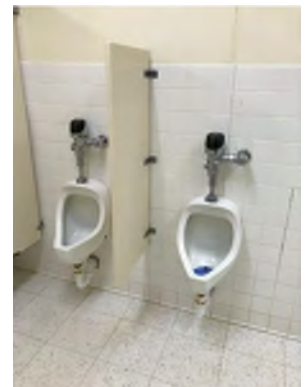
The restroom fixtures include urinals, water closets and lavatories.

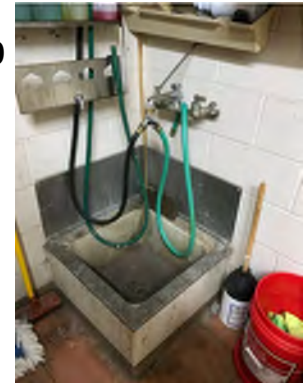
The plumbing fixtures include custodial/utility sinks. Includes rough-in and faucet.

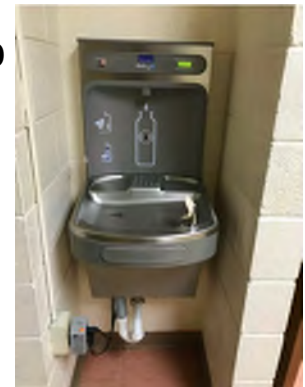
Plumbing fixtures include wall-mounted water coolers.

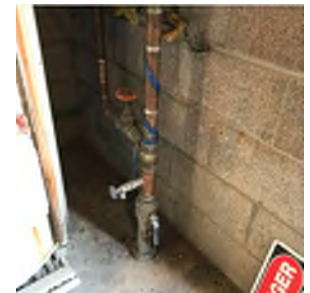
The building domestic water distribution system includes a four inch main line, water meter, backflow preventer, with rough ins included. The water heater is captured in a separate system. Years remaining have been increased because the system is currently functioning, however the system is beyond its useful life and should be budgeted for repair/replacement.

Auto generated renewal for Water Dist Complete. System Description: The building domestic water distribution system includes a four inch main line, water meter, backflow preventer, with rough ins included. The water heater is captured in a separate system. Years remaining have been increased because the system is currently functioning, however the system is beyond its useful life and should be budgeted for repair/replacement.

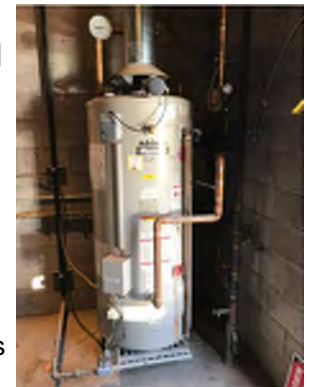
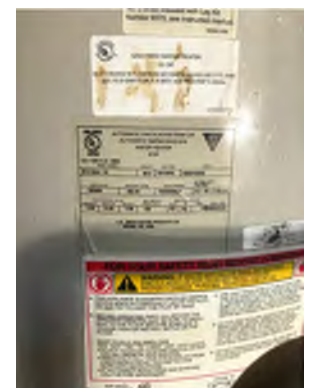
The domestic hot water is provided by a gas-fired, commercial-grade water heater. Years remaining have been increased because the system is currently functioning, however the system is beyond its useful life and should be budgeted for repair/replacement.

Auto generated renewal for Water Heater - Gas - 2005. System Description: The domestic hot water is provided by a gas-fired, commercial-grade water heater. Years remaining have been increased because the system is currently functioning, however the system is beyond its useful life and should be budgeted for repair/replacement.

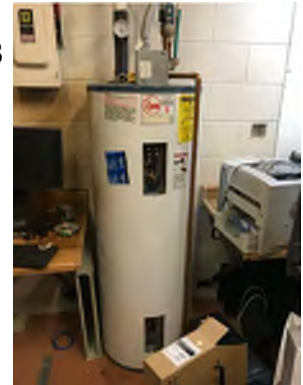
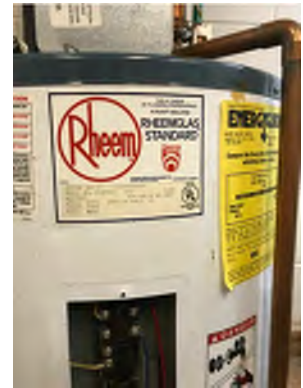
The domestic hot water is provided by a gas-fired, commercial-grade water heater. Years remaining have been increased because the system is currently functioning, however the system is beyond its useful life and should be budgeted for repair/replacement.

Auto generated renewal for Water Heater - Gas - 1996. System Description: The domestic hot water is provided by a gas-fired, commercial-grade water heater. Years remaining have been increased because the system is currently functioning, however the system is beyond its useful life and should be budgeted for repair/replacement.

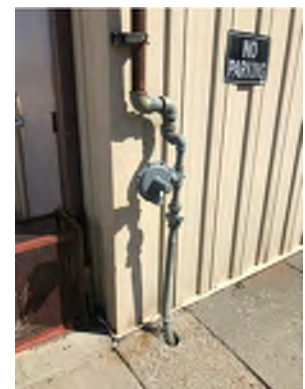
The building includes a natural gas supply line coming into the building. The supply is for boilers, kitchen and other equipment. Years remaining have been increased because the system is currently functioning, however the system is beyond its useful life and should be budgeted for repair/replacement.

Auto generated renewal for Natural Gas Service to Bldg - 1972. System Description: The building includes a natural gas supply line coming into the building. The supply is for boilers, kitchen and other equipment. Years remaining have been increased because the system is currently functioning, however the system is beyond its useful life and should be budgeted for repair/replacement.

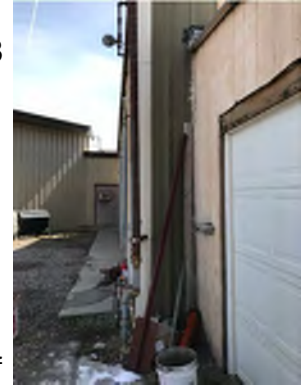
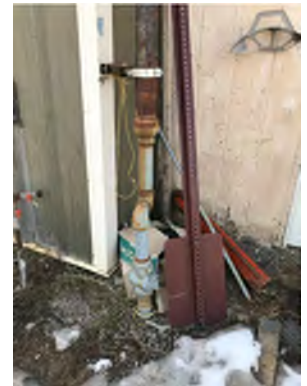
The building includes a natural gas supply with a 4" line coming into the building. The supply is for boilers, kitchen and other equipment. The ground supply is located outside of the maintenance building and is then run overhead to the 1996 Addition.

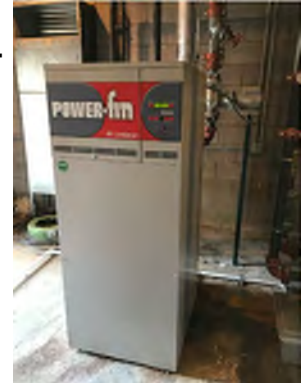
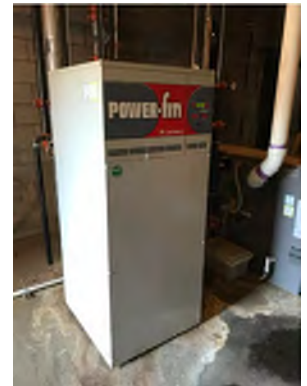
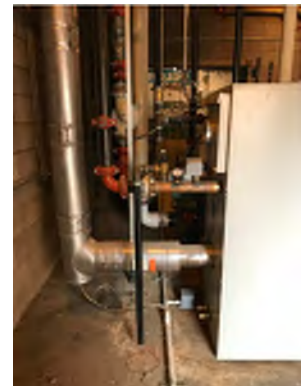
Heat is provided by a gas-fired HW (hot water) boiler. Full redundancy is included.

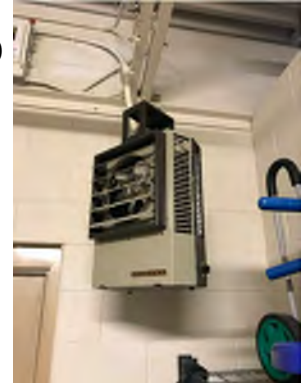
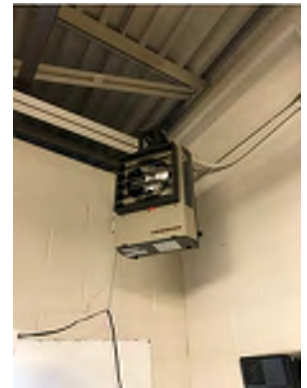
Heating is provided by suspended, electric unit heaters. Years remaining have been increased because the system is currently functioning, however the system is beyond its useful life and should be budgeted for repair/replacement.

Auto generated renewal for Unit Heaters - Electric. System Description: Heating is provided by suspended, electric unit heaters. Years remaining have been increased because the system is currently functioning, however the system is beyond its useful life and should be budgeted for repair/replacement.

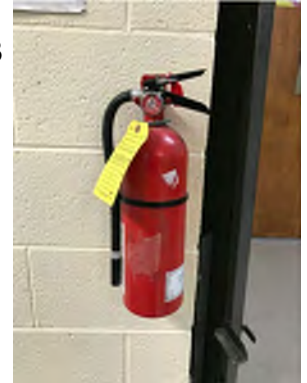
Handheld type dry chemical fire extinguishers are located throughout the building.

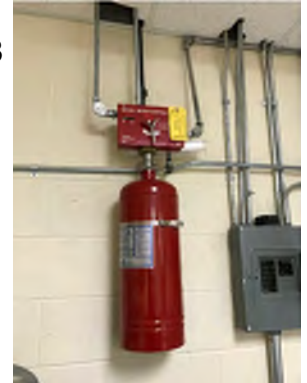
System includes a chemical fire suppression system for a typical commercial kitchen. Fire suppression includes fusible links, manual pull stations, 3 gallon tanks, nozzles, and control panels. Hood included under a separate system. Years remaining have been increased because the system is currently functioning, however the system is beyond its useful life and should be budgeted for repair/replacement.

Auto generated renewal for Kitchen Hood Suppression. System Description: System includes a chemical fire suppression system for a typical commercial kitchen. Fire suppression includes fusible links, manual pull stations, 3 gallon tanks, nozzles, and control panels. Hood included under a separate system. Years remaining have been increased because the system is currently functioning, however the system is beyond its useful life and should be budgeted for repair/replacement.

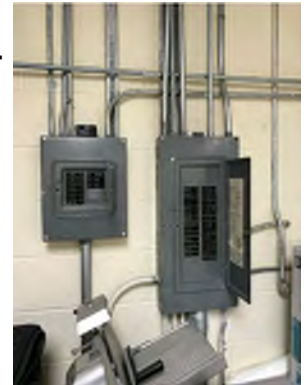
The electrical distribution system for this building includes panelboards, feeders, and associated equipment. Years remaining have been increased because the system is currently functioning, however the system is beyond its useful life and should be budgeted for repair/replacement.

Auto generated renewal for Distribution Equipment, Panelboards, and Feeders - 600A 208Y/120V - 1972. System Description: The electrical distribution system for this building includes panelboards, feeders, and associated equipment. Years remaining have been increased because the system is currently functioning, however the system is beyond its useful life and should be budgeted for repair/replacement.

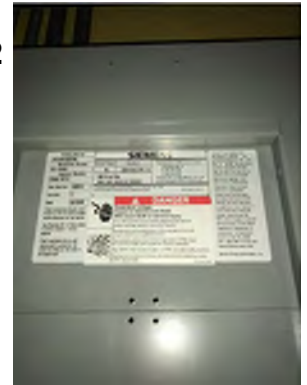
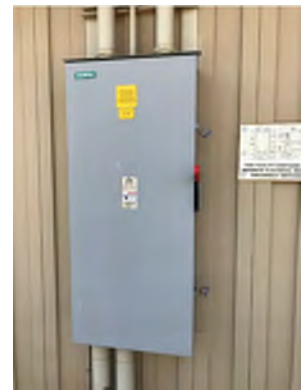
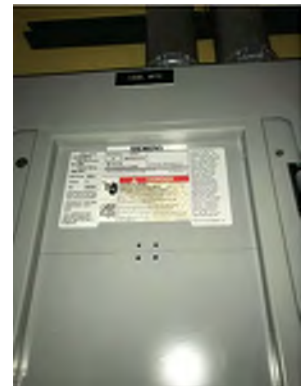
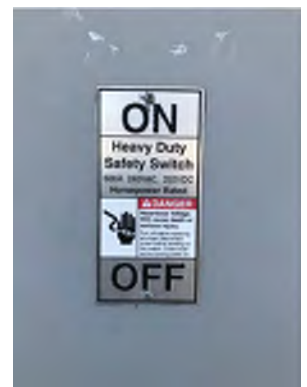
The original structure includes three electrical main services, which include incoming feeders, main panels, and metering. One of these panels is for the solar panel array.

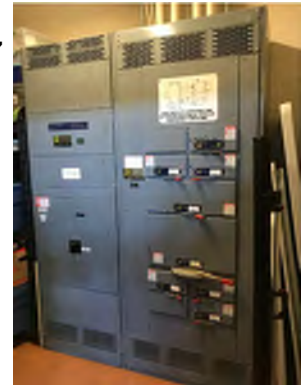
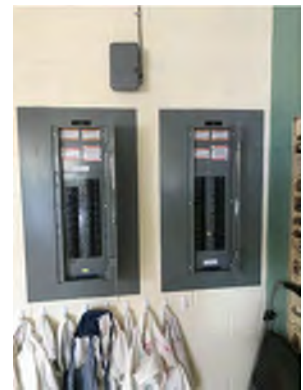
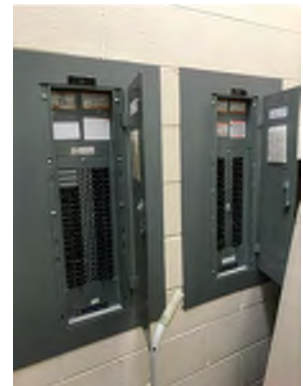
The electrical distribution system for this building includes panelboards, feeders, and associated equipment.

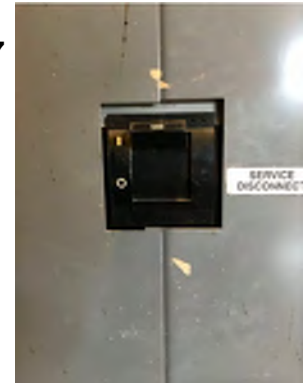
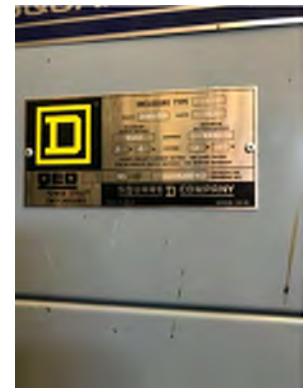
The building includes an electrical service, which includes incoming feeders, main panel, and metering.

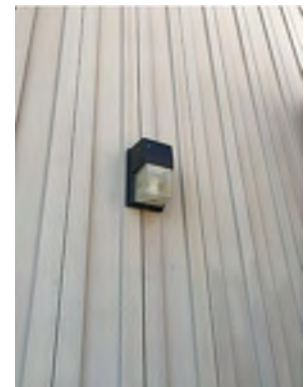
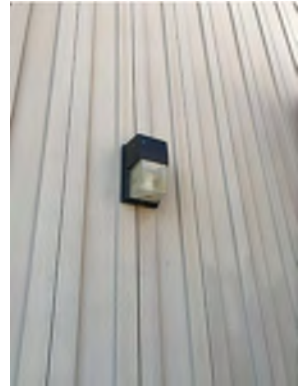
Exterior lighting consists of HID (High-Intensity Discharge) wall pack units. Years remaining have been increased because the system is currently functioning, however the system is beyond its useful life and should be budgeted for repair/replacement.

Cost:	\$4,177	Priority:	3 - Due within 5 Years of Inspection
Action Date:	3/25/23	Prime Sys:	Lighting and Branch Wiring
		Action:	Lighting - Exterior - HID Wall Packs Renewal

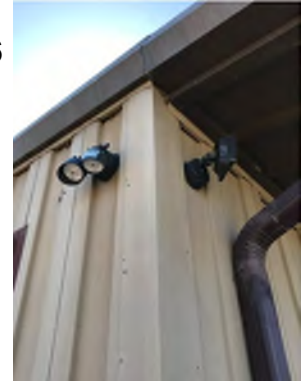
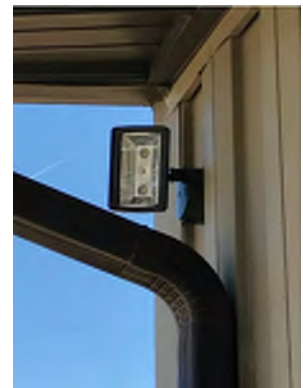
Exterior lighting consists of LED (Light-Emitting Diodes) wall pack units.

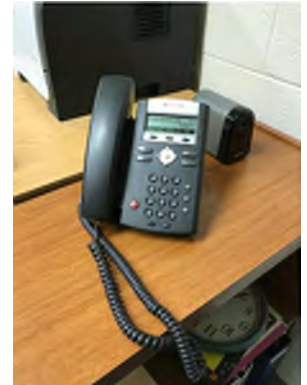
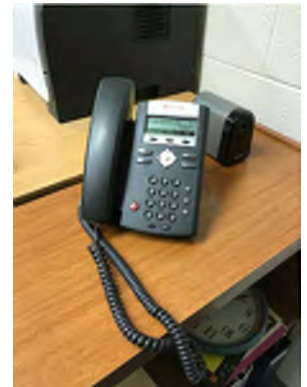
The building includes a telephone system with VOIP and intercom through the phone system. Years remaining have been increased because the system is currently functioning, however the system is beyond its useful life and should be budgeted for repair/replacement.

Auto generated renewal for Telephone System. System Description: The building includes a telephone system with VOIP and intercom through the phone system. Years remaining have been increased because the system is currently functioning, however the system is beyond its useful life and should be budgeted for repair/replacement.

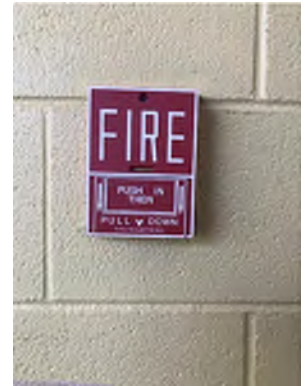
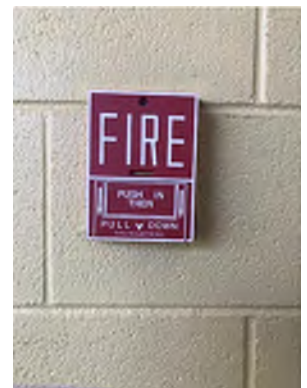
The fire alarm system includes head end equipment, pull stations, audio/visual strobes, visual strobes, smokes, conduit, wire and connections. Years remaining have been increased because the system is currently functioning, however the system is beyond its useful life and should be budgeted for repair/replacement.

Cost: \$365,476	Priority: 3 - Due within 5 Years of Inspection
Action Date: 3/25/24	Prime Sys: Fire Alarm Systems
	Action: Fire Alarm System Renewal

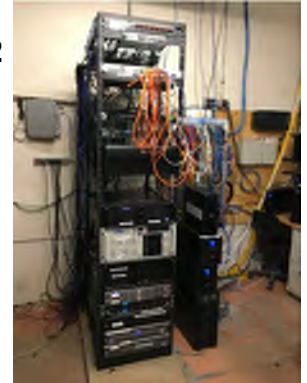
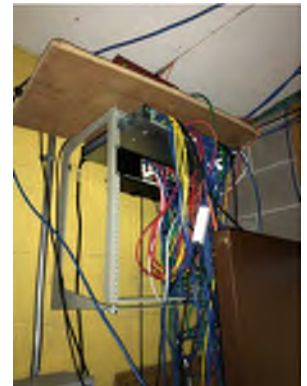
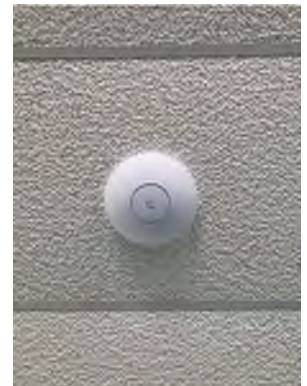
Building includes a local area network system.

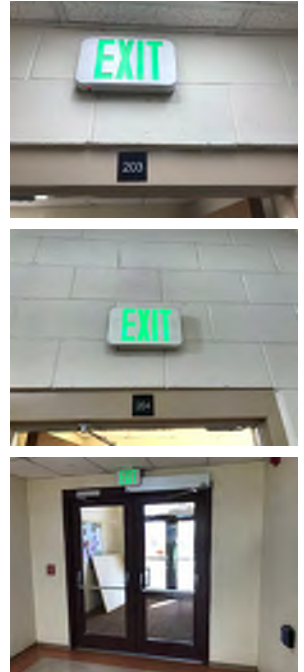
Auto generated renewal for Exit Signs - 1996. System Description: The emergency lighting system includes the installation of Exit signs. Installation includes single and double sided Exit signs, conduit, wire, boxes, conduit bends, connections and circuit breakers. Years remaining have been increased because the system is currently functioning, however the system is beyond its useful life and should be budgeted for repair/replacement.

Cost:	\$18,761	Priority:	3 - Due within 5 Years of Inspection
Action Date:	3/25/24	Prime Sys:	Emergency Light and Power Systems
		Action:	Exit Signs - 1996 Renewal

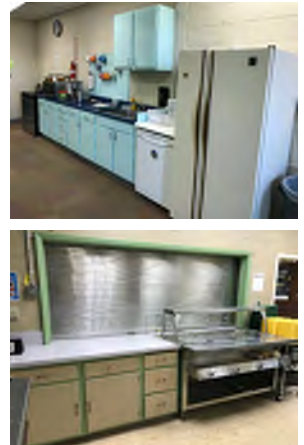
The building includes laminate casework, including wall and under-counter cabinets and counter-tops. Years remaining have been increased because the system is currently functioning, however the system is beyond its useful life and should be budgeted for repair/replacement.

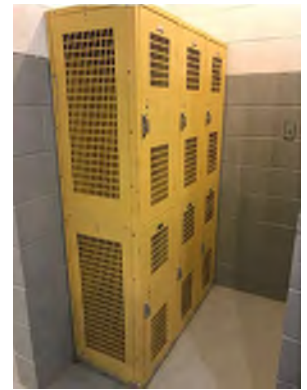
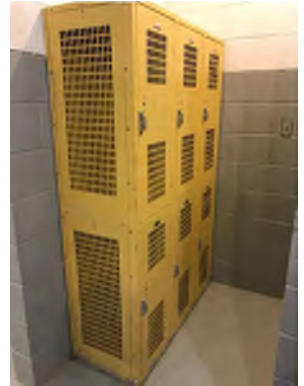
Fixed furnishings include student lockers. Years remaining have been increased because the system is currently functioning, however the system is beyond its useful life and should be budgeted for repair/replacement.

Cost: \$13,415 **Priority:** 3 - Due within 5 Years of Inspection
Action Date: 3/25/23 **Prime Sys:** Fixed Furnishings
Action: Student Lockers - Steel Renewal

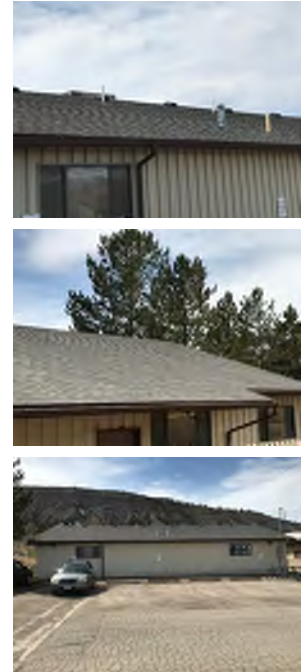
Auto generated renewal for Asphalt Shingled Roofing. System Description: The roof covering is comprised of asphalt strip shingles over asphalt felt sheathing paper. This system is approaching the end of its useful life and should be budgeted for repair/replacement.

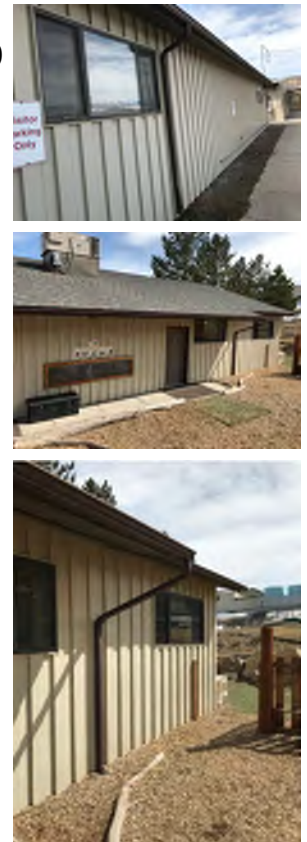
Gutters and Downspouts - Aluminum

Rain water is removed from the roof by perimeter aluminum gutters, scuppers and downspouts which discharge to the surrounding property.

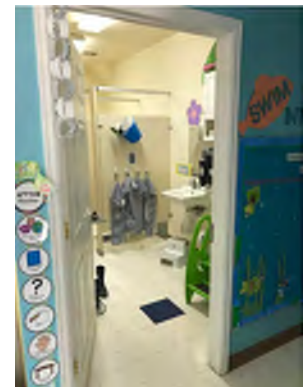
Interior doors include non-rated 3 x 7 wood door and frame with hinges, lockset and closer. Includes finished door and frame.

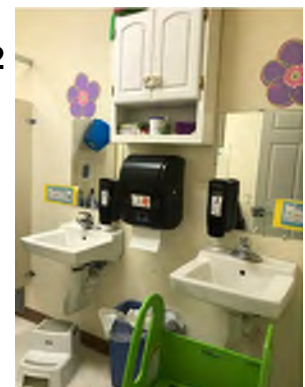
The restroom accessories include mirrors, grab bars, paper towel dispensers and disposal, toilet paper holders and soap dispensers.

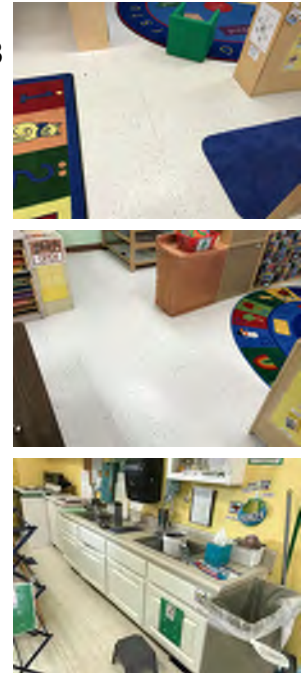
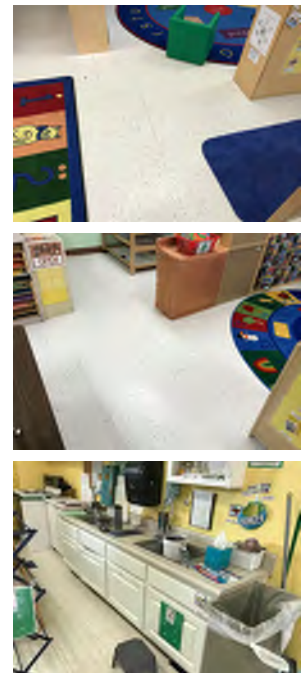
VCT Renewal

Floor finishes include areas of VCT (Vinyl Composition Tile) flooring and base. Years remaining have been increased because the system is currently functioning, however the system is beyond its useful life and should be budgeted for repair/replacement.

Auto generated renewal for VCT. System Description: Floor finishes include areas of VCT (Vinyl Composition Tile) flooring and base. Years remaining have been increased because the system is currently functioning, however the system is beyond its useful life and should be budgeted for repair/replacement.
