Ridgway School District R-2 Facilities Master Plan

December 14, 2020

1.0 Executive Summary

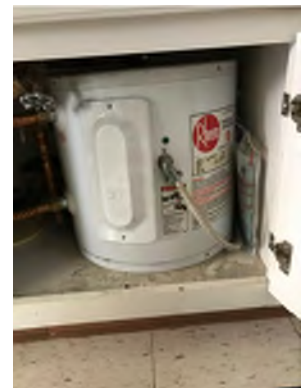
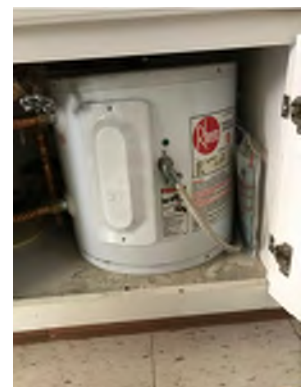
Water Heater - Electric - Point of Use Renewal

The domestic hot water is provided by a 2.5-gallon point of use electric water heater. Years remaining have been increased because the system is currently functioning, however the system is beyond its useful life and should be budgeted for repair/replacement.

Auto generated renewal for Water Heater - Electric - Point of Use. System Description: The domestic hot water is provided by a 2.5-gallon point of use electric water heater. Years remaining have been increased because the system is currently functioning, however the system is beyond its useful life and should be budgeted for repair/replacement.

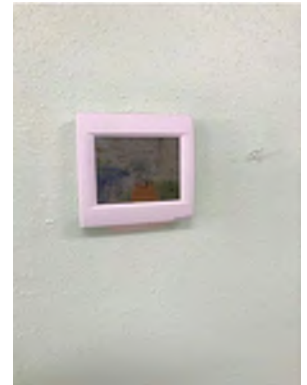
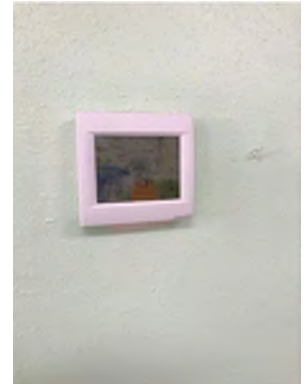
HVAC controls include a DDC system for system optimization, pc control and sensors. This system is approaching the end of its useful life and should be budgeted for repair/replacement.

Auto generated renewal for DDC System. System Description: HVAC controls include a DDC system for system optimization, pc control and sensors. This system is approaching the end of its useful life and should be budgeted for repair/replacement.

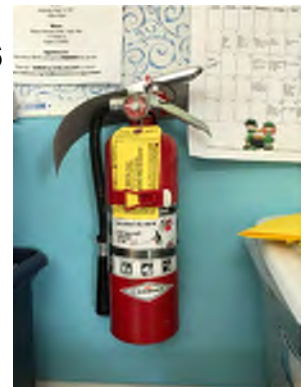
Fire Extinguishers - Dry Chemical

Handheld type dry chemical fire extinguishers are located throughout the building. Includes cabinets.

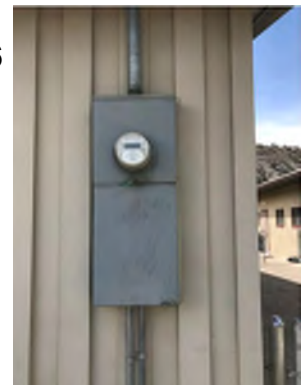
The building includes a typical electrical service, which includes incoming feeders, main panel, and metering.

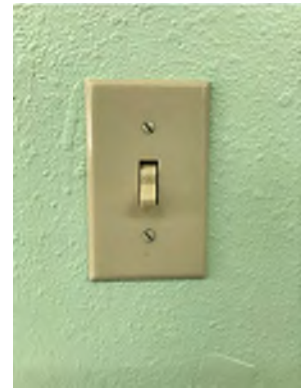
Branch wiring for this building includes interior and exterior branch wiring, devices, and utilization equipment.

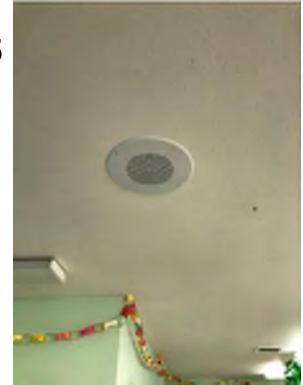
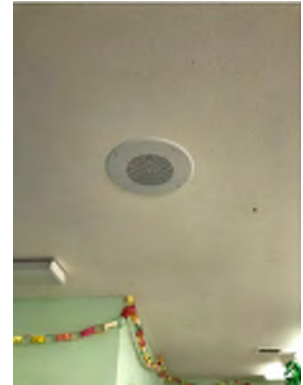
Public Address System Renewal

The building includes a public address system. The public address system includes an amplifier, intercom/monitor, volume control, speakers, conduit and shielded wiring. Years remaining have been increased because the system is currently functioning, however the system is beyond its useful life and should be budgeted for repair/replacement.

Auto generated renewal for Public Address System. System Description: The building includes a public address system. The public address system includes an amplifier, intercom/monitor, volume control, speakers, conduit and shielded wiring. Years remaining have been increased because the system is currently functioning, however the system is beyond its useful life and should be budgeted for repair/replacement.

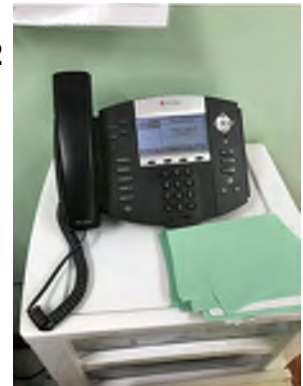
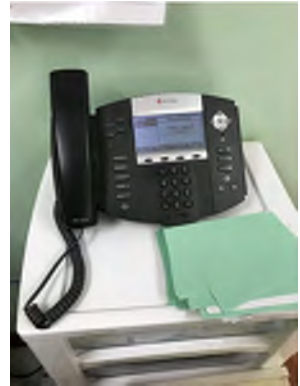
The building includes a telephone system. Years remaining have been increased because the system is currently functioning, however the system is beyond its useful life and should be budgeted for repair/replacement.

Cost: \$11,461 **Priority:** 3 - Due within 5 Years of Inspection
Action Date: 3/25/24 **Prime Sys:** Telephone Systems
Action: Telephone System Renewal

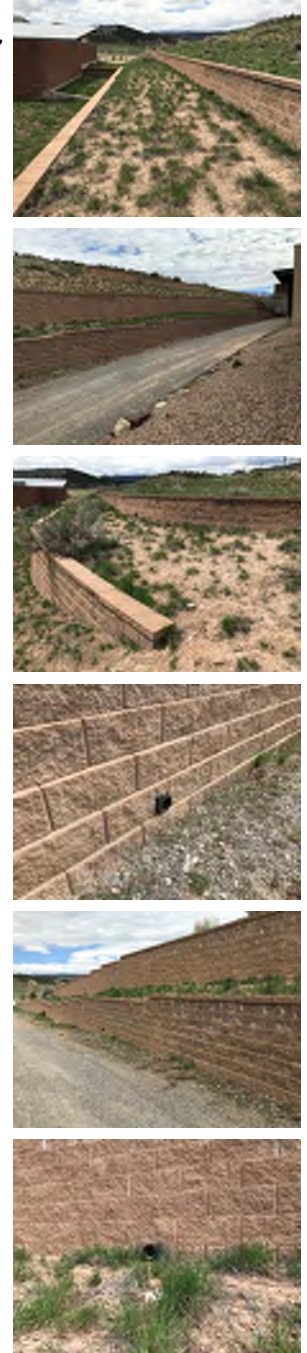
Site development includes retaining wall consisting of decorative concrete masonry units (CMU).

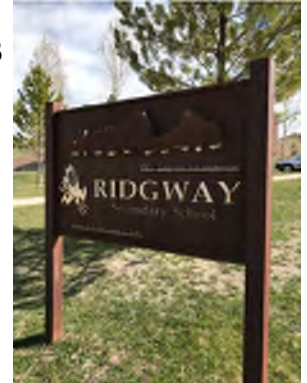
Site improvements include a monument sign identifying the building.

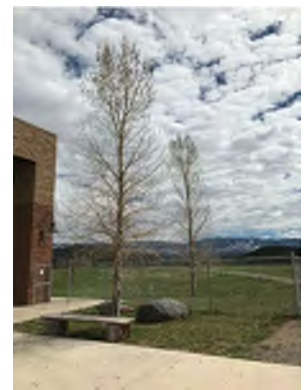
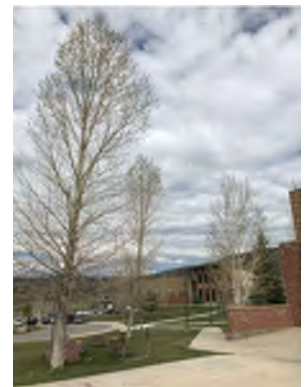
Landscaping includes trees with prepared beds.

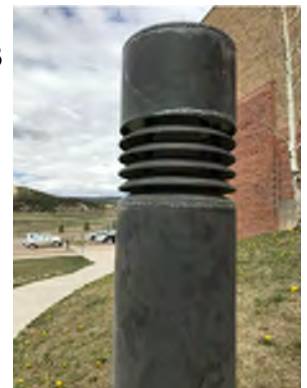
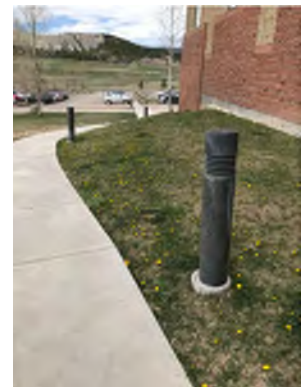
Site lighting includes light bollards. Note: concrete base and circuitry is captured in a separate system.

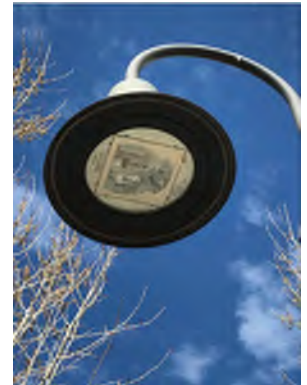
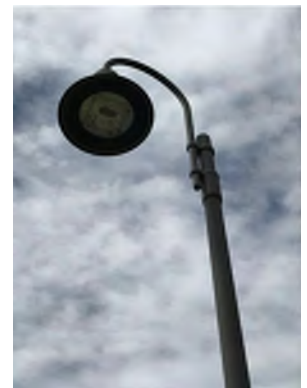
Site lighting includes 400W HID (High-Intensity Discharge) light fixtures for parking/pathway/roadway lighting. Bracket arms are included. Note: concrete base and circuitry is captured in a separate system.

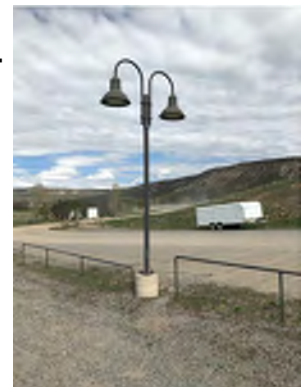
Site lighting includes 400W HID (High-Intensity Discharge) light fixtures for parking/pathway/roadway lighting. Bracket arms are included. Note: concrete base and circuitry is captured in a separate system.

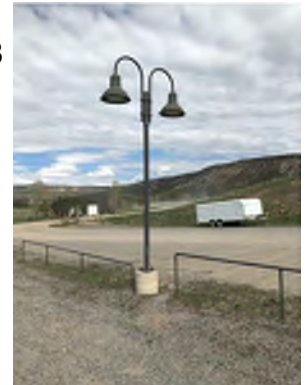
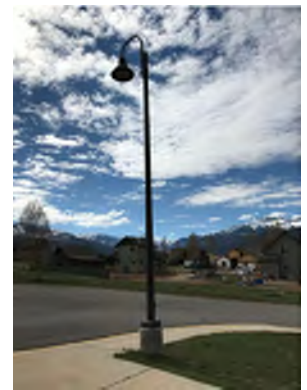
Site lighting includes aluminum light poles. Light fixtures, bracket arms and circuitry are captured in a separate system.

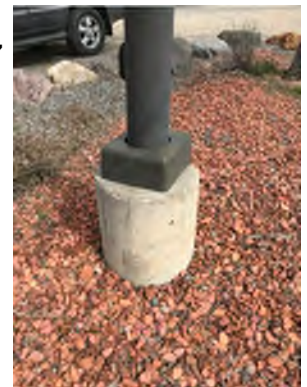
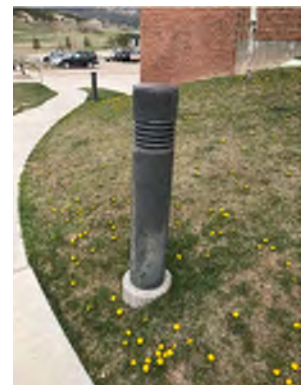
Site lighting includes concrete base for lighting poles.

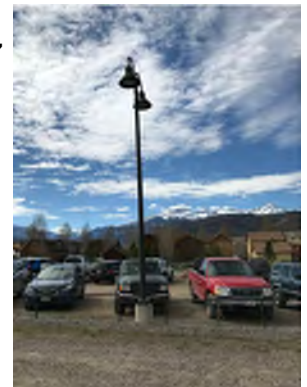
Controls for site lighting include a photocell.

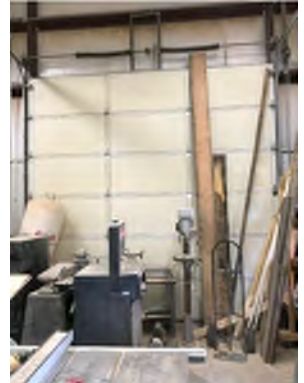
Exterior openings include overhead rolling doors with manual operation.

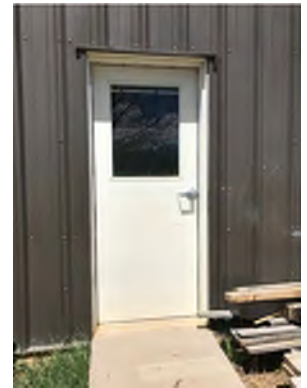
Exterior doors include 3 x 7 HM (Hollow Metal) steel door and steel frame with hinges, lockset, exit hardware and closer. Includes painted door and painted frame.

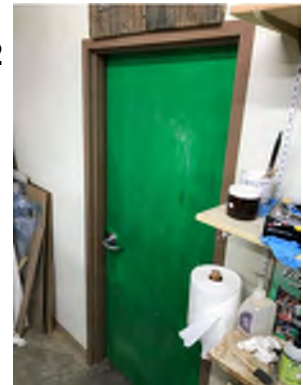
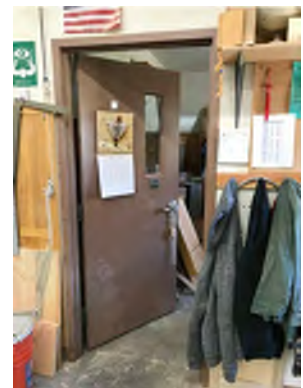
Interior doors include non-rated 3 x 7 Wood door and frame with hinges, lockset and closer. Includes finished door and frame.

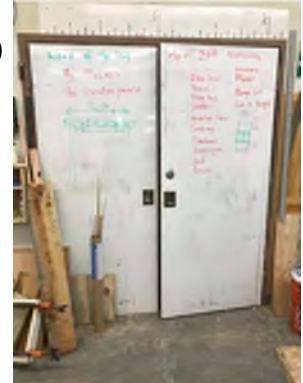
Interior doors include a pair of non-rated 3 x 7 Wood doors and frame with hinges, locksets and closers. Includes finished doors and frame.

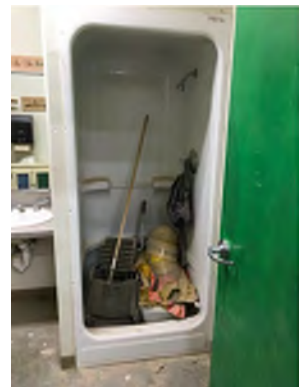
The restroom fixtures include fiberglass individual shower stalls.

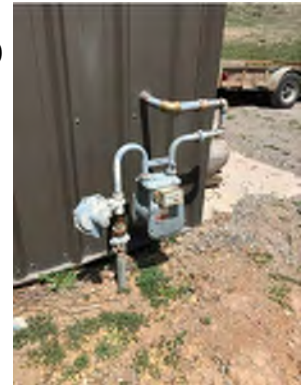
The building includes a natural gas supply with a 2" line coming into the building. The supply is primarily for unit heaters.

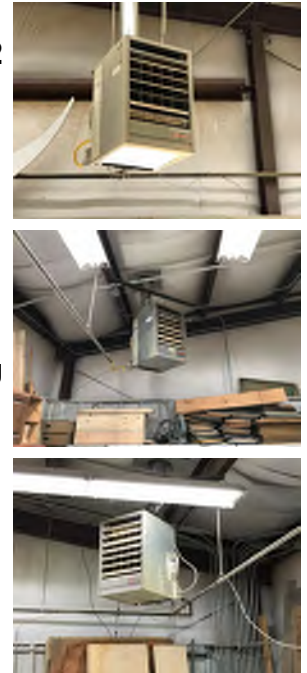
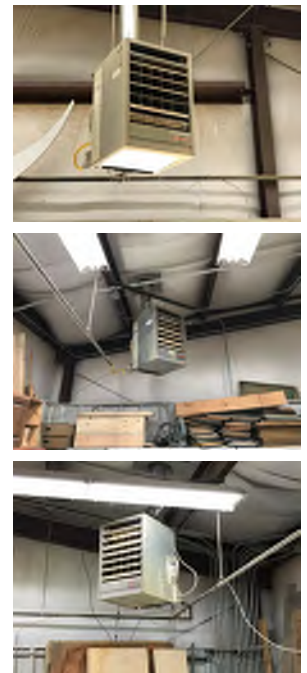
Heating is provided by suspended, gas-fired unit heaters. Years remaining have been increased because the system is currently functioning, however the system is approaching the end of its useful life and should be budgeted for repair/replacement.

Auto generated renewal for Unit Heaters - Gas Fired. System Description: Heating is provided by suspended, gas-fired unit heaters. Years remaining have been increased because the system is currently functioning, however the system is approaching the end of its useful life and should be budgeted for repair/replacement.

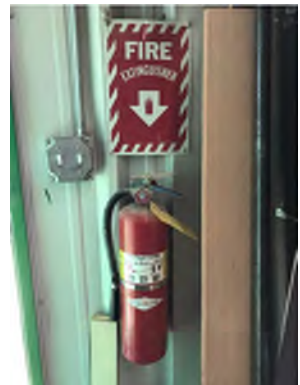
Handheld type dry chemical fire extinguishers are located throughout the building. Includes cabinets.

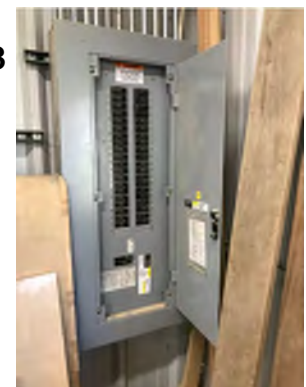
The electrical distribution system for this building includes an average concentration of panelboards, feeders, and associated equipment.

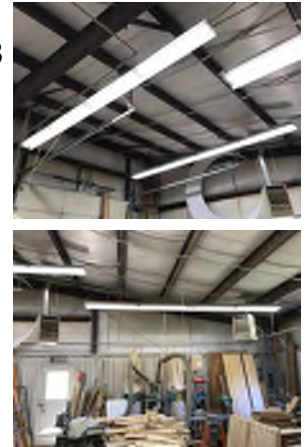
The lighting system includes LED (Light-Emitting Diodes) lighting fixtures, lamps, conduit and wire.

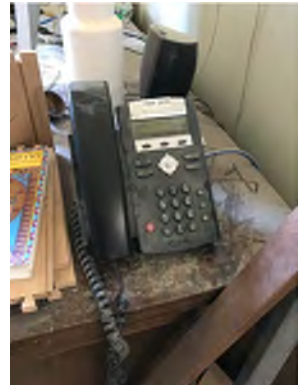
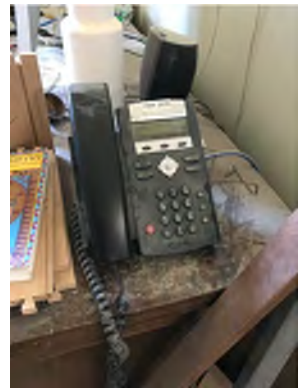
The building includes a telephone system. Years remaining have been increased because the system is currently functioning, however the system is beyond its useful life and should be budgeted for repair/replacement.

Cost: \$9,763	Priority: 3 - Due within 5 Years of Inspection
Action Date: 4/24/24	Prime Sys: Telephone Systems
	Action: Telephone System Renewal

Auto generated renewal for Telephone System. System Description: The building includes a telephone system. Years remaining have been increased because the system is currently functioning, however the system is beyond its useful life and should be budgeted for repair/replacement.

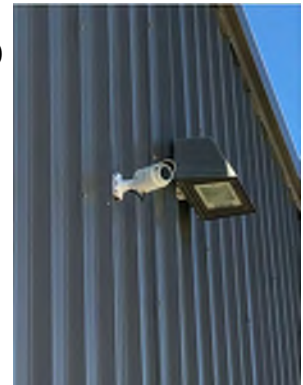
The building includes a CCTV (Closed-Circuit Television) security system. The system monitors points of egress. The CCTV security system includes: cameras, conduit, and cabling.

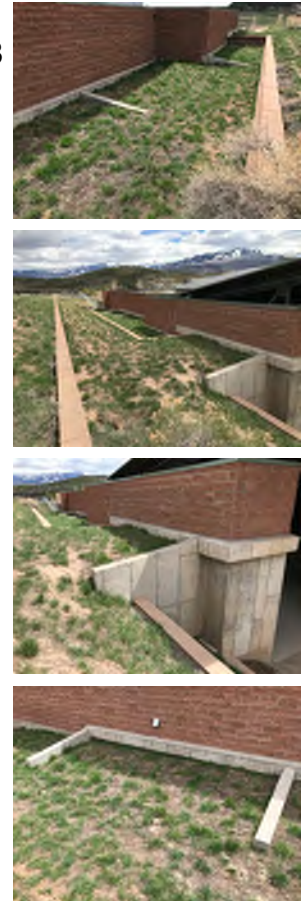
The substructure includes grade beams with a span of 30-feet and 40-inches deep.

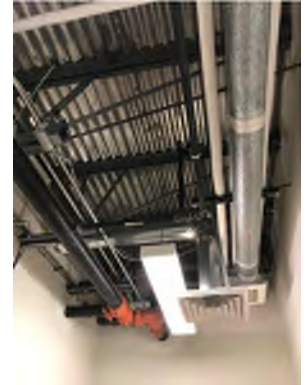
Multi-story steel building includes steel columns, beams, floor pans, and roof structure.

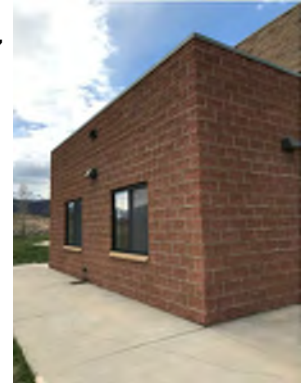
Single-story steel framed building with steel columns and steel joist roof structure. Exterior walls are covered under a separate system.

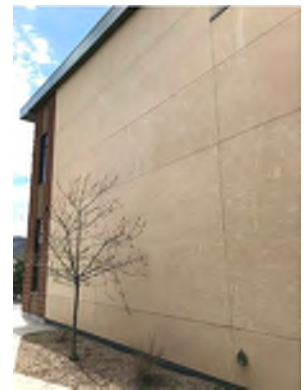
The exterior wall construction is EIFS (Exterior Insulation Finish System) wall panels with stucco and CMU (Concrete Masonry Unit) backup.

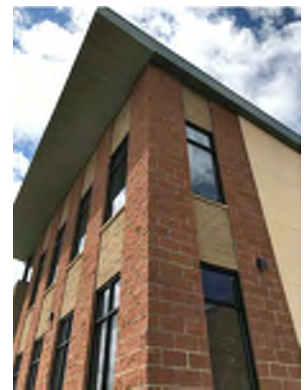
The building includes aluminum framed exterior units with insulating glass.

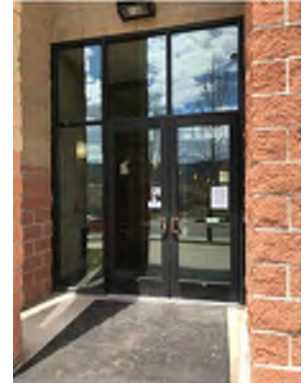
Exterior doors include 3 x 7 HM (Hollow Metal) steel door and steel frame with hinges, lockset, exit hardware and closer. Includes painted door and painted frame.

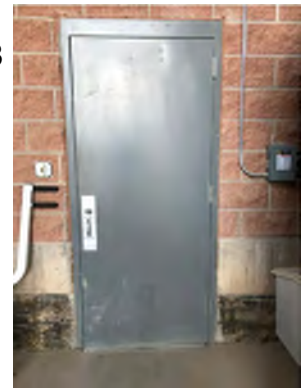
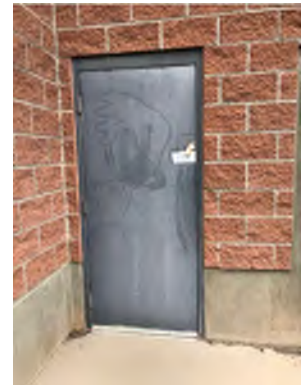
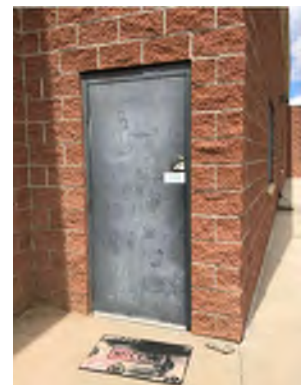
Exterior doors include a pair of 3 x 7 HM (Hollow Metal) steel doors and steel frame with hinges, locksets, exit hardware and closers. Includes painted doors and painted frame.

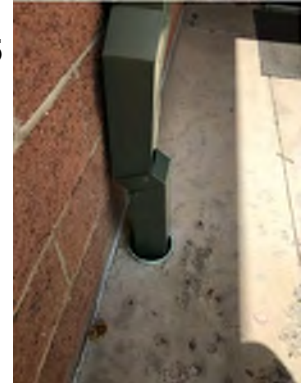
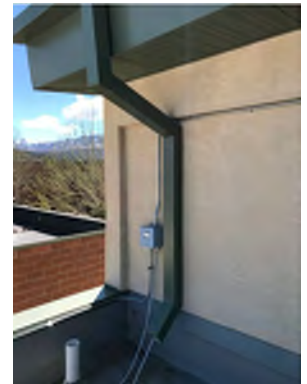
Rain water is removed from the roof by perimeter aluminum gutters, scuppers and downspouts which discharge to the surrounding property.

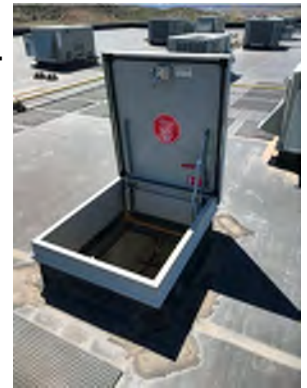
The facility includes a roof hatch with insulated curb.

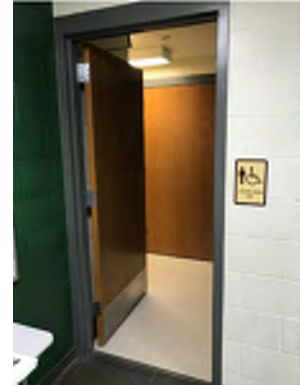
Interior doors include non-rated 3 x 7 Wd (wood) door and frame with hinges, lockset and closer. Includes finished door and frame.

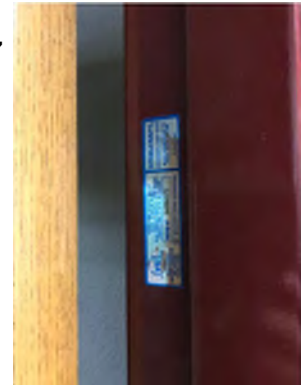
Interior doors include rated 3 x 7 Wd (wood) door and frame with vision lite, hinges, lockset and closer. Includes finished door and frame.

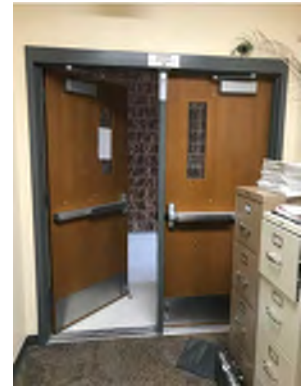
Interior doors include a pair of non-rated 3 x 7 Wd (wood) doors and frame with hinges, locksets and closers. Includes finished doors and frame.

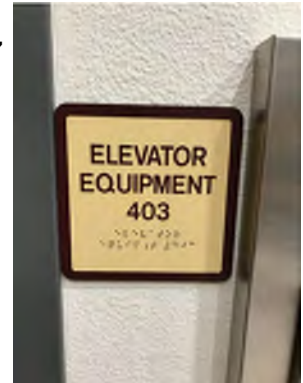
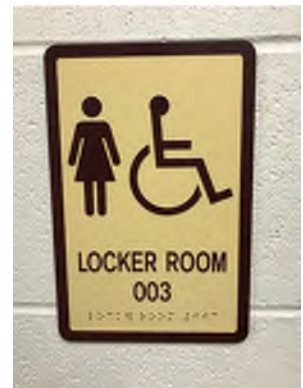
Finishes include room, door and graphic symbol signs. Years remaining have been increased because the system is currently functioning, however the system is beyond its useful life and should be budgeted for repair/replacement.

Auto generated renewal for Fittings - Signage. System Description: Finishes include room, door and graphic symbol signs. Years remaining have been increased because the system is currently functioning, however the system is beyond its useful life and should be budgeted for repair/replacement.

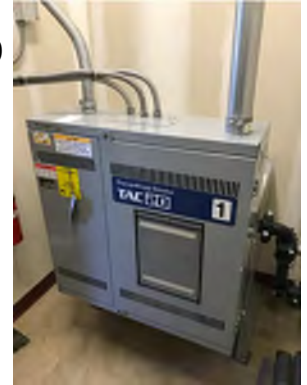
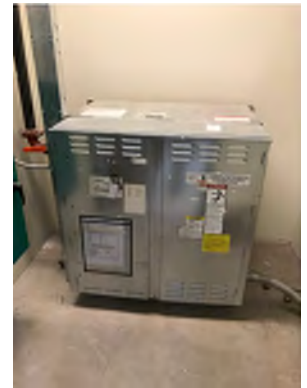
Building includes elevator equipment controls. Master control cabinet and associated equipment.

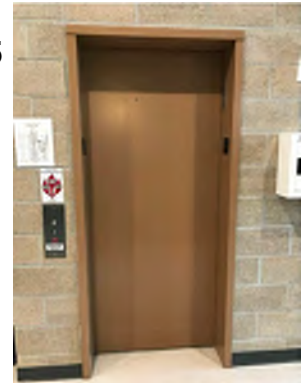
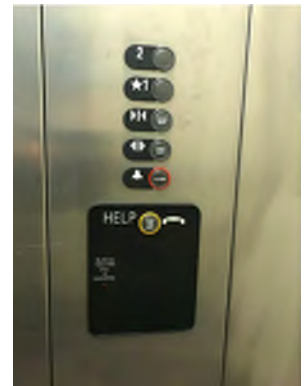
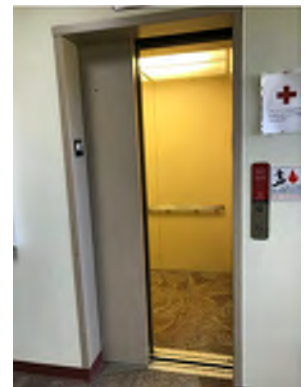
The building includes a passenger hydraulic elevator - two stories.

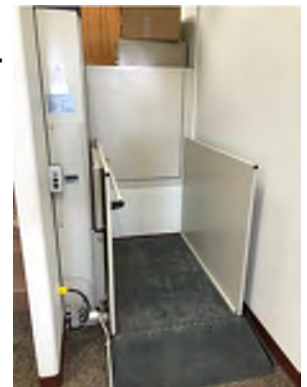
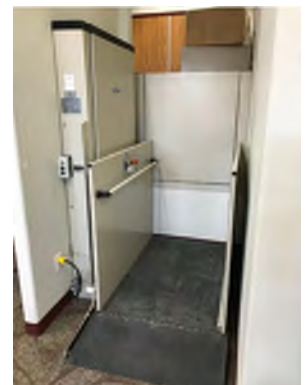
The building includes a wheelchair lift.

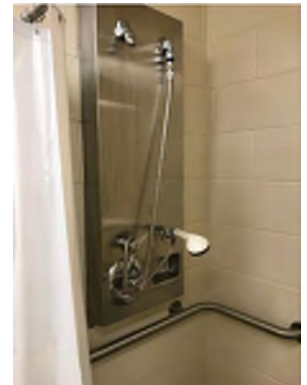
The restroom fixtures include shower heads and controls in a single shower room.

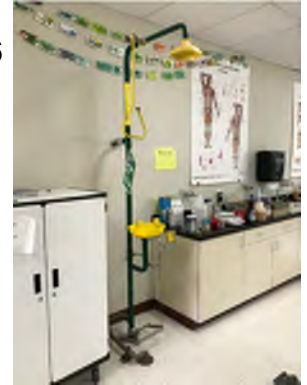
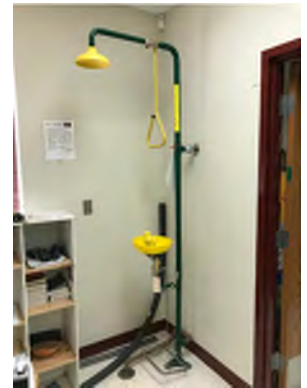
Plumbing fixtures include emergency safety shower.

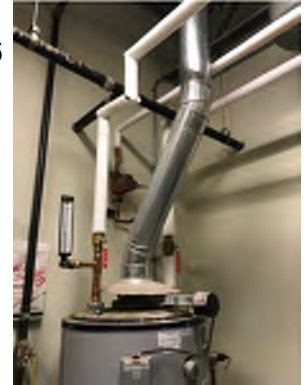
The building domestic water distribution system includes a four inch main line, water meter, backflow preventer, with rough ins included. The water heater is captured in a separate system.

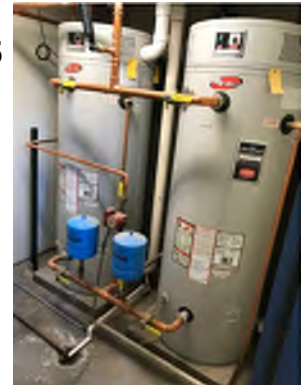
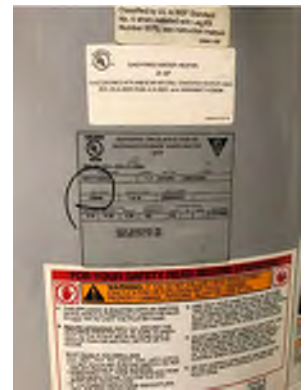
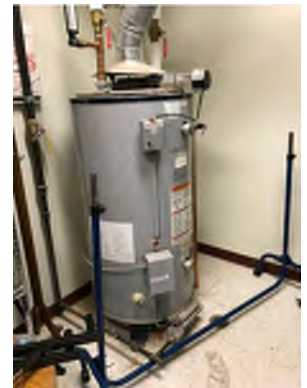
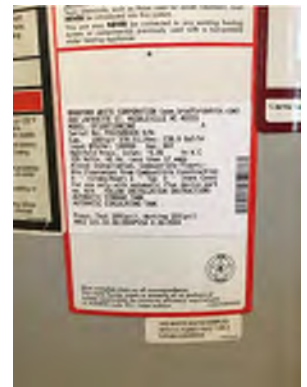
The domestic hot water is provided by a gas-fired, commercial-grade water heater, with recirculation pump. Years remaining have been increased because the system is currently functioning, however the system is approaching the end of its useful life and should be budgeted for repair/replacement.

Auto generated renewal for Water Heater - Gas. System Description: The domestic hot water is provided by a gas-fired, commercial-grade water heater, with recirculation pump. Years remaining have been increased because the system is currently functioning, however the system is approaching the end of its useful life and should be budgeted for repair/replacement.

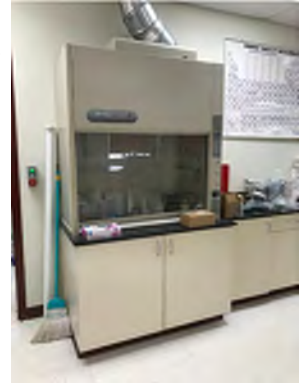
The HVAC ventilation system includes fume hood and exhaust system for a science lab.

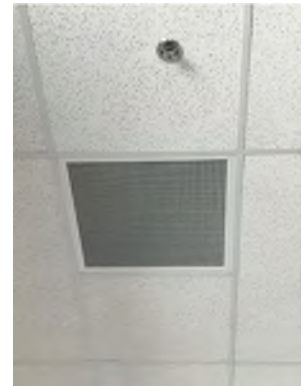
The HVAC ventilation system includes roof-mounted exhaust fans with ducting.

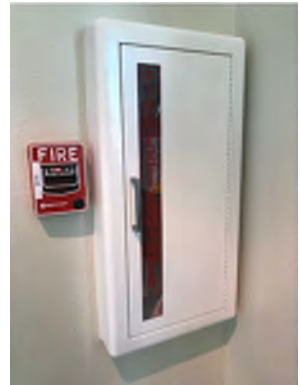
Fire Extinguishers - Dry Chem w/Cabinet

Current Age:	13 years	Year Installed:	2006
Exp. Use. Life:	30 years	Obs. Yrs. Rem:	17 years
Quantity:	59,500 SF	Unit Cost:	\$0.05
Insp. Date:	4/24/19	Inspector:	Mark Hillen

Handheld type dry chemical fire extinguishers are located throughout the building. Includes cabinets.

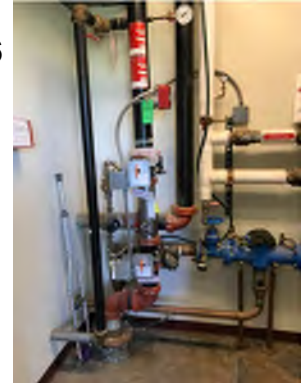
The fire protection systems include a wet fire sprinkler system with backflow protection and standpipes, but no fire pump.

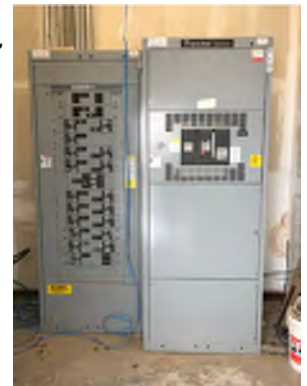
D5012 - Low Tension Service and Dist. Main Electrical Service - 2000A 480Y/277V

Current Age:	13 years	Year Installed:	2006
Exp. Use. Life:	30 years	Obs. Yrs. Rem:	17 years
Quantity:	1 Each	Unit Cost:	\$189,656.98
Insp. Date:	4/24/19	Inspector:	Mark Hillen

The building includes an electrical service, which includes incoming feeders, main panel, and metering.

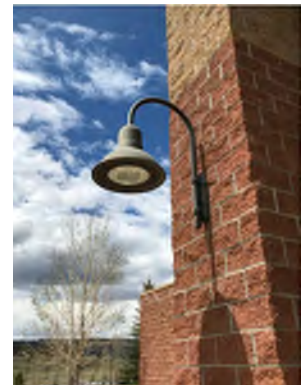
Exterior lighting consists of HID (High-Intensity Discharge) wall pack units.

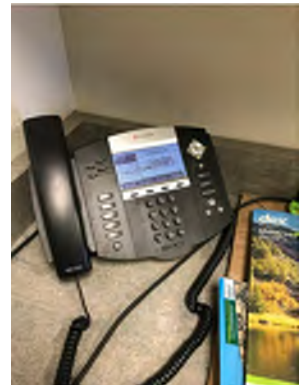
Current Age: 13 years **Year Installed:** 2006
Exp. Use. Life: 10 years **Obs. Yrs. Rem:** 5 years
Quantity: 59,500 SF **Unit Cost:** \$4.00
Insp. Date: 4/24/19 **Inspector:** Mark Hillen

The building includes a telephone system. Years remaining have been increased because the system is currently functioning, however the system is beyond its useful life and should be budgeted for repair/replacement.

Auto generated renewal for Telephone System. System Description: The building includes a telephone system. Years remaining have been increased because the system is currently functioning, however the system is beyond its useful life and should be budgeted for repair/replacement.

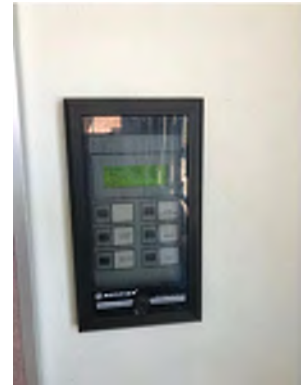
The fire alarm system includes head end equipment, pull stations, audio/visual strobes, visual strobes, smokes, conduit, wire and connections. Years remaining have been increased because the system is currently functioning, however the system is beyond its useful life and should be budgeted for repair/replacement.

Auto generated renewal for Fire Alarm System. System Description: The fire alarm system includes head end equipment, pull stations, audio/visual strobes, visual strobes, smokes, conduit, wire and connections. Years remaining have been increased because the system is currently functioning, however the system is beyond its useful life and should be budgeted for repair/replacement.

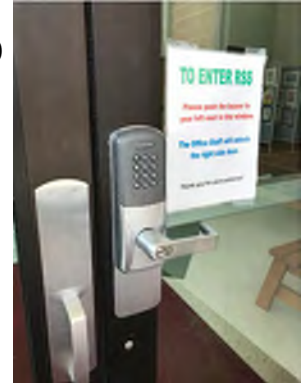
The building includes a card access security system. The security system includes: control panels, card swipe pads, conduit, and cabling. Also included is buzz-in system at the main entry door.

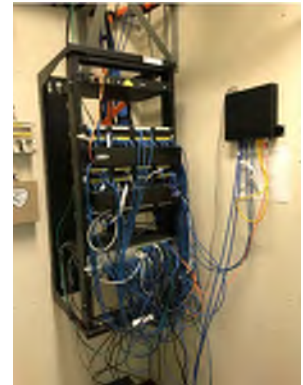
Building includes a local area network system.

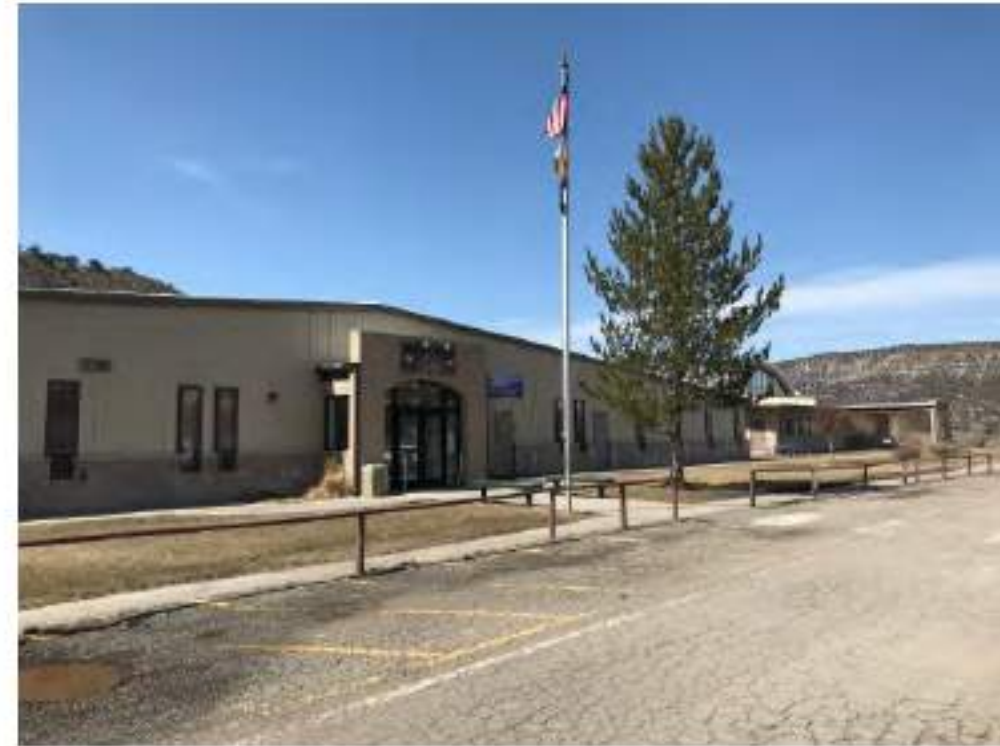
District:	Auditor - Ridgway R-2
School Name:	Ridgway ES
Address:	1115 WEST CLINTON STREET
City:	RIDGWAY
Gross Area (SF):	64,700
Number of Buildings:	2
Replacement Value:	\$18,253,041
Condition Budget:	\$9,327,348
Total FCI:	0.51
Adequacy Index:	0.28

System Group	Replacement Cost	Requirement Cost	SCI
Electrical System	\$2,665,798	\$1,267,485	0.48
Equipment and Furnishings	\$420,888	\$493,595	1.17
Exterior Enclosure	\$3,847,856	\$1,076,673	0.28
Fire Protection	\$13,596	\$795,676	58.52
Furnishings	\$407,175	\$455,307	1.12
HVAC System	\$2,524,974	\$2,179,398	0.86
Interior Construction and Conveyance	\$3,247,920	\$2,132,354	0.66
Plumbing System	\$1,004,945	\$694,393	0.69
Site	\$1,967,727	\$1,015,214	0.52
Structure	\$2,152,161	\$0	0.00
Overall - Total	\$18,253,041	\$10,110,095	0.55

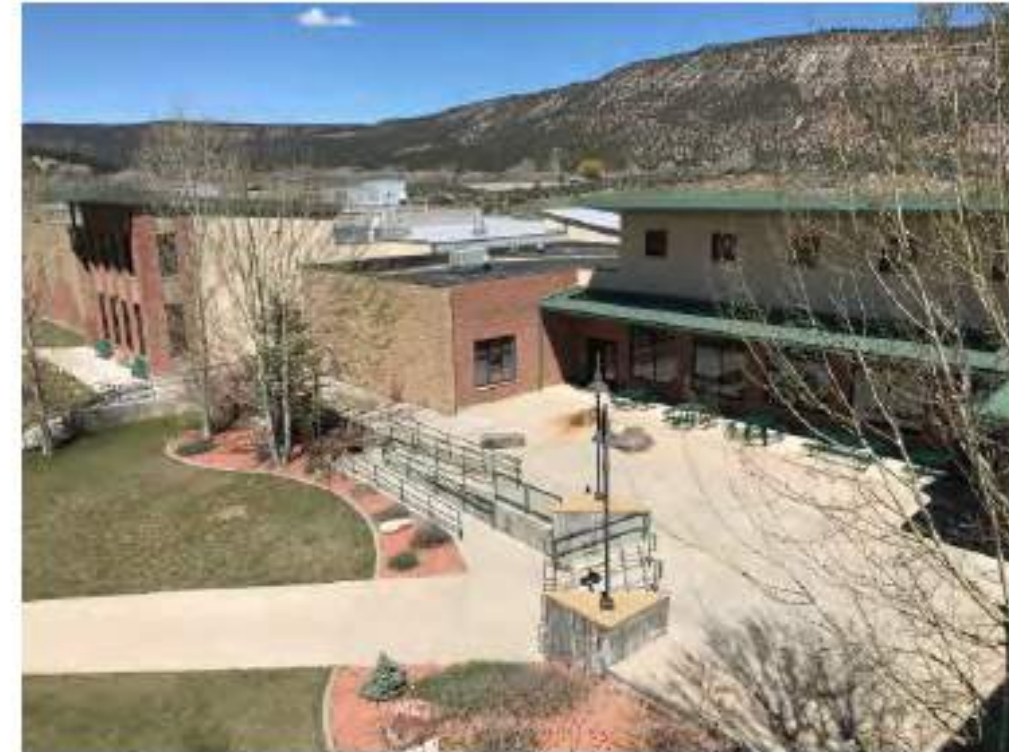
District:	Auditor - Ridgway R-2
School Name:	Ridgway MS/HS
Address:	1200 GREEN STREET
City:	RIDGWAY
Gross Area (SF):	61,800
Number of Buildings:	2
Replacement Value:	\$18,058,602
Condition Budget:	\$2,869,060
Total FCI:	0.16
Adequacy Index:	0.19

System Group	Replacement Cost	Requirement Cost	SCI
Electrical System	\$2,745,295	\$887,058	0.32
Equipment and Furnishings	\$628,066	\$0	0.00
Exterior Enclosure	\$2,375,643	\$0	0.00
Fire Protection	\$600,387	\$24,720	0.04
Furnishings	\$544,325	\$0	0.00
HVAC System	\$1,433,461	\$935,549	0.65
Interior Construction and Conveyance	\$3,064,271	\$737,734	0.24
Plumbing System	\$1,196,475	\$199,455	0.17
Site	\$2,619,639	\$109,266	0.04
Structure	\$2,851,041	\$0	0.00
Overall - Total	\$18,058,602	\$2,893,782	0.16

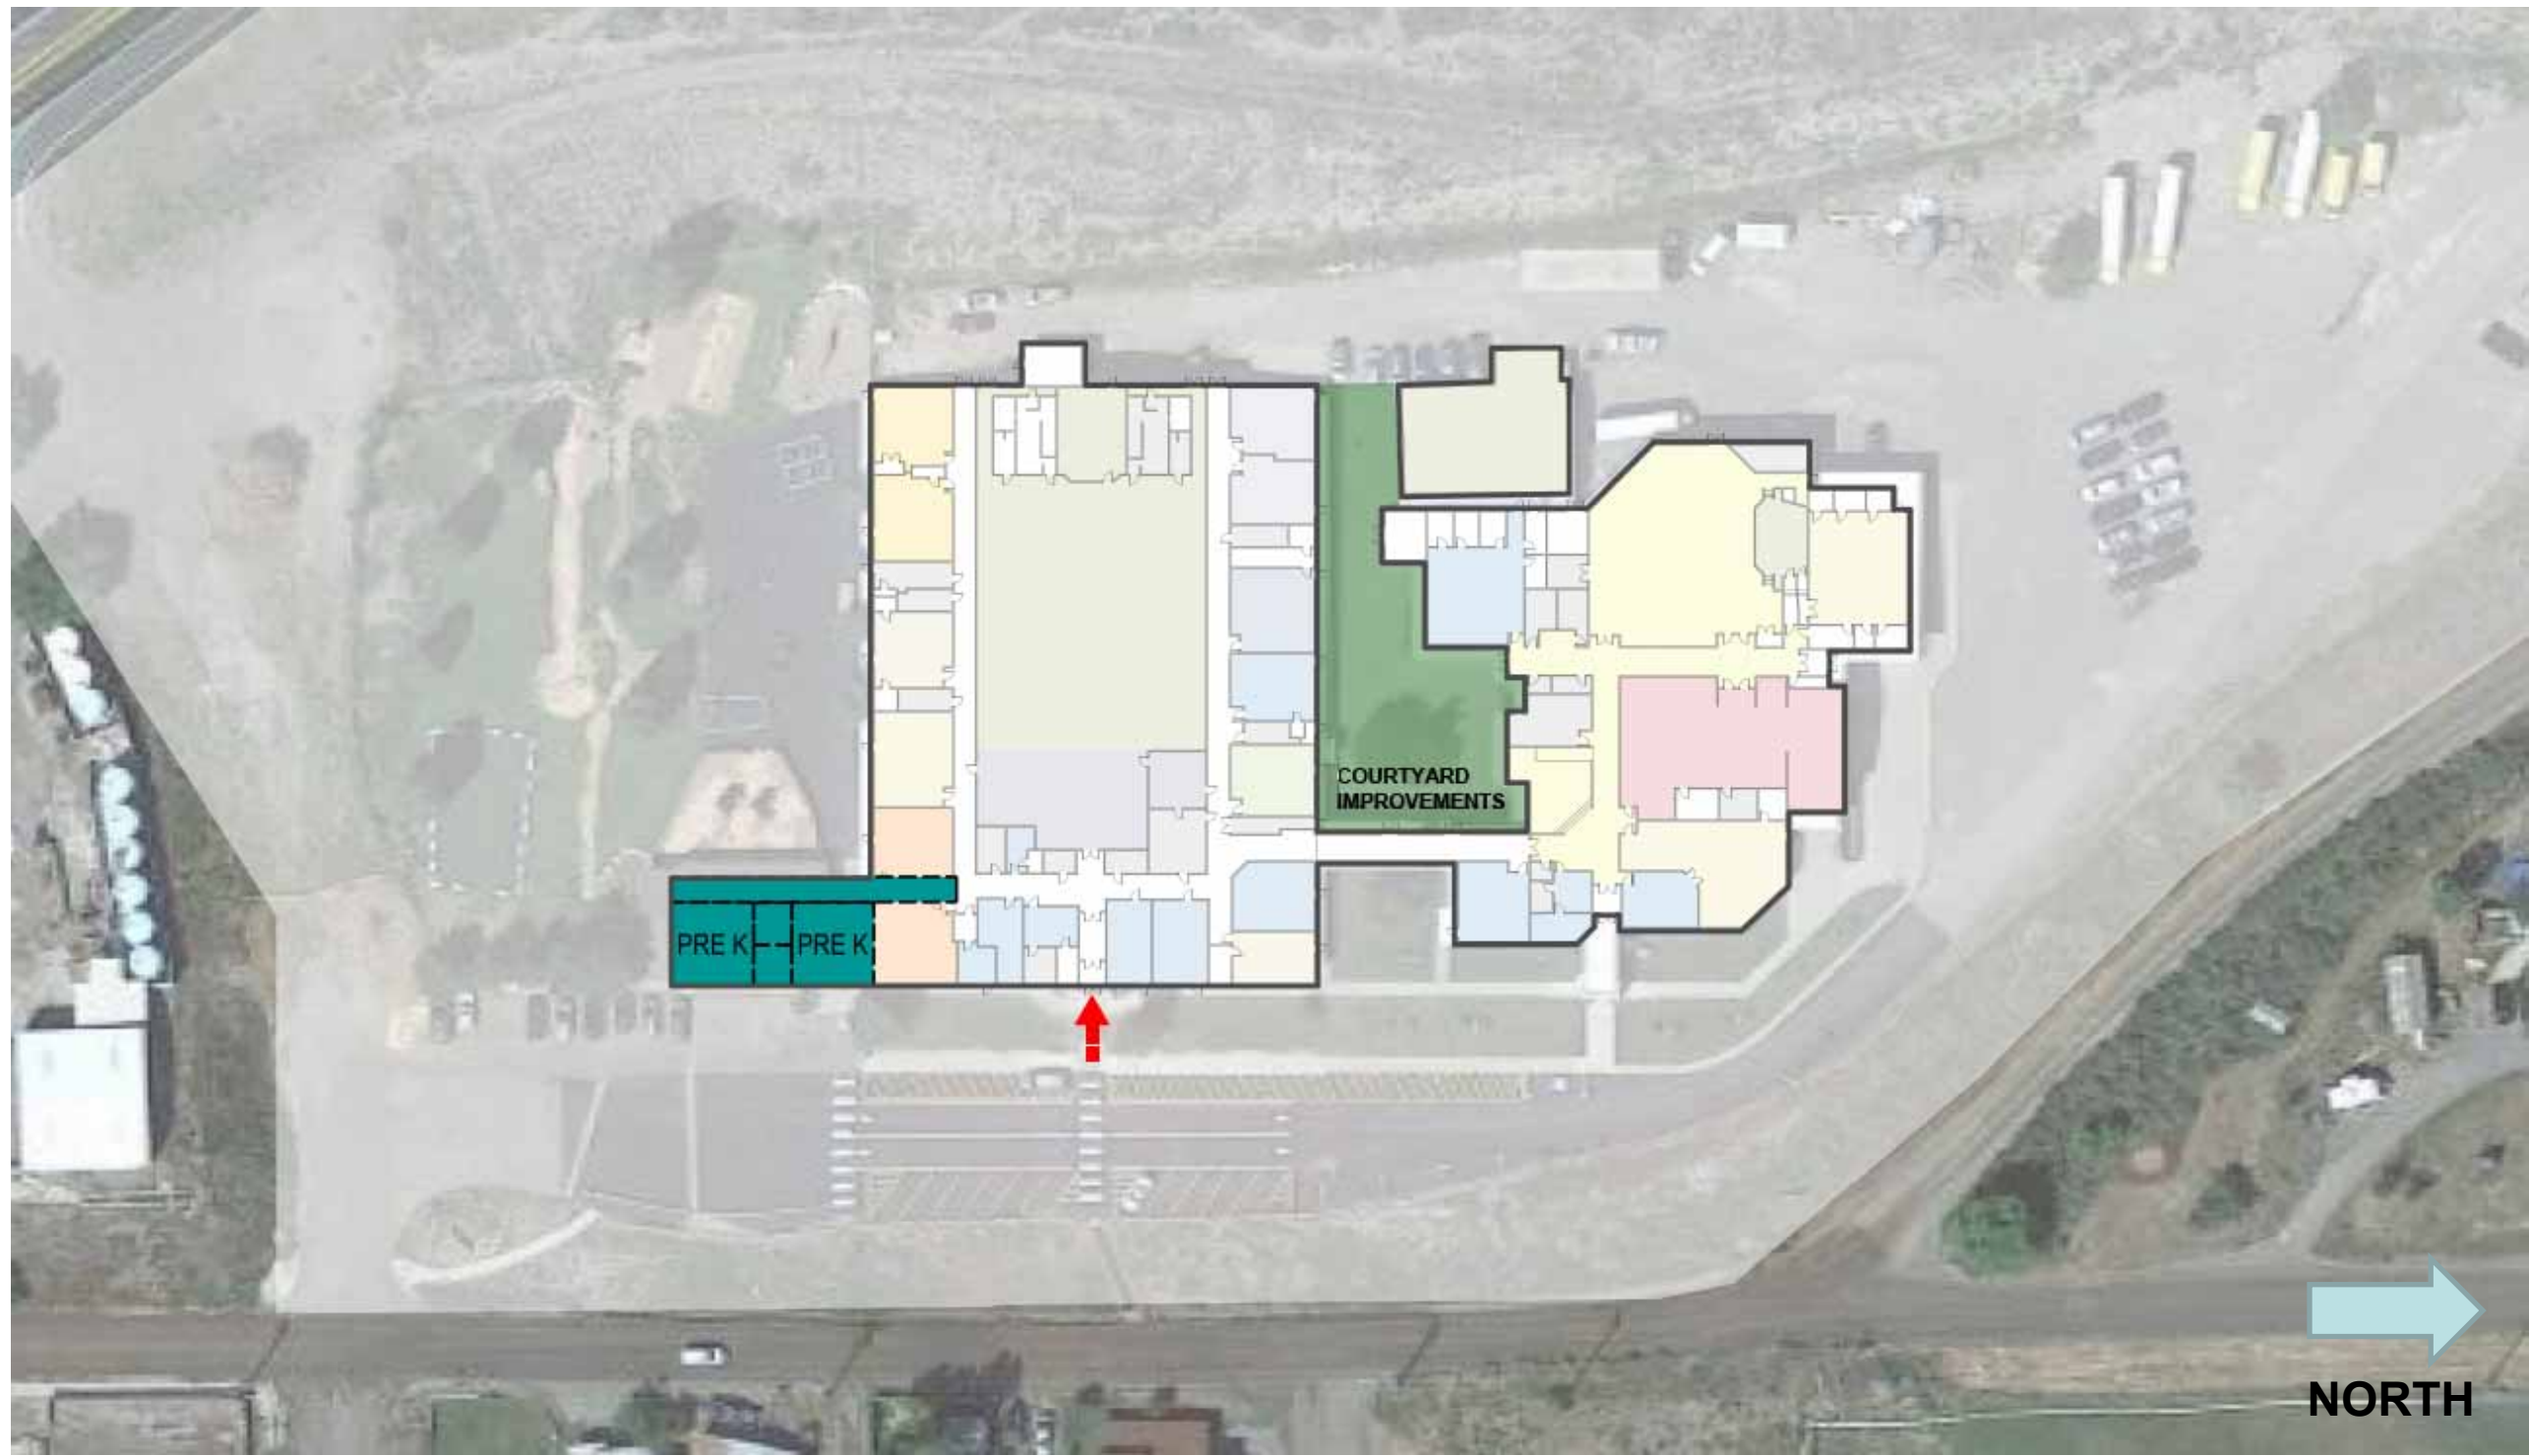
E1

Remodel/Addition

- New Roof
- New HVAC
- Update Finishes
