Ridgway School District R-2 Facilities Master Plan

December 14, 2020

1.0 Executive Summary

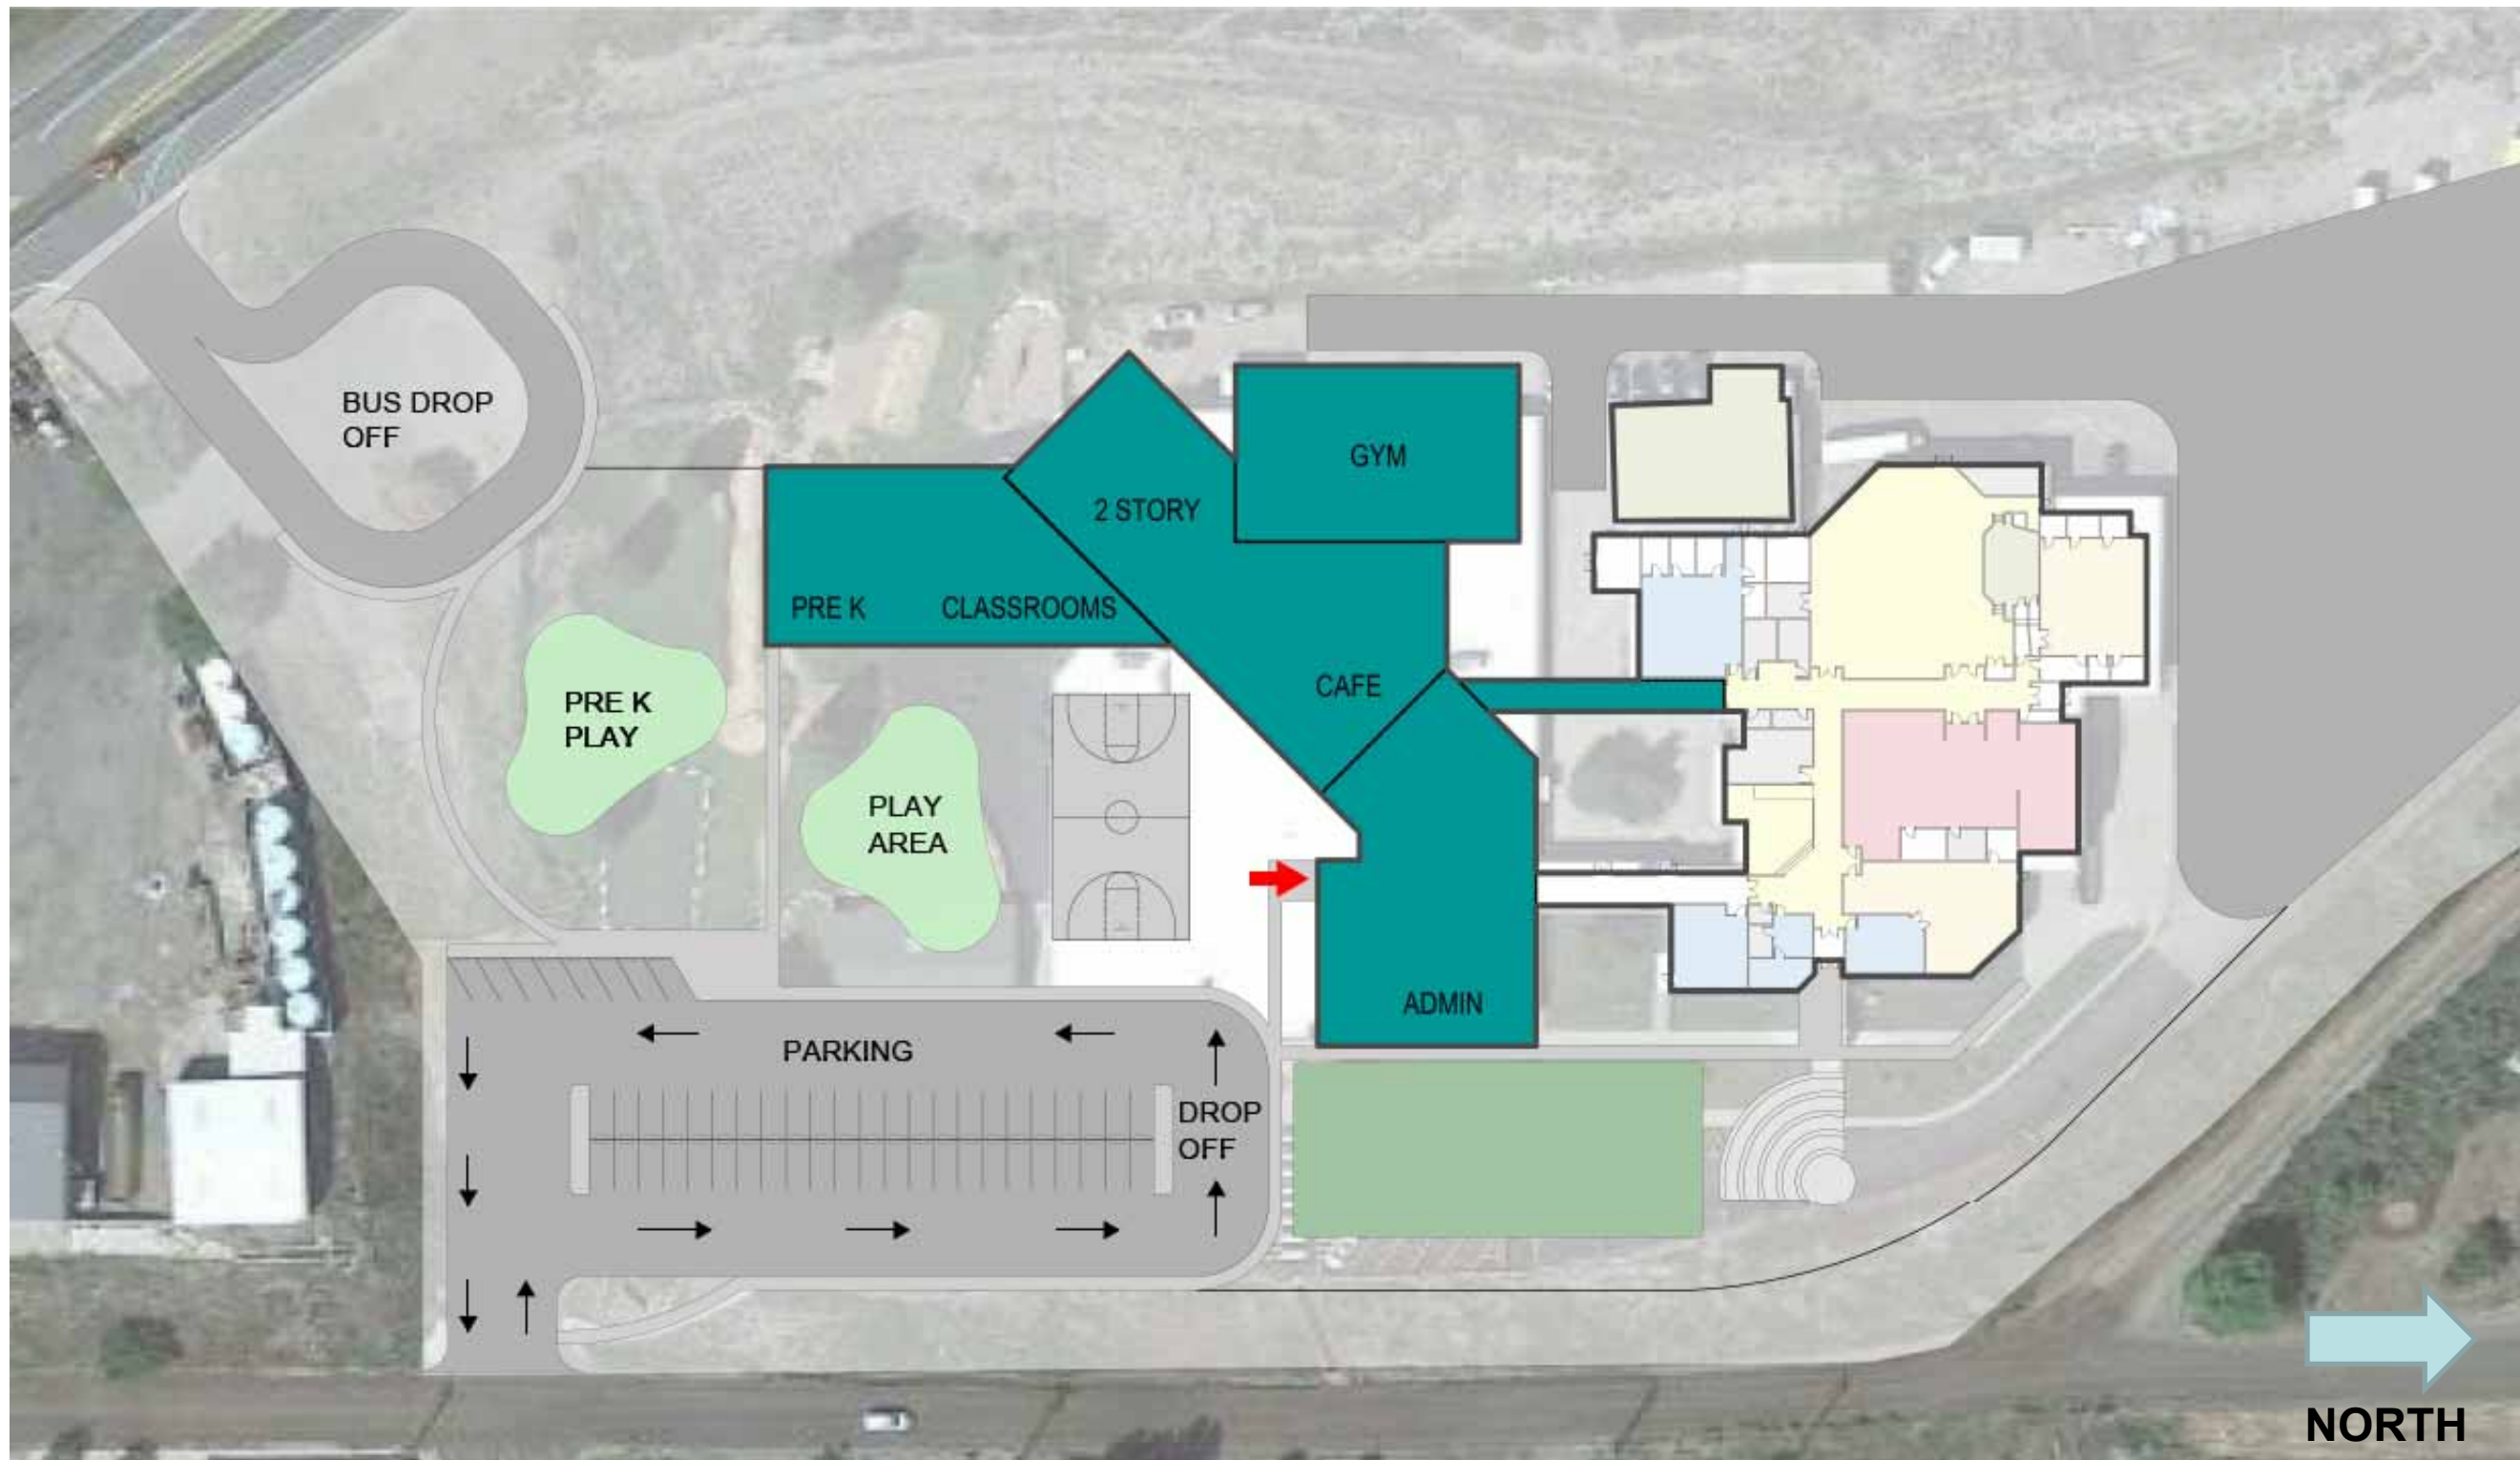
E3

Remodel/Major Addition

- Maintenance on '96 Building
- Temporarily move to '96 Building
- Demo '72 and Construct New
- New Playgrounds in front (with separate Pre-K area)
- New Drop-off/parking
- Separate Bus/Parents
- New small gym
- Leave BOCES and District Offices
- Classroom areas include Learning Commons concept
- Renovate existing library?

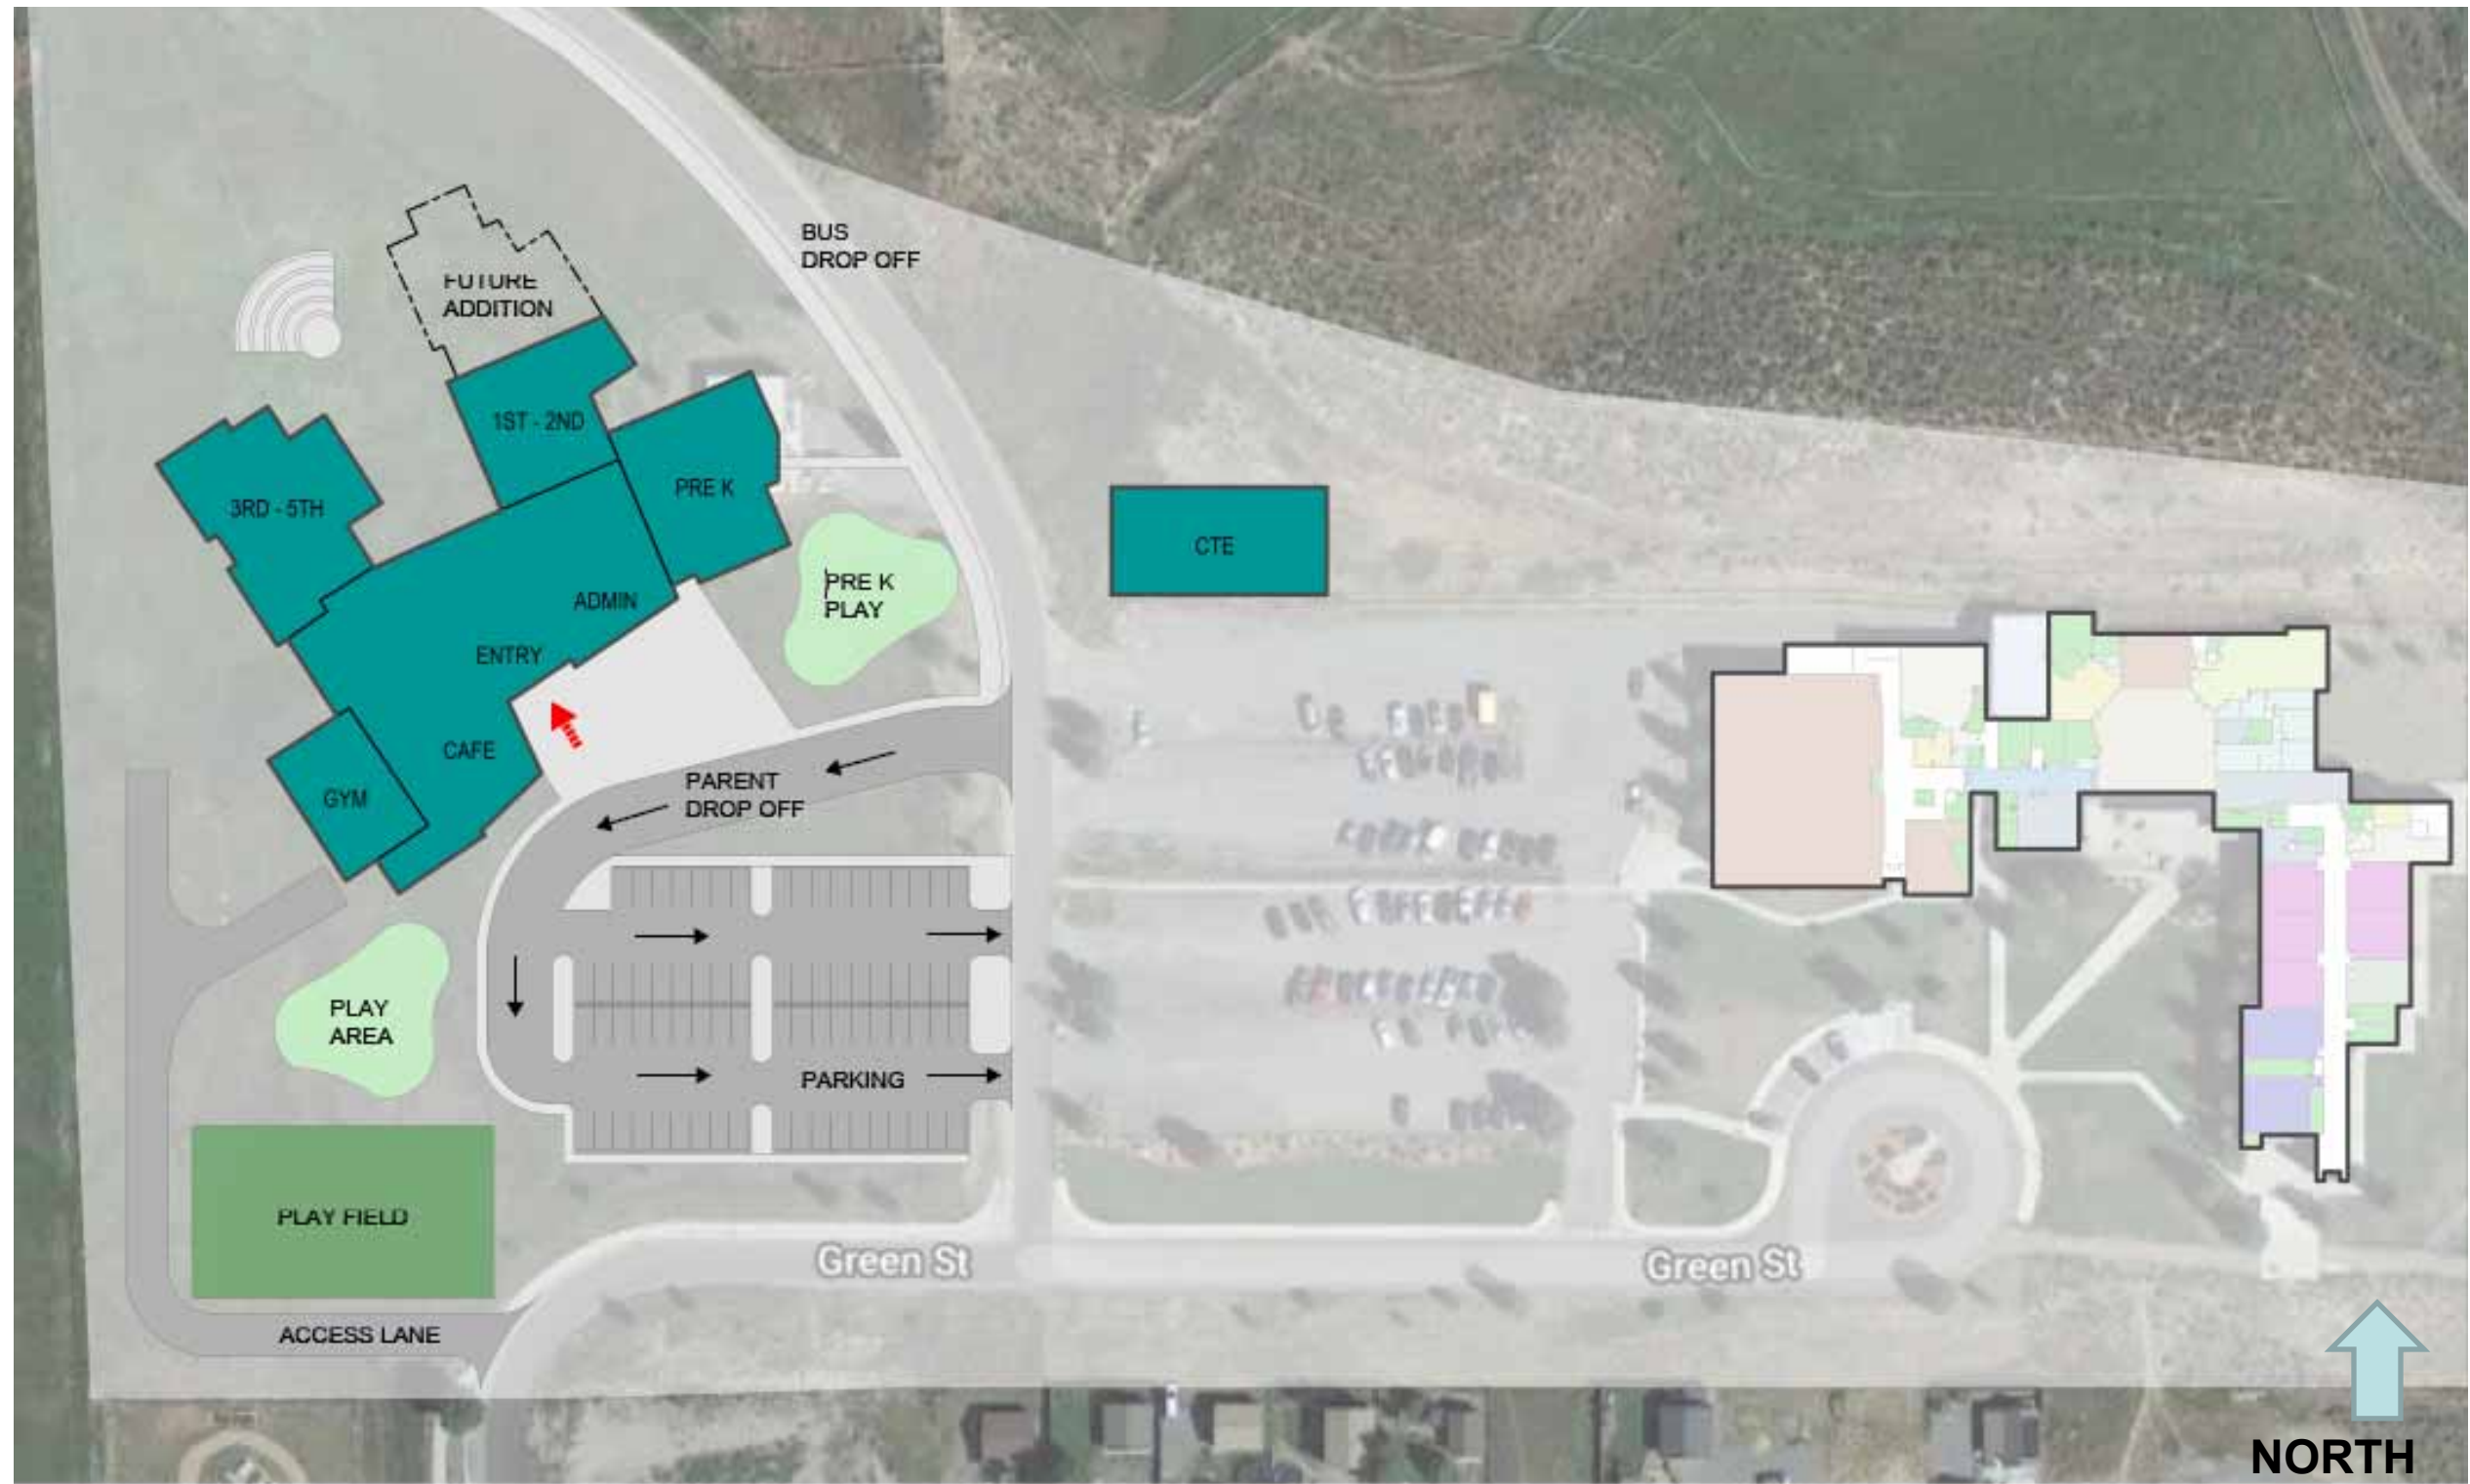
E4

New Building

- Build a new K-5 School on site west of Secondary (225+ Students)
- Shared Campus Parking
- Plan for future expansion
- Building new CTE Program on Secondary Site
- Includes all design features of a new 21st Century School

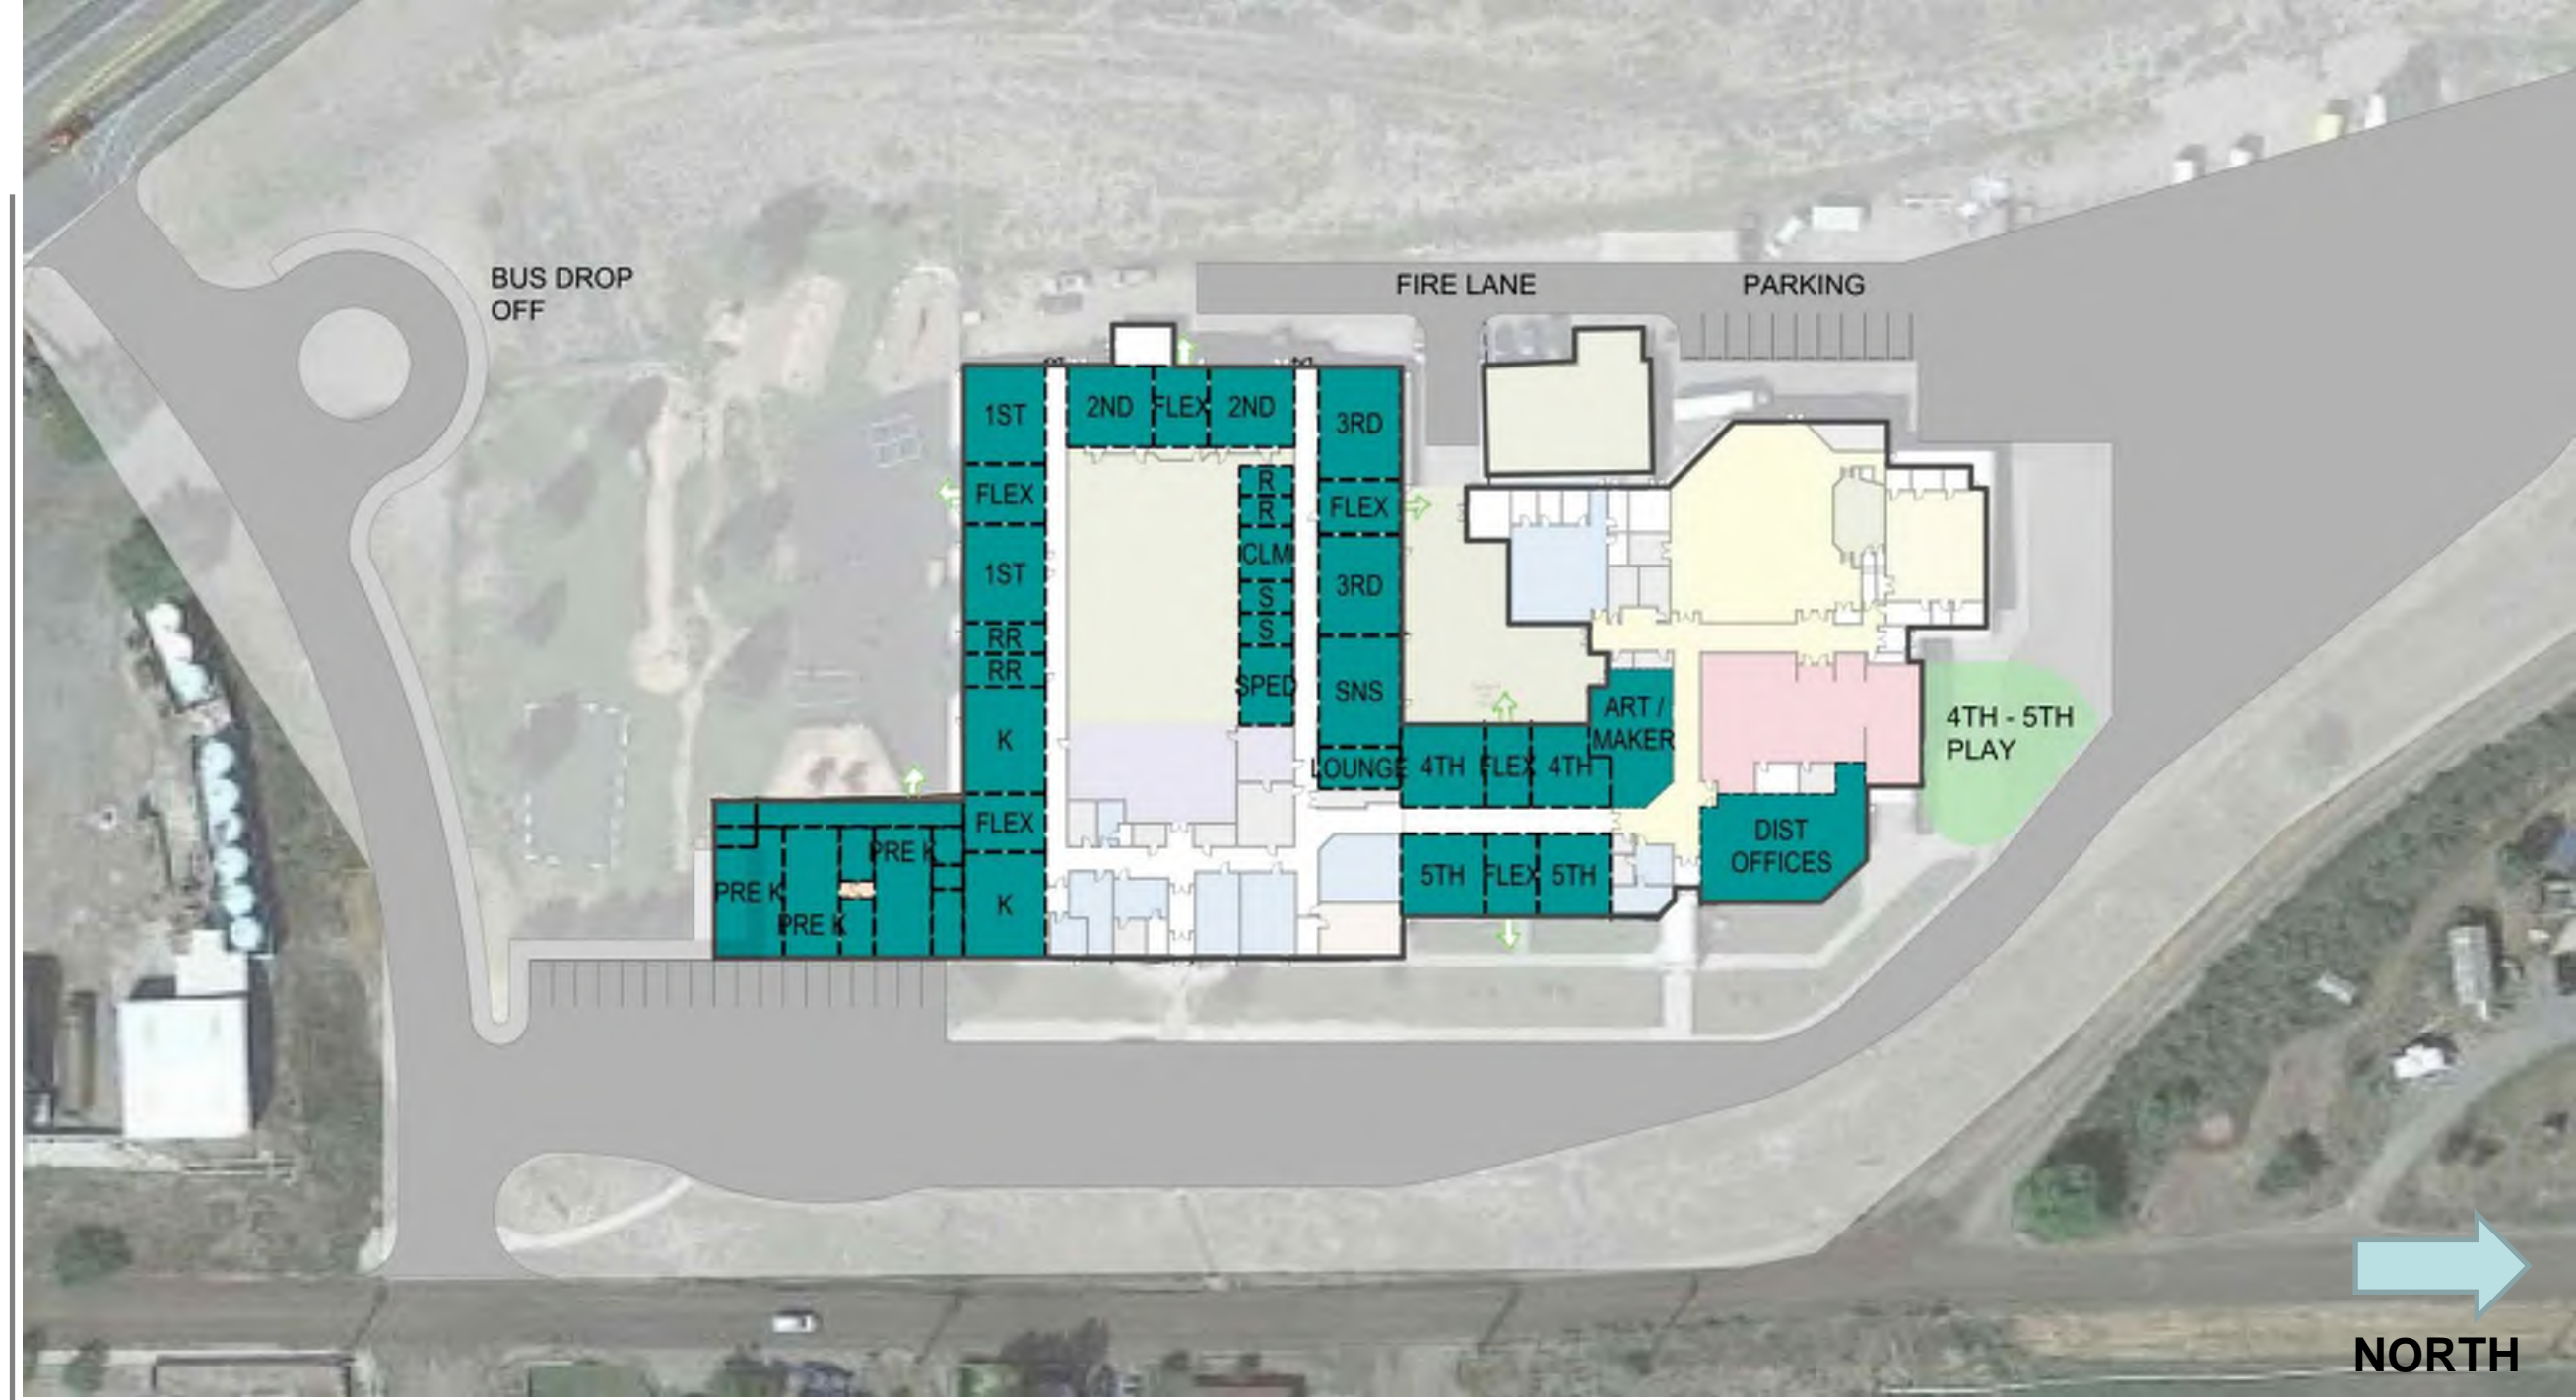
Remodel/Addition

- New Roof
- New HVAC/Electrical
- Update Finishes
- Fire Sprinkler
- Pre-K Addition (3rd CR)
- Create additional SPED areas
- Improve outdoor spaces (fence courtyard)
- Create Flex Spaces
- Larger Classrooms
- New Admin area
- Reconfigure District Offices
- **Extensive Abatement**

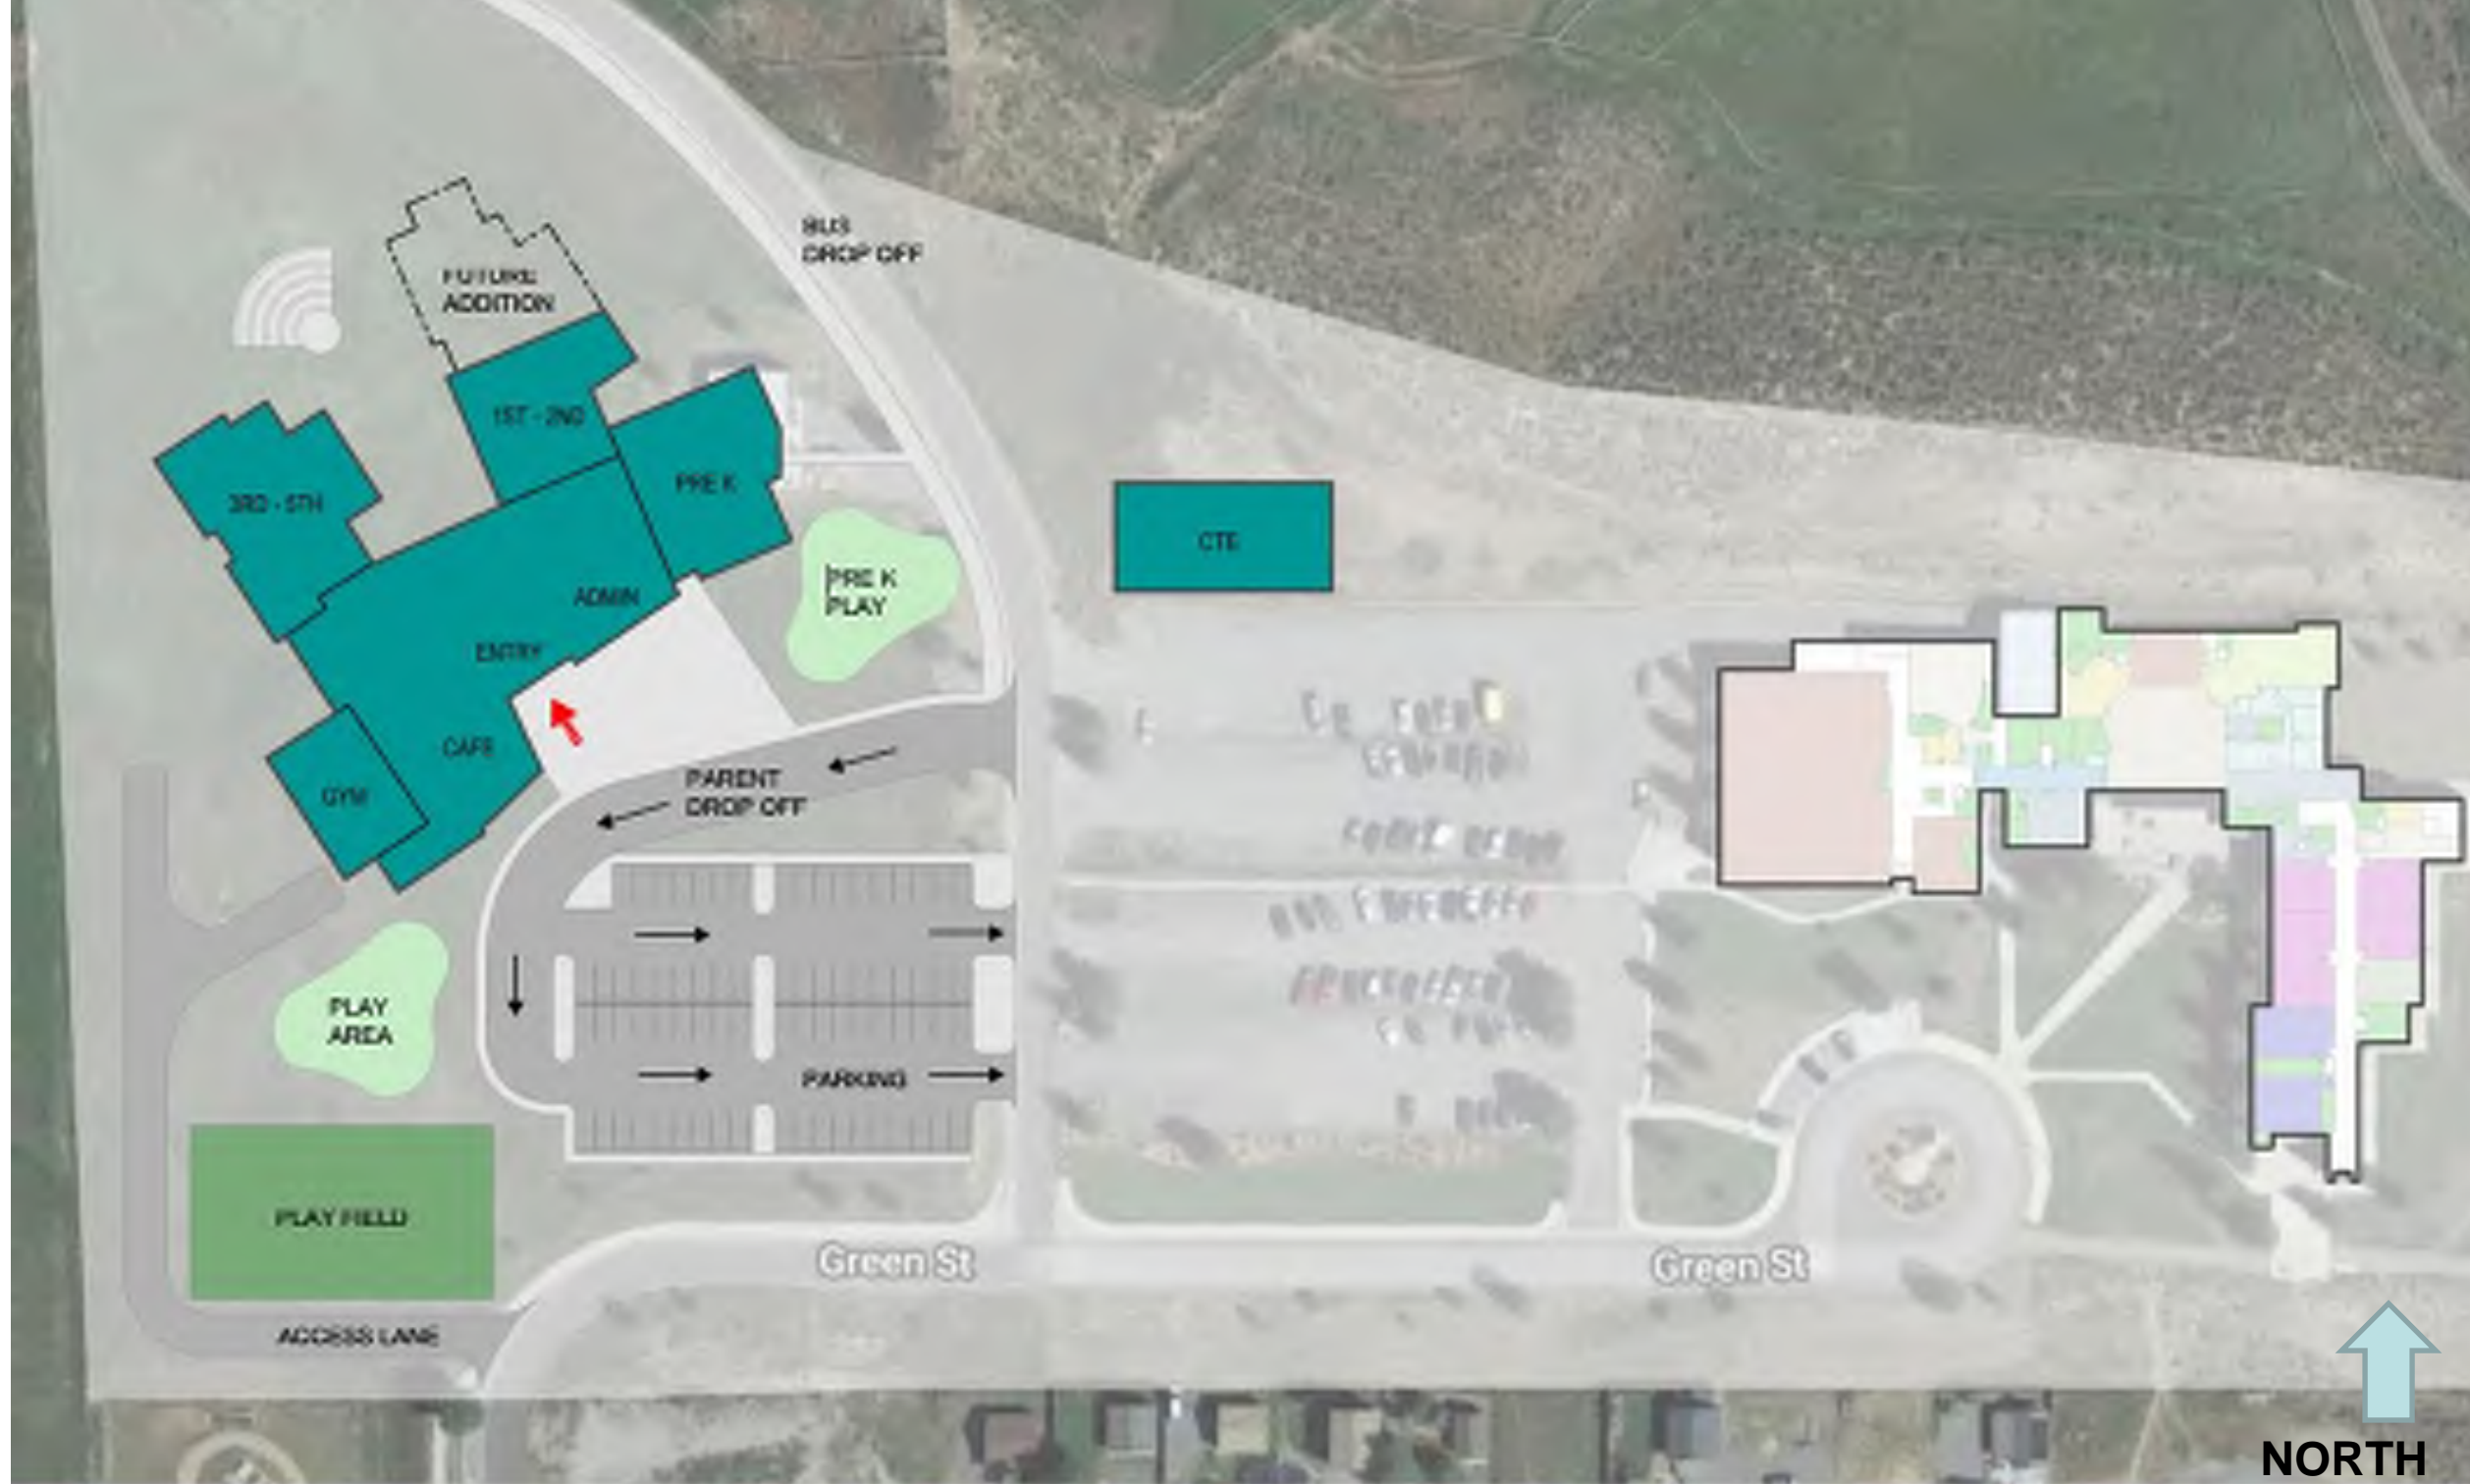
New Building

- Build a new K-5 School on site west of Secondary (225+ Students)
- Shared Campus Parking
- Plan for future expansion
- Building new CTE Program on Secondary Site
- Includes all design features of a new 21st Century School

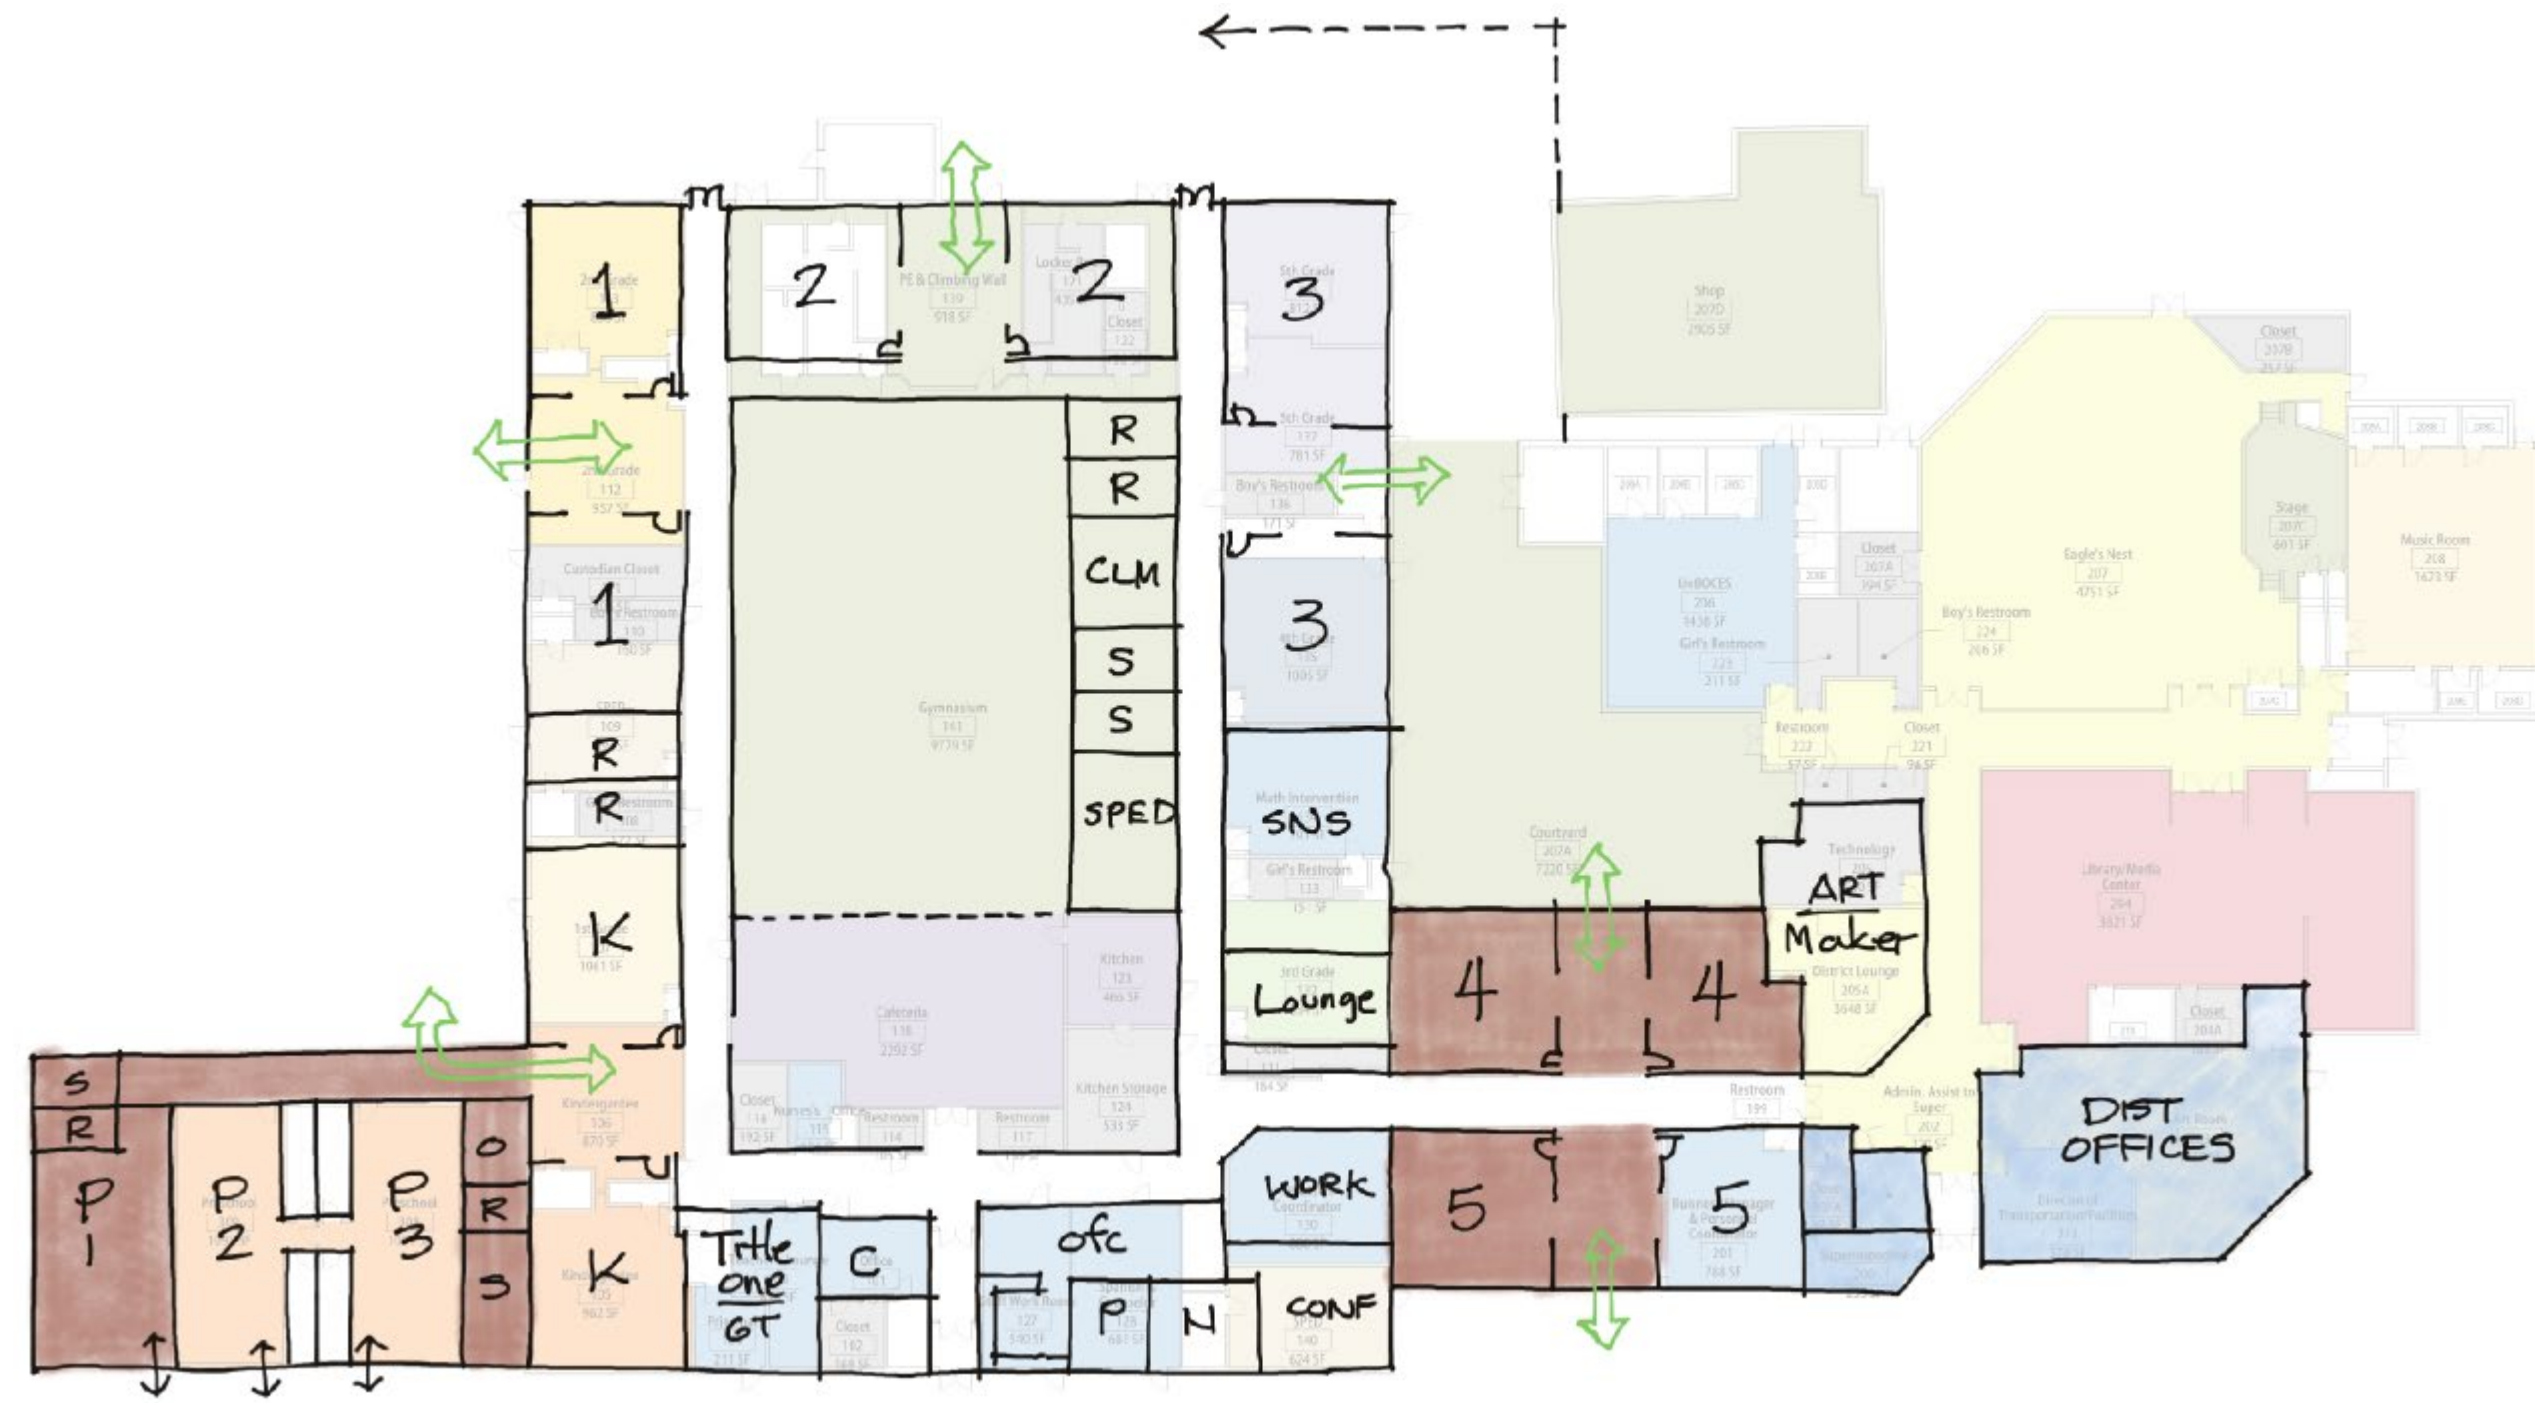
Remodel/Addition

- New Roof
- New HVAC/Electrical
- Update Finishes
- Fire Sprinkler
- Pre-K Addition (3rd CR)
- Create additional SPED areas
- Improve outdoor spaces (fence courtyard)
- Create Flex Spaces
- Larger Classrooms
- New Admin area
- Reconfigure District Offices
- Bus Drop-Off
- **Extensive Abatement**

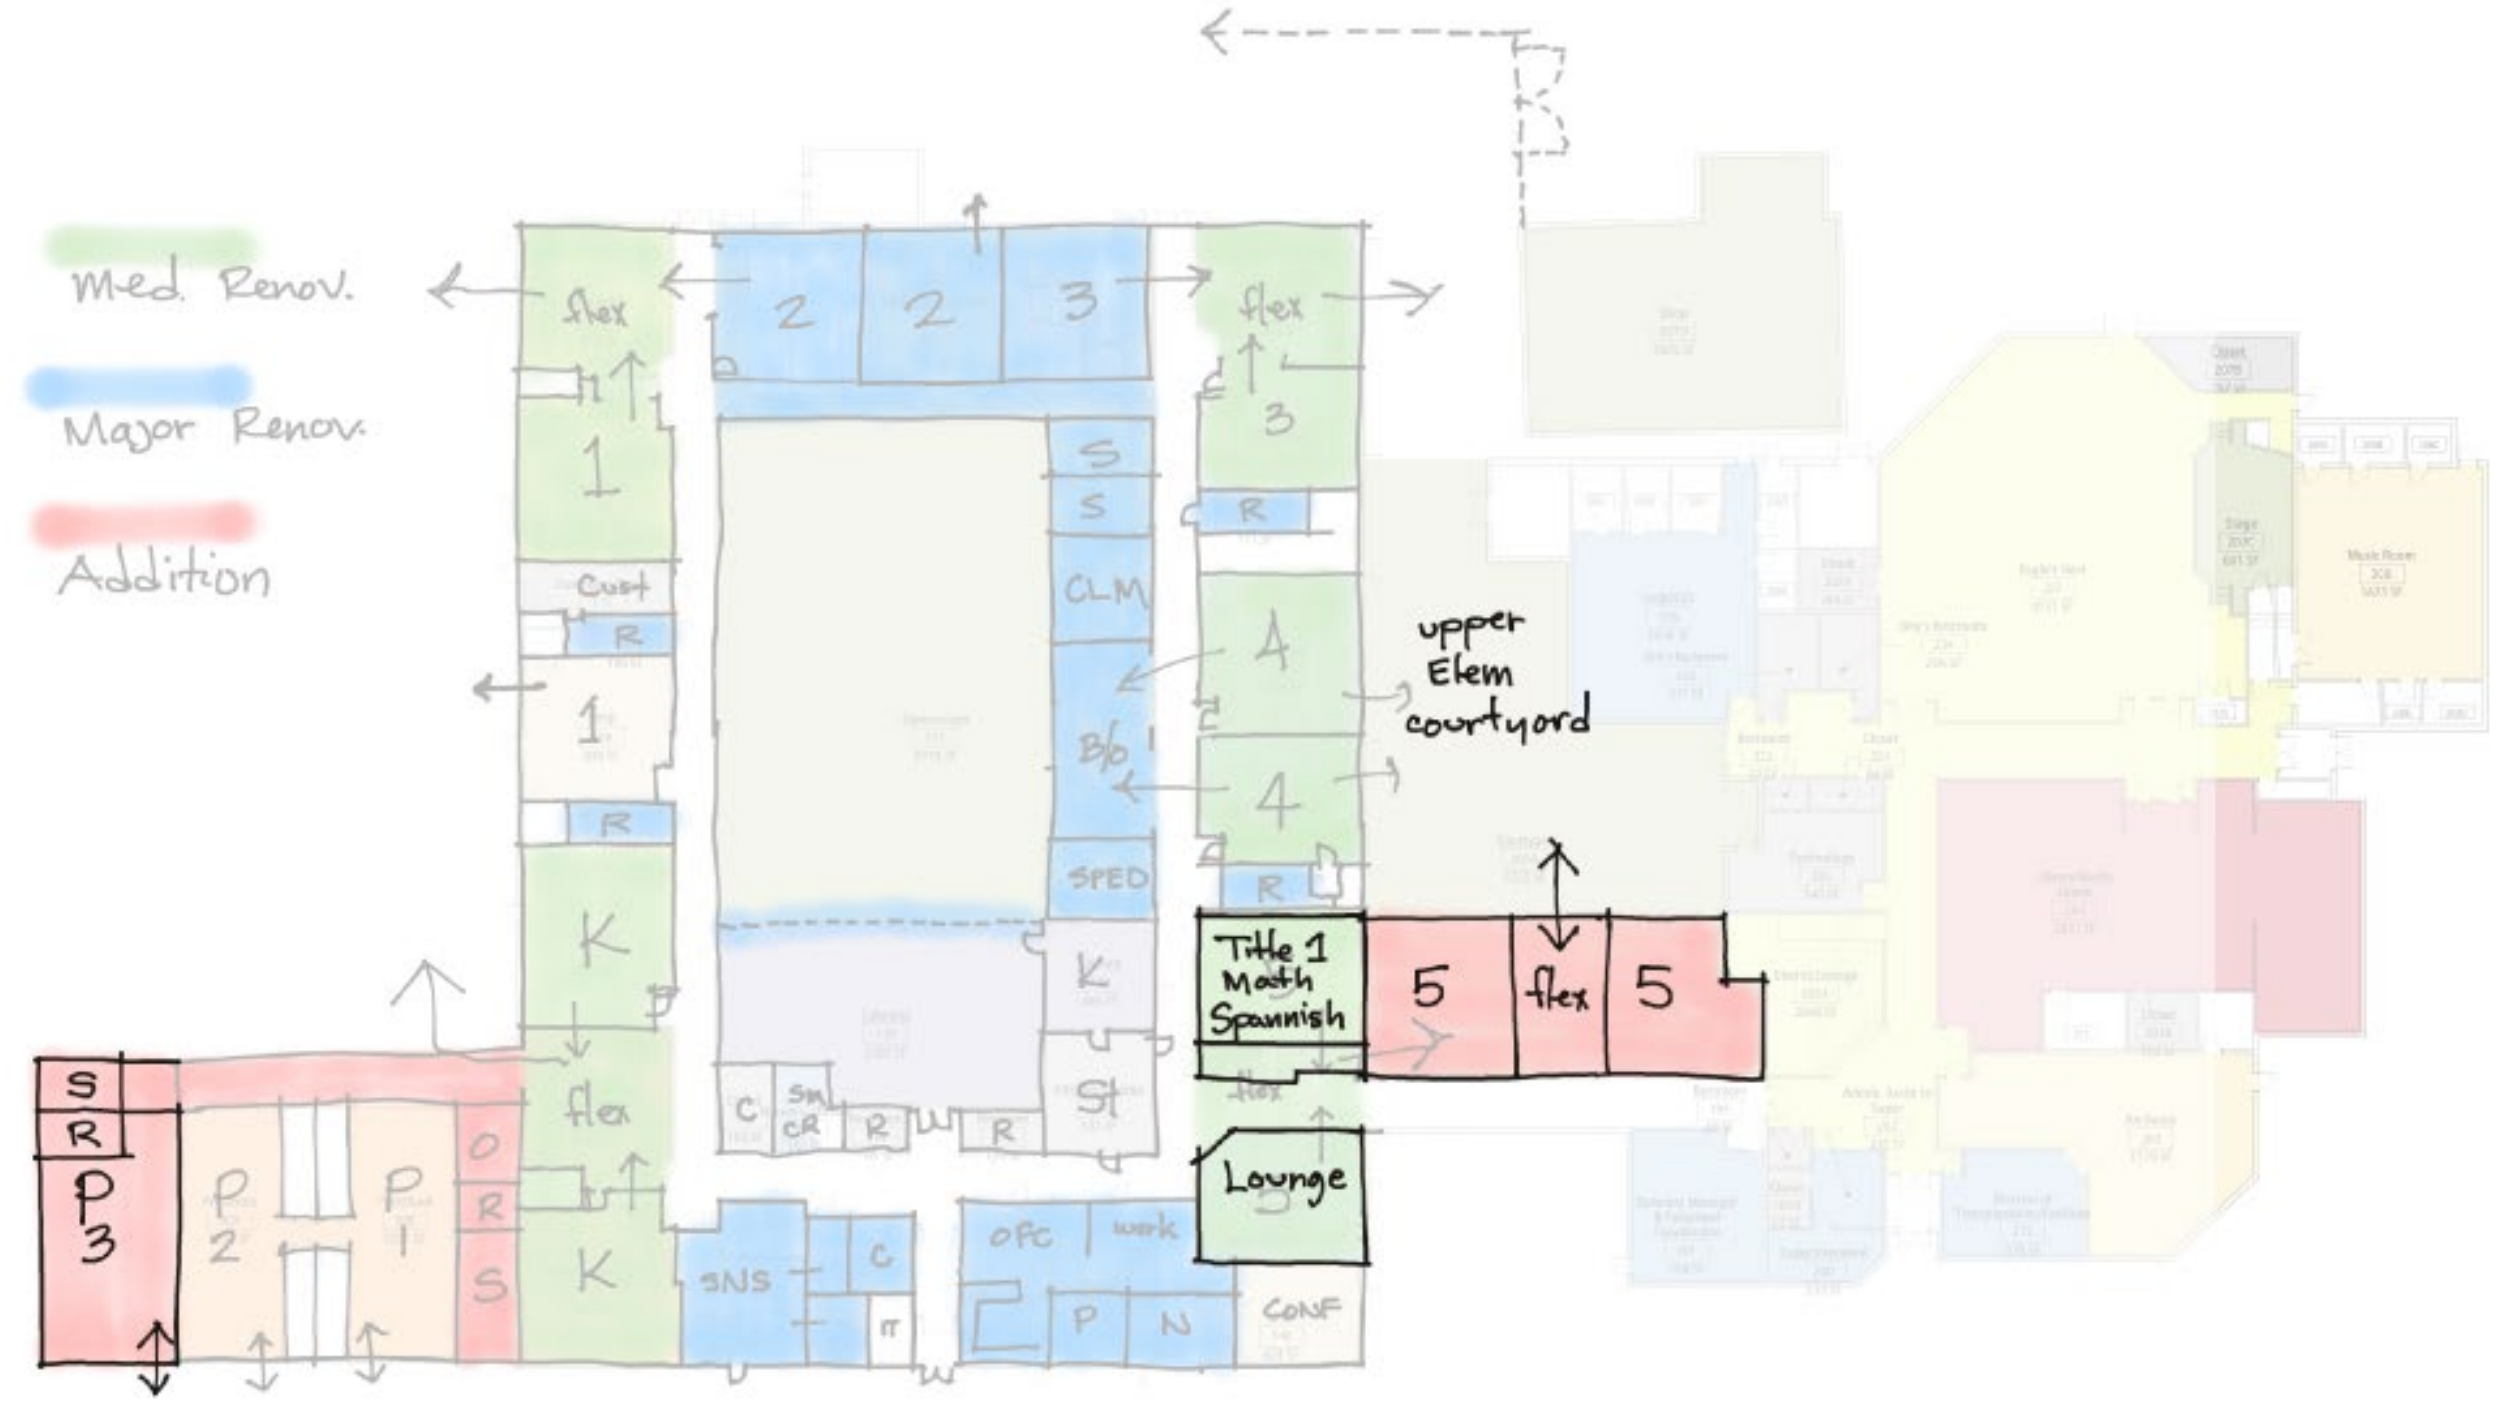
Remodel/Addition

- Third Pre-School Classroom
- Fifth Grade Addition
- Extra Classroom
