Ridgway School District R-2 Facilities Master Plan

December 14, 2020

1.0 Executive Summary

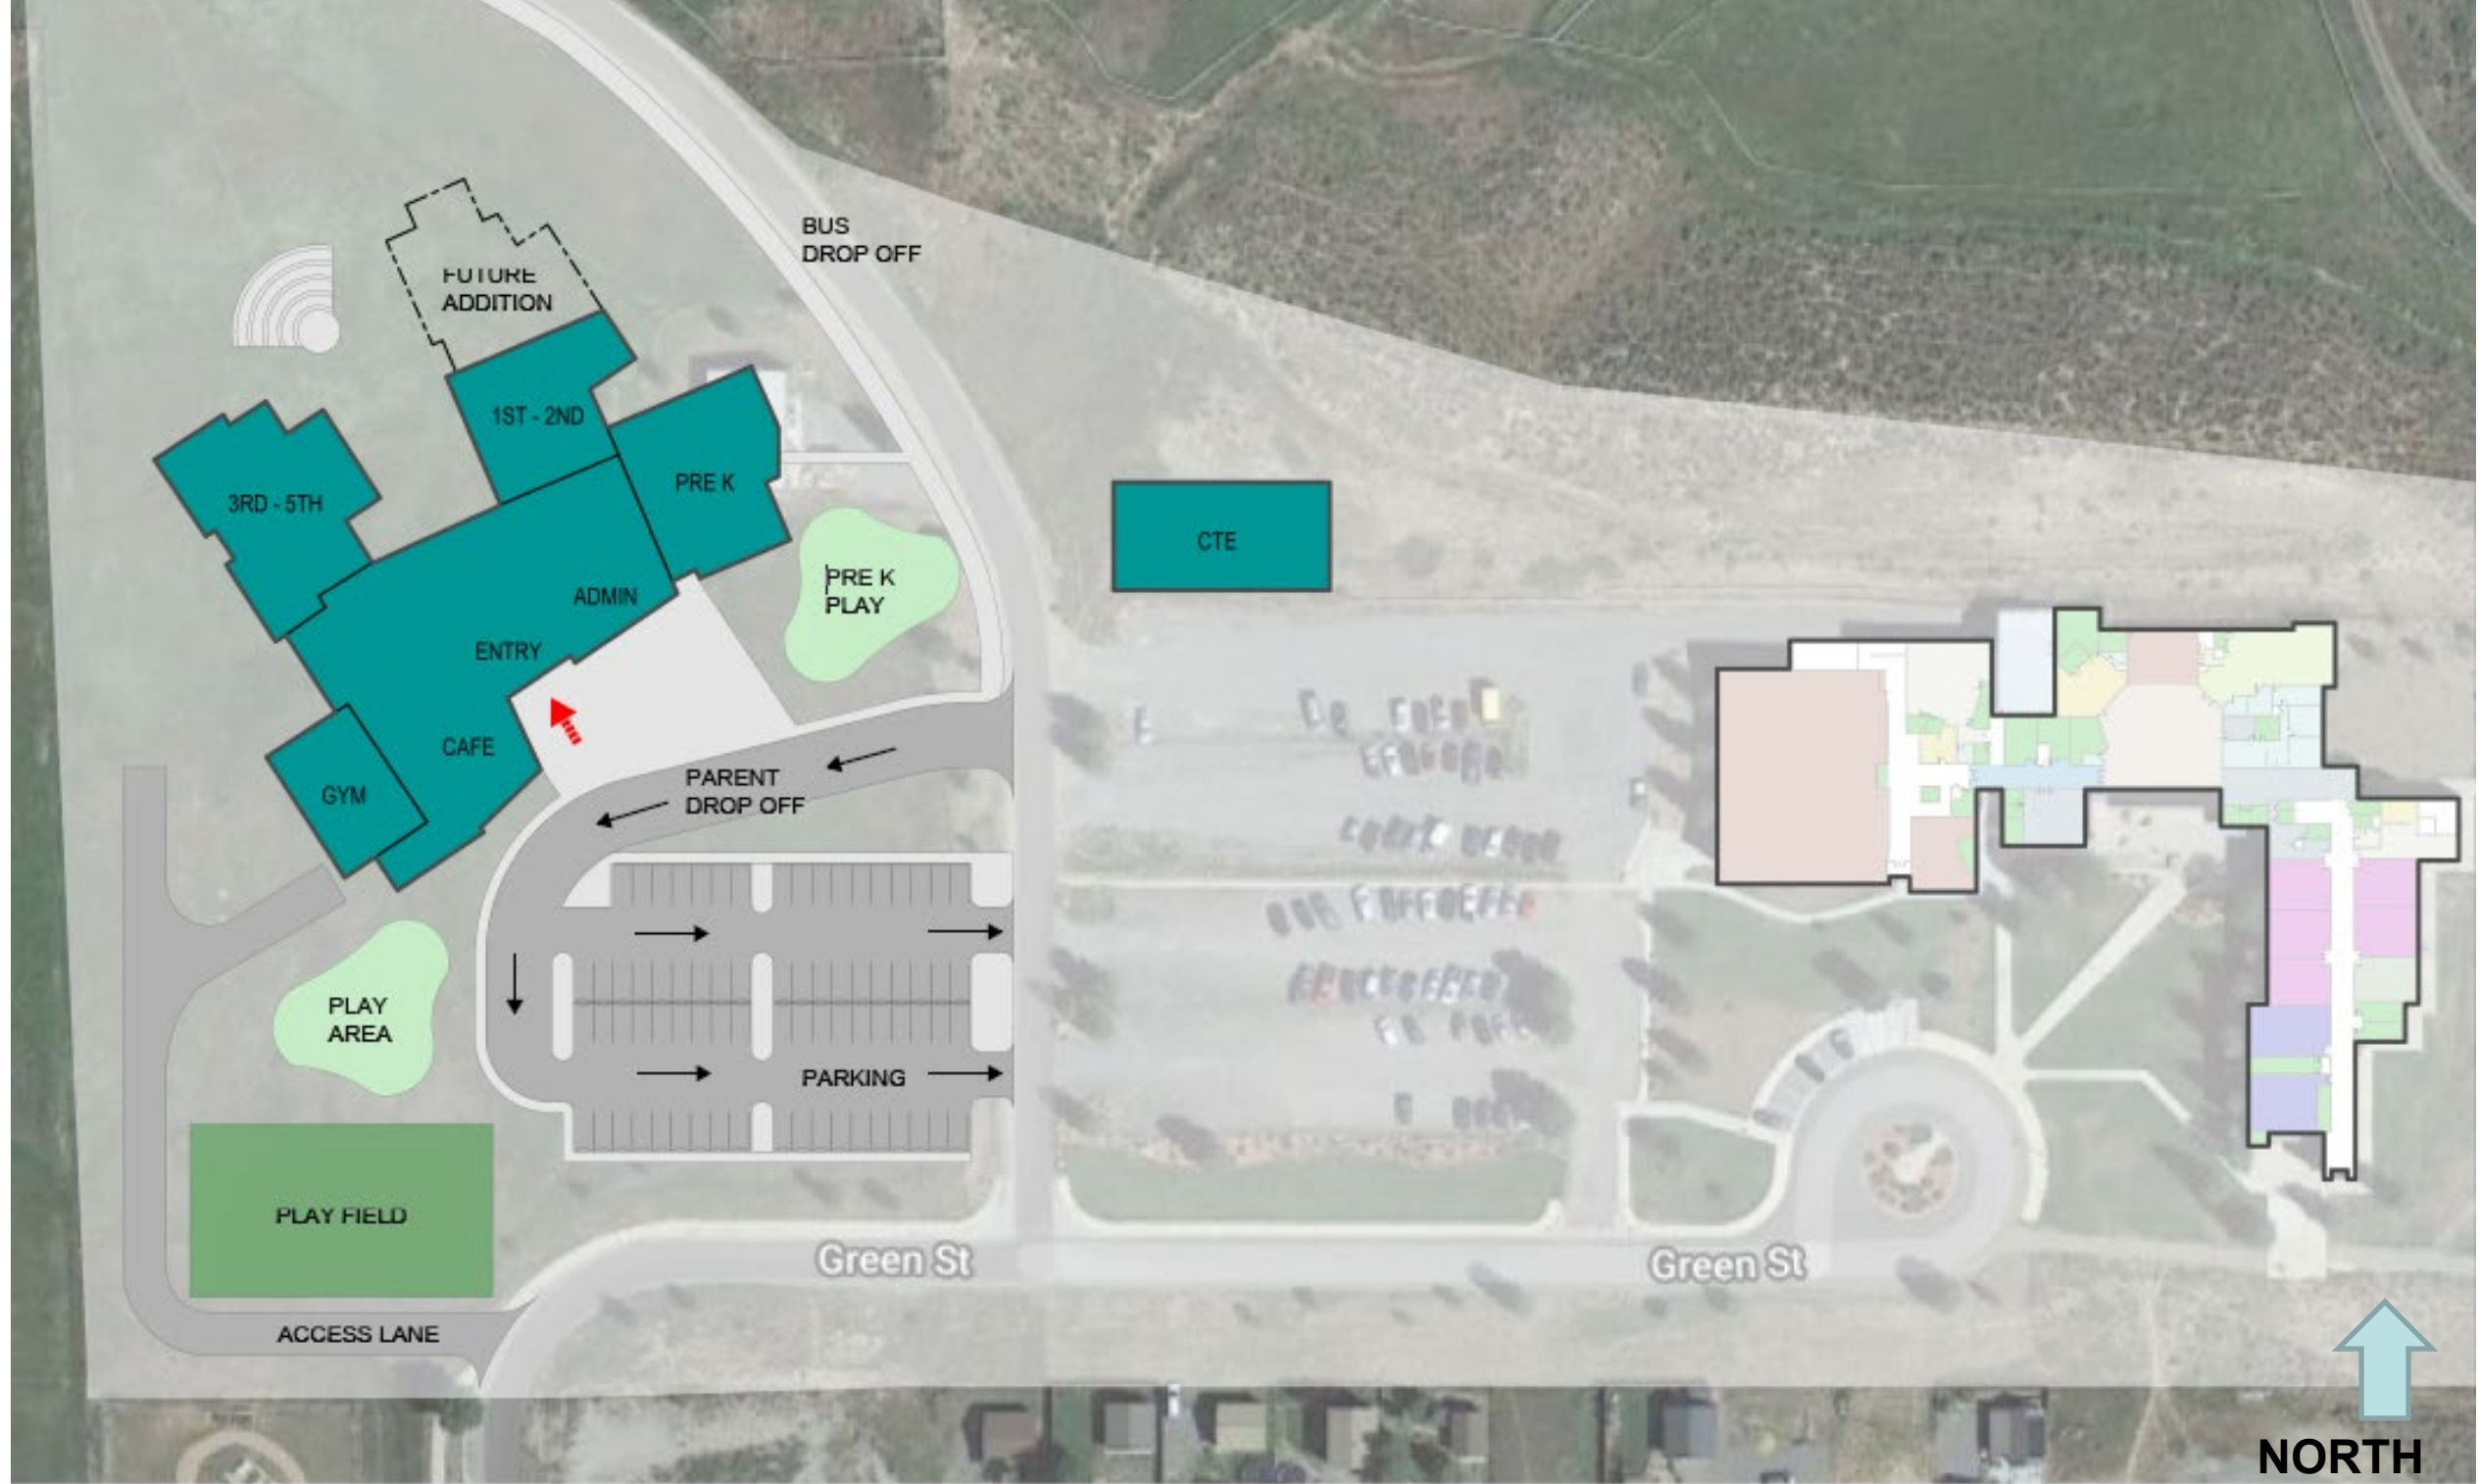
New Building

- Build a new K-5 School on site west of Secondary (225+ Students)
- Shared Campus Parking
- Plan for future expansion
- Building new CTE Program on Secondary Site
- Includes all design features of a new 21st Century School

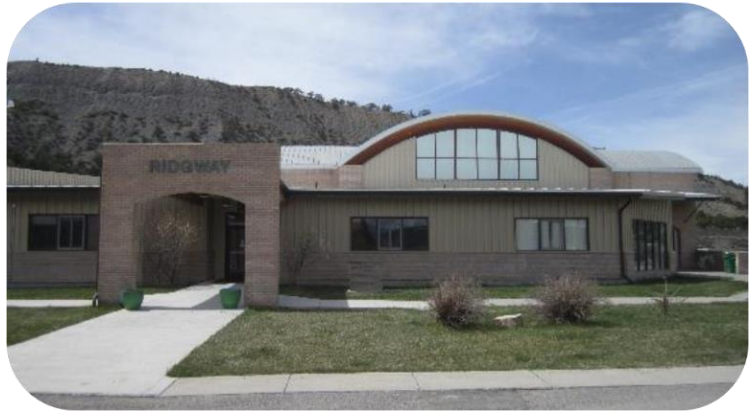
Ridgway Elementary School is located at 1115 Clinton Street in Ridgway, Colorado. The school has a gross floor area of approximately 60,996 square feet and was built in 1972. Electricity for Ridgway Elementary School is supplied by San Miguel Power Association, natural gas is supplied by Black Hills Energy, and both water and wastewater services are provided by the Town of Ridgway.

Although the original building was built in 1972, there was a major addition in 1996. A single electric meter serves the building but the original building and the addition have separate electrical disconnects. The preschool is a separate building and is not included in this report. The main spaces include classrooms, gym, cafeteria, kitchen, media center/library, and offices. Typical hours of operation are 7:00 a.m. to 5:00 p.m. Monday through Friday. The school includes grades pre-K through 5 and is generally occupied from August to May with approximately 157 students and 33 staff during this time. During the summer, the district offices are used, summer cleaning and maintenance takes place, and summer school uses a couple of classrooms during August.

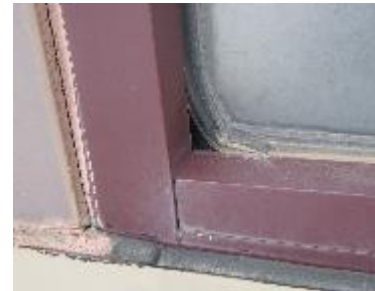
During the site visit a few maintenance and upgrade opportunities were noted. The seals on the library clerestory windows have shrunk and are pulling away from the corners. It is recommended that they be resealed or caulked to prevent moisture damage from rain and snow. The exhaust fan louvers in gym have been screwed shut but are not completely sealed. It is recommended that they be sealed and insulated to prevent air infiltration and heat loss. There is a fan or other equipment running in the locker rooms that are no longer used and it should be turned off if not needed. The supply ductwork in the library does not provide effective conditioning of the space because the supply grills are 25 feet in the air and are aimed horizontally at the wall. It is recommended that 90° transitions be added to the ductwork and that the discharge be lowered to the level of the lights with the grills facing the floor to provide better mixing and conditioning at the occupant level.

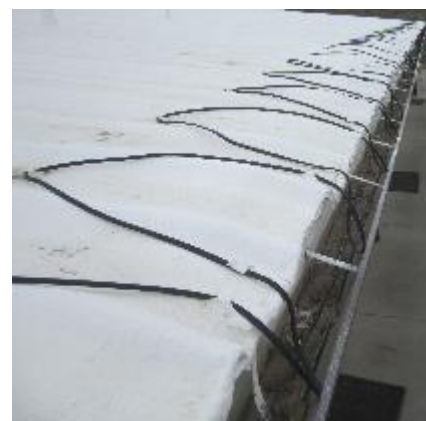
The school has a self-regulating gutter heat tape snow and ice melt system on the north facing gutters that is estimated to have about 400 to 600 feet of heat tape. To reduce electricity consumption, the system should be turned off at the circuit breaker when not needed. Manual control allows for the system to be turned on only when needed but it is only as effective as the operator. The benefit of automated precipitation controls is that they prevent the system from being accidentally left on when not needed or turned off when needed.

Installing a control module would eliminate unnecessary runtime during the winter when moisture is not present. Raychem has optional accessory control modules (model numbers GIT-4 and GIT-3A) that can incorporate moisture sensing and better temperature controls to limit operation to only the times when it is needed. Tekmar and Chromalox also offer gutter and snowmelt system controls.

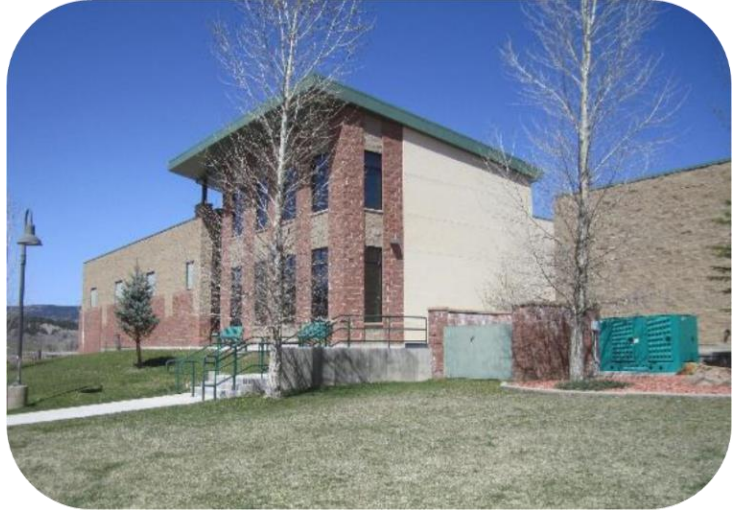
Ridgway Secondary School is located at 1200 Green St. in Ridgway, Colorado. The school has a gross floor area of approximately 46,110 square feet and was built in 2005. Electricity for Ridgway Secondary School is supplied by San Miguel Power, natural gas is supplied by Black Hills Energy, and both water and wastewater services are provided by the Town of Ridgway.

Although the original building was built in 2005, the gym, weight room, and locker rooms were added in 2010. The main spaces include classrooms, cafeteria/commons, kitchen, media center/library, gym, weight room/climbing wall, locker rooms, and offices. The wood shop across the parking lot was not included in this report. Typical hours of operation are 7:00 a.m. to 5:00 p.m. Monday through Friday and the building is also used roughly twice a month on Saturday for other activities. The school includes grades 6 through 12 and is generally occupied from August to May with approximately 170 students and 30 staff during this time. Cleaning and maintenance takes place during the summer and summer school uses a couple of classrooms in August.

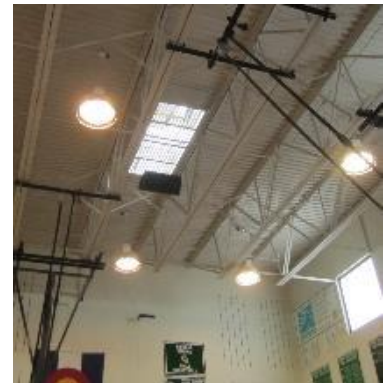
The gym has a large relief hood in the ceiling with motorized dampers. During the site visit, it was noted that the dampers were open approximately 50% and that an electrical buzzing could be heard coming from the hood. It was confirmed that the buzzing was not the lights and it is suspected that dampers are bound and that the buzzing is the motors attempting to close them. School staff reported that in recent memory the dampers have always been open and that snow will blow in through the hood on occasion.

The ERVs do not have full relief potential, meaning that their design exhaust airflow is less than the full outside air (economizer) airflow capability of the RTUs. The design intent of the relief hood is to provide a means for exhausting excess air when the RTU economizer airflow into the gym exceeds the exhaust capability of the ERVs. The sequence of operations for the motorized dampers is likely to open the dampers when the RTU outside air damper (economizer) position exceeds some fixed setpoint, although this was not confirmed in the BAS.

The open and uninsulated relief hood dampers represent a large amount of heat loss during the winter and it is recommended that they be addressed before the next winter. Some potential solutions are listed below:

- Fixing the dampers so they will not bind up
- Installing spring loaded barometric relief dampers
- Adding insulated damper/covers like some whole-house fans have
- Sealing and insulating the relief hood - Before this is done the school should evaluate the potential impact this could have on pressurization of the gym and fresh air changes during large events, such as a game or an assembly. If the building does become overpressurized when the RTU outside air economizer dampers are fully open, then one potential solution could be to limit the maximum outside air damper position. The

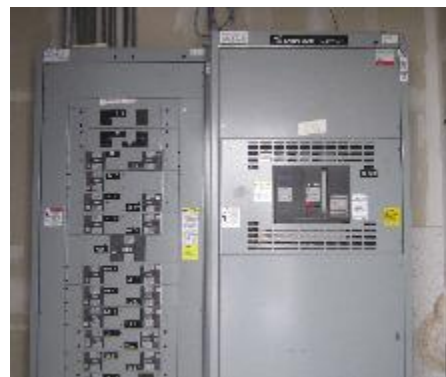
The school is interested in reducing its monthly electric demand (kW) and the associated charges. It is recommended that electric demand monitoring equipment, such as an eGauge, be installed to provide the necessary information to inform demand reduction strategies. eGauge is an affordable, flexible, secure, web-based meter that can measure and record total building electric power and energy consumption. Schools can view their real-time and historical data on a web-based

dashboard that can be accessed from any web-enabled device. The display is updated every second, giving immediate feedback on any load or generation changes and the device records the most recent 30 years of data in its built-in solid-state memory. These devices are being provided to eight schools participating in the Colorado Energy Office Energy Savings for Schools Program and will be permanently installed in these schools to illustrate the energy use data of the schools in real time. Students and school staff will be able to analyze their energy use to supplement science and sustainability curriculum and also to inform decision making relative to energy management and building systems.
