# IGNACIO ELEMENTARY SCHOOL

Retro-Commissioning Report\_DRAFT 2

November 2024

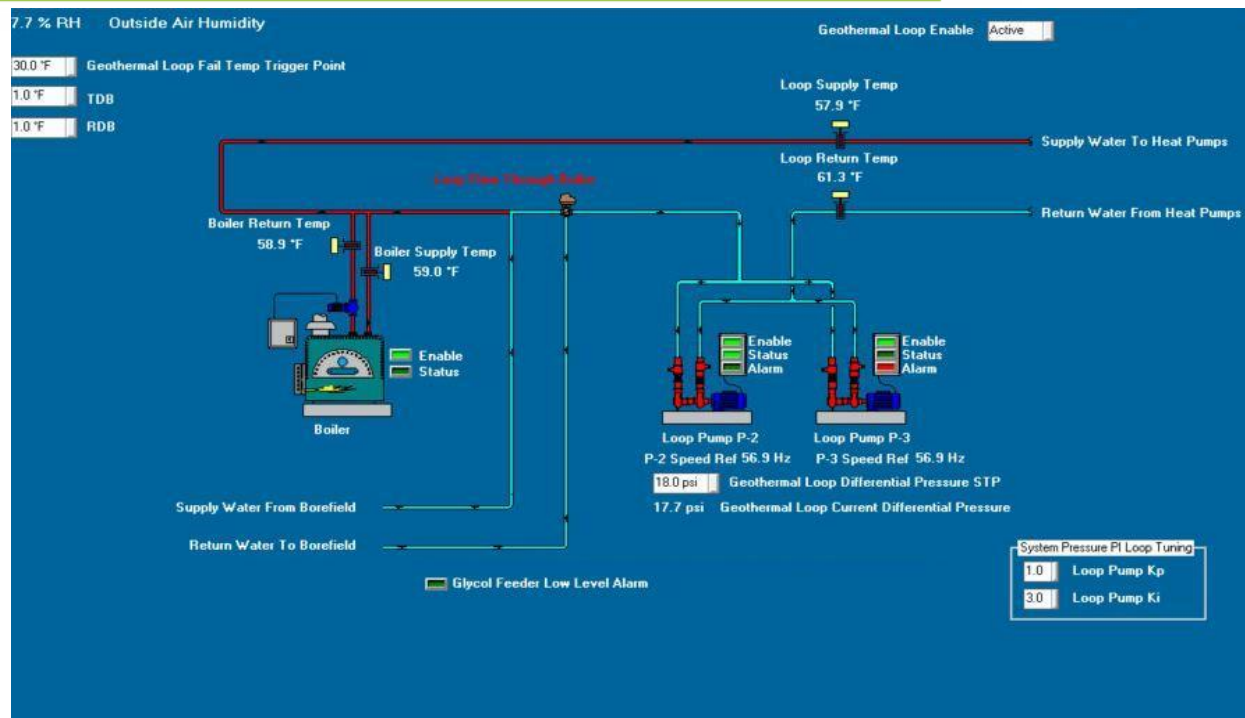
# Heating Hot Water and Geothermal System Assessment

## Overall Condition: Good (B-)

The geothermal system consists of 7-pipe supply and return groundwater manifolds. The ground loop is the primary source of heating and cooling for the building. The heating hot water plant is located in a mechanical space and is operated as a supplemental heating source to the closed loop geothermal system. The boiler piping ties into the main distribution piping via a three-way valve. The valve modulates to maintain the heating water supply temperature setpoint. The plant consists of one 3500 MBH condensing, gas-fired boiler with an in-line boiler pump. Two base-mounted pumps provide heating and cooling water distribution to water source heat pumps.

The pressure gauge at P-1 inlet is not operational. Recommend repair or replacement of gauge.

Multiple piping fittings and accessories were not insulated. Recommend installing insulation at all pipe fittings and accessories.

After replacement of control valves and autoflow valve orifices as recommended, reset distribution loop differential setpoint to 6-8psi.

To accommodate higher flow rates through heat pumps as recommended in the Appendix, it is recommended that the existing Bell and Gossett model 1510-2.5AB distribution pumps be replaced with Bell and Gossett Model 1510-3AC pumps. Size pumps for 515 gpm at 100 ft. HD. Program new pumps to operate in a lead/lag configuration.

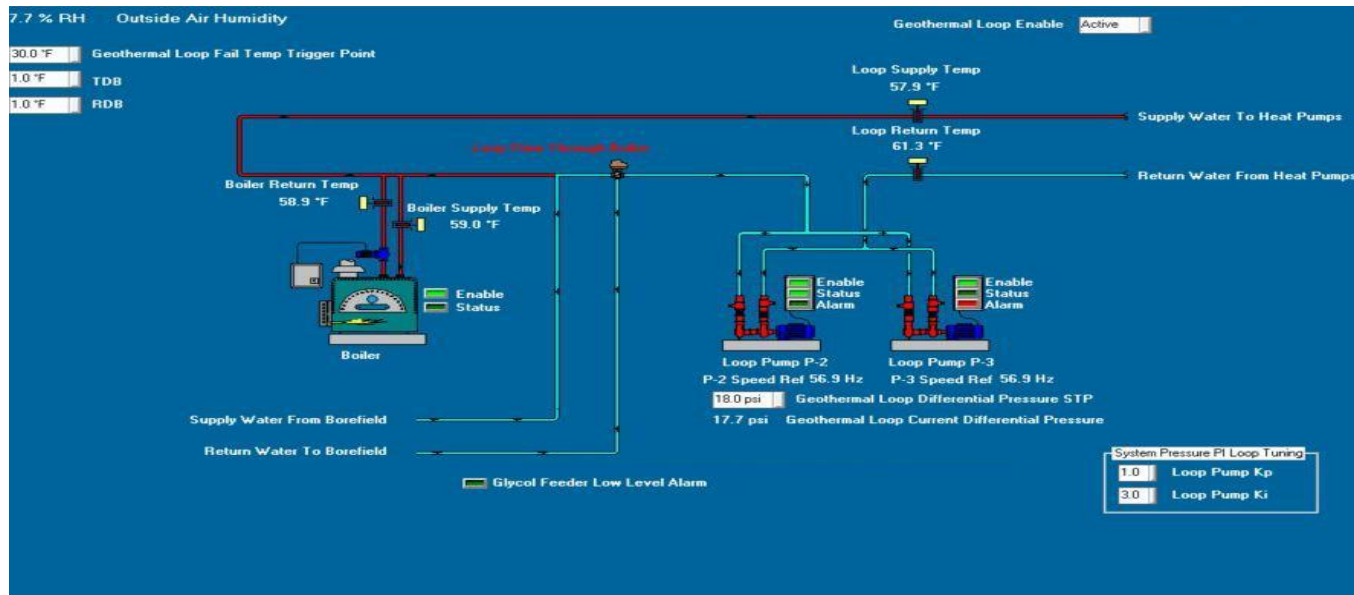
# Heat Pump System Assessment

## Overall Condition: D

The elementary school has experienced continuous issues with heat pump compressor, coil, reversing valve, and board failures.

The scheduled flow rate for the heat pumps appears to be based on the calculated cooling capacity. The installed heat pump in most cases is a nominal size larger than the calculated capacity. Many of the heat pump flow rates are less than the optimal 3 gpm/ton. Many of the heat pumps in the elementary school are less than 2 gpm/ton. Increasing the flow rate to each individual heat pump will improve reliability, function, and equipment durability. This can be accomplished by replacing the orifice or entire flow cartridge with the desired flow rate as determined by the manufacturer. See figure. The flow to each heat pump is limited by a Hays autoflow valve. The diaphragm and orifice are set from the factory to the designated flow rate. To increase the flow output of each valve the diaphragm and orifice can be replaced by a new factory set cartridge at the higher flow rate. Farnsworth Group recommends increasing the flow rate to each heat pump by replacing the flow cartridge of all heat pumps in the elementary school. RE Appendix A for recommended flow rates.
