# IGNACIO HIGH SCHOOL

Retro-Commissioning Report\_DRAFT 2

November 2024

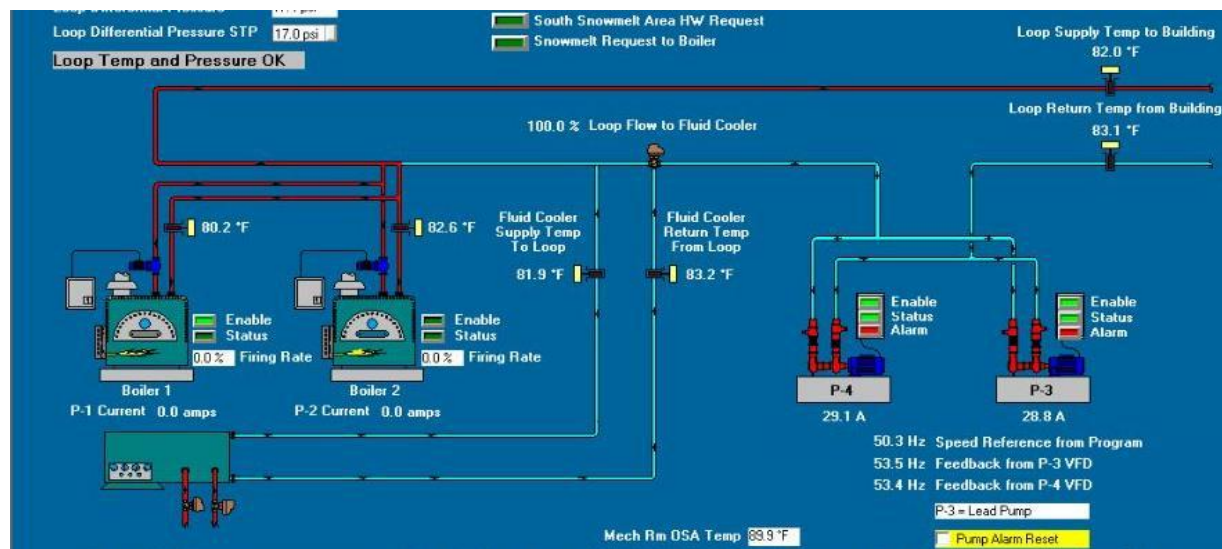
The heating hot water plant is located in the mechanical space near the southwest corner of the building. It consists of two 3500 MBH condensing, gas-fired boilers with in-line boiler pumps. Two base-mounted pumps provide heating and cooling water distribution to water source heat pumps. A 250-ton evaporative fluid cooler provides cooling and ties into the distribution system via a three-way valve.

To accommodate higher flow rates through heat pumps as recommended in the Appendix, it is recommended that the existing sequence of operation for the secondary pumps be edited to operate in a lead/lag configuration to provide additional capacity and redundancy. Reset the distribution loop differential pressure setpoint to between 6-8 psi.

A scheme check was performed on the heating water and distribution system against drawings provided by Mechanical, Electrical, & Environmental Engineering Inc. dated 12/9/2013. No pressure/temperature ports are installed within the mechanical space. Recommend installing p/t ports at locations provided in design drawings.

Maintain routine boiler inspection schedule provided by manufacturer, check pump belt tensions/alignment, provide pump belt replacement schedule, provide user interface for on-site maintenance control of space set-points, develop consistent nomenclature for service and tracking.
