IGNACIO MIDDLE SCHOOL

Retro-Commissioning Report_DRAFT 2

November 2024

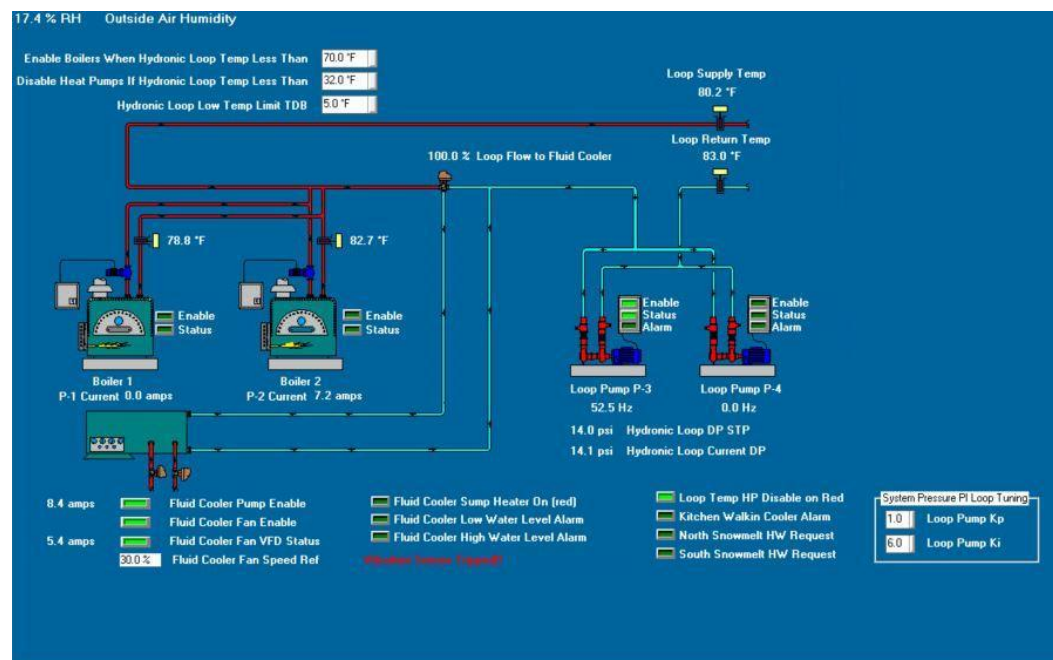
Heating Hot Water and Fluid Cooler System Assessment

Overall Condition: Fair (B+)

The heating hot water plant is located in the mechanical space adjacent to the kitchen in the northwest corner of the building. It consists of two 3500 MBH condensing, gas-fired boilers with in-line boiler pumps. Two base-mounted pumps provide heating and cooling water distribution to water source heat pumps. A 210-ton evaporative fluid cooler provides cooling and ties into the distribution system via a three-way valve.

Pump speed may exceed 60 hz if overall flow to heat pumps is increased. The existing pumps will accommodate the increased flow rate through the heat pumps recommended in the Appendix of this document.

Maintain routine boiler inspection schedule provided by manufacturer, check pump belt tensions/alignment, provide pump belt replacement schedule for distribution pumps.

It is recommended that the sequence of operation for the pumps be adjusted to a lead/standby configuration to provide redundancy and energy savings.

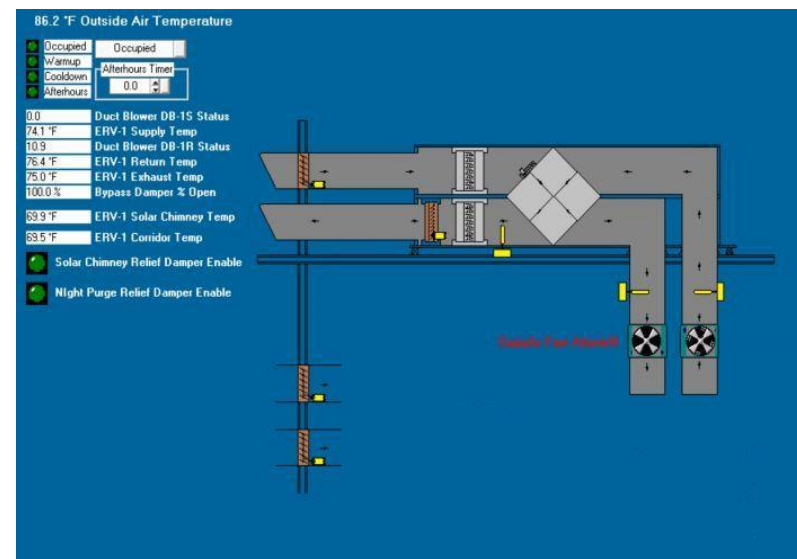
The ERVs were not on an occupancy schedule and appear to operate 24/7. Recommend putting ERVs on a schedule to disable during unoccupied hours. This will result in fan energy savings.
