Bus Barn

**1002 Colorado Ave,
Montrose, CO 81401**

Description of Facility: Facilities, Custodial, Food Service Offices, Maintenance Shops, and District warehouse

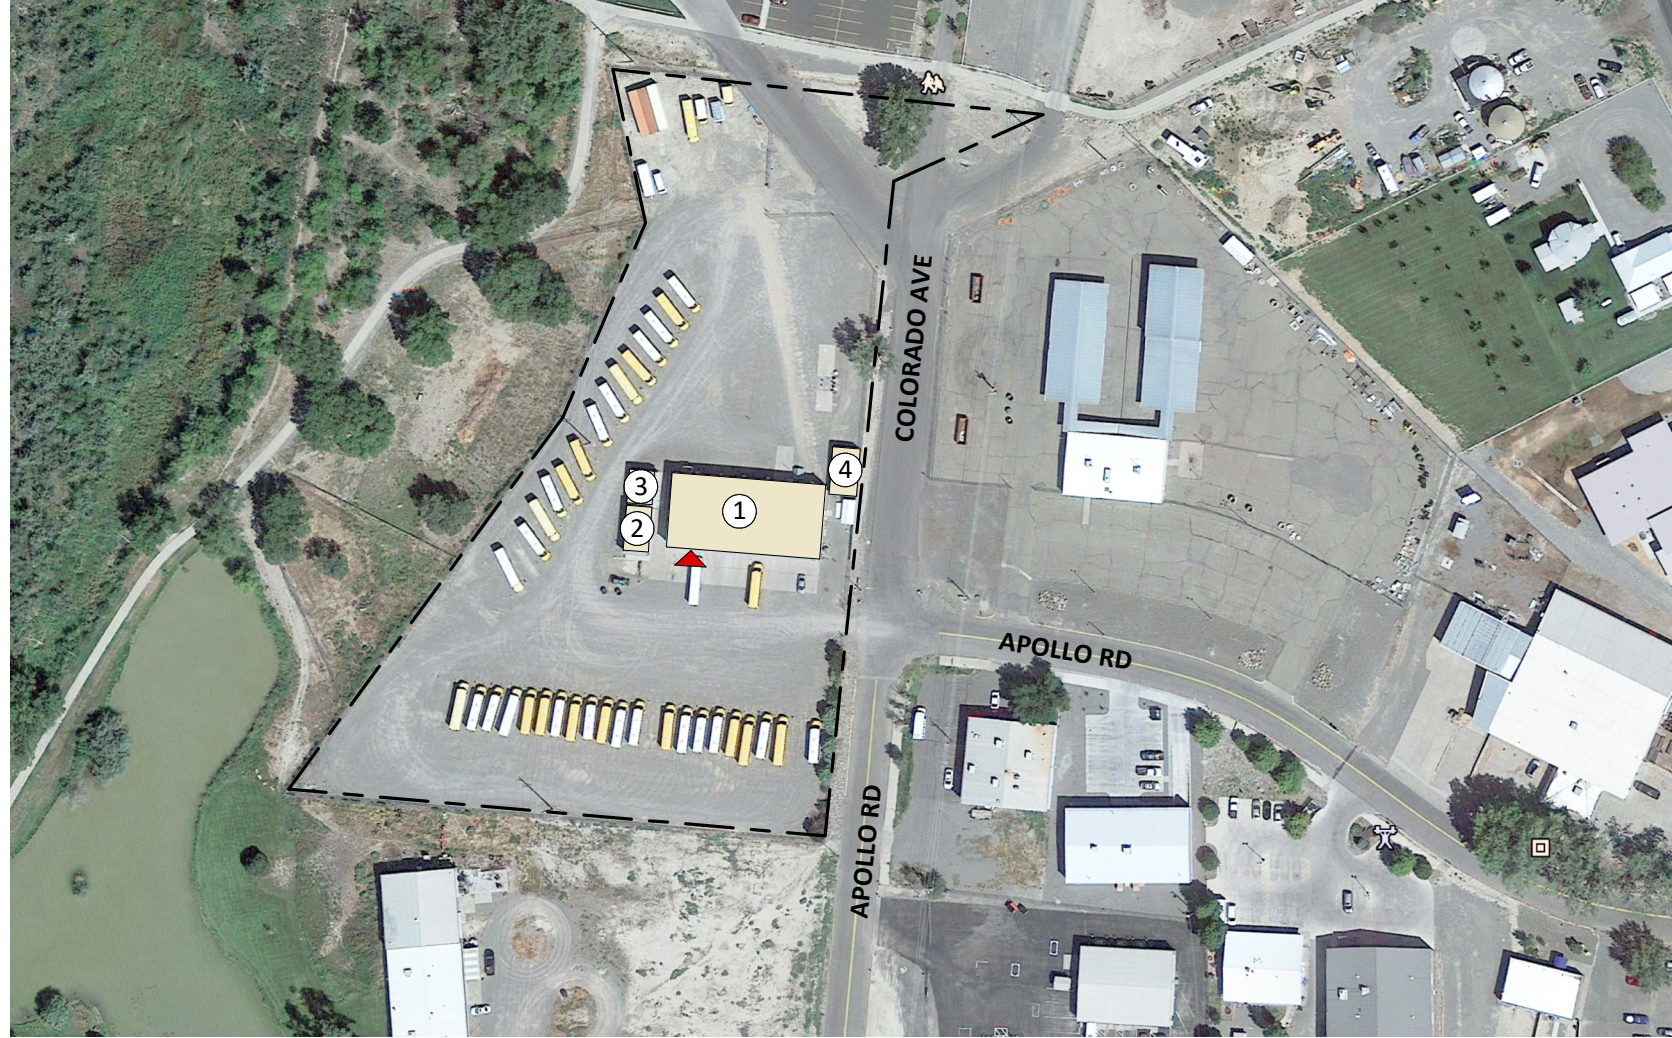
BUS BARN

- 1. BUS BARN
- 2. FREEZER A
- 3. COOLER B
- 4. TRAINING ROOM

SITE PLAN LEGEND
