# PEAK VIRTUAL ACADEMY

**529 North 6th Street  
Montrose, CO 81401**

**Campus Summary:** A “hybrid” learning school, Peak Virtual Academy occupies an older wood-framed building less than a block from Northside Elementary School. Currently serving students in grades 3-12, it is expected to see an increase in enrolment over the next few years; factors other than overall district-wide grade-level student count (i.e., the potential desire for more remote/hybrid learning) could cause additional growth. The bulk of the administrative and teaching functions happen in the main building; the “Carriage House” near the alley is an open study area, typically for younger students, and the math and science are taught in the modular building.

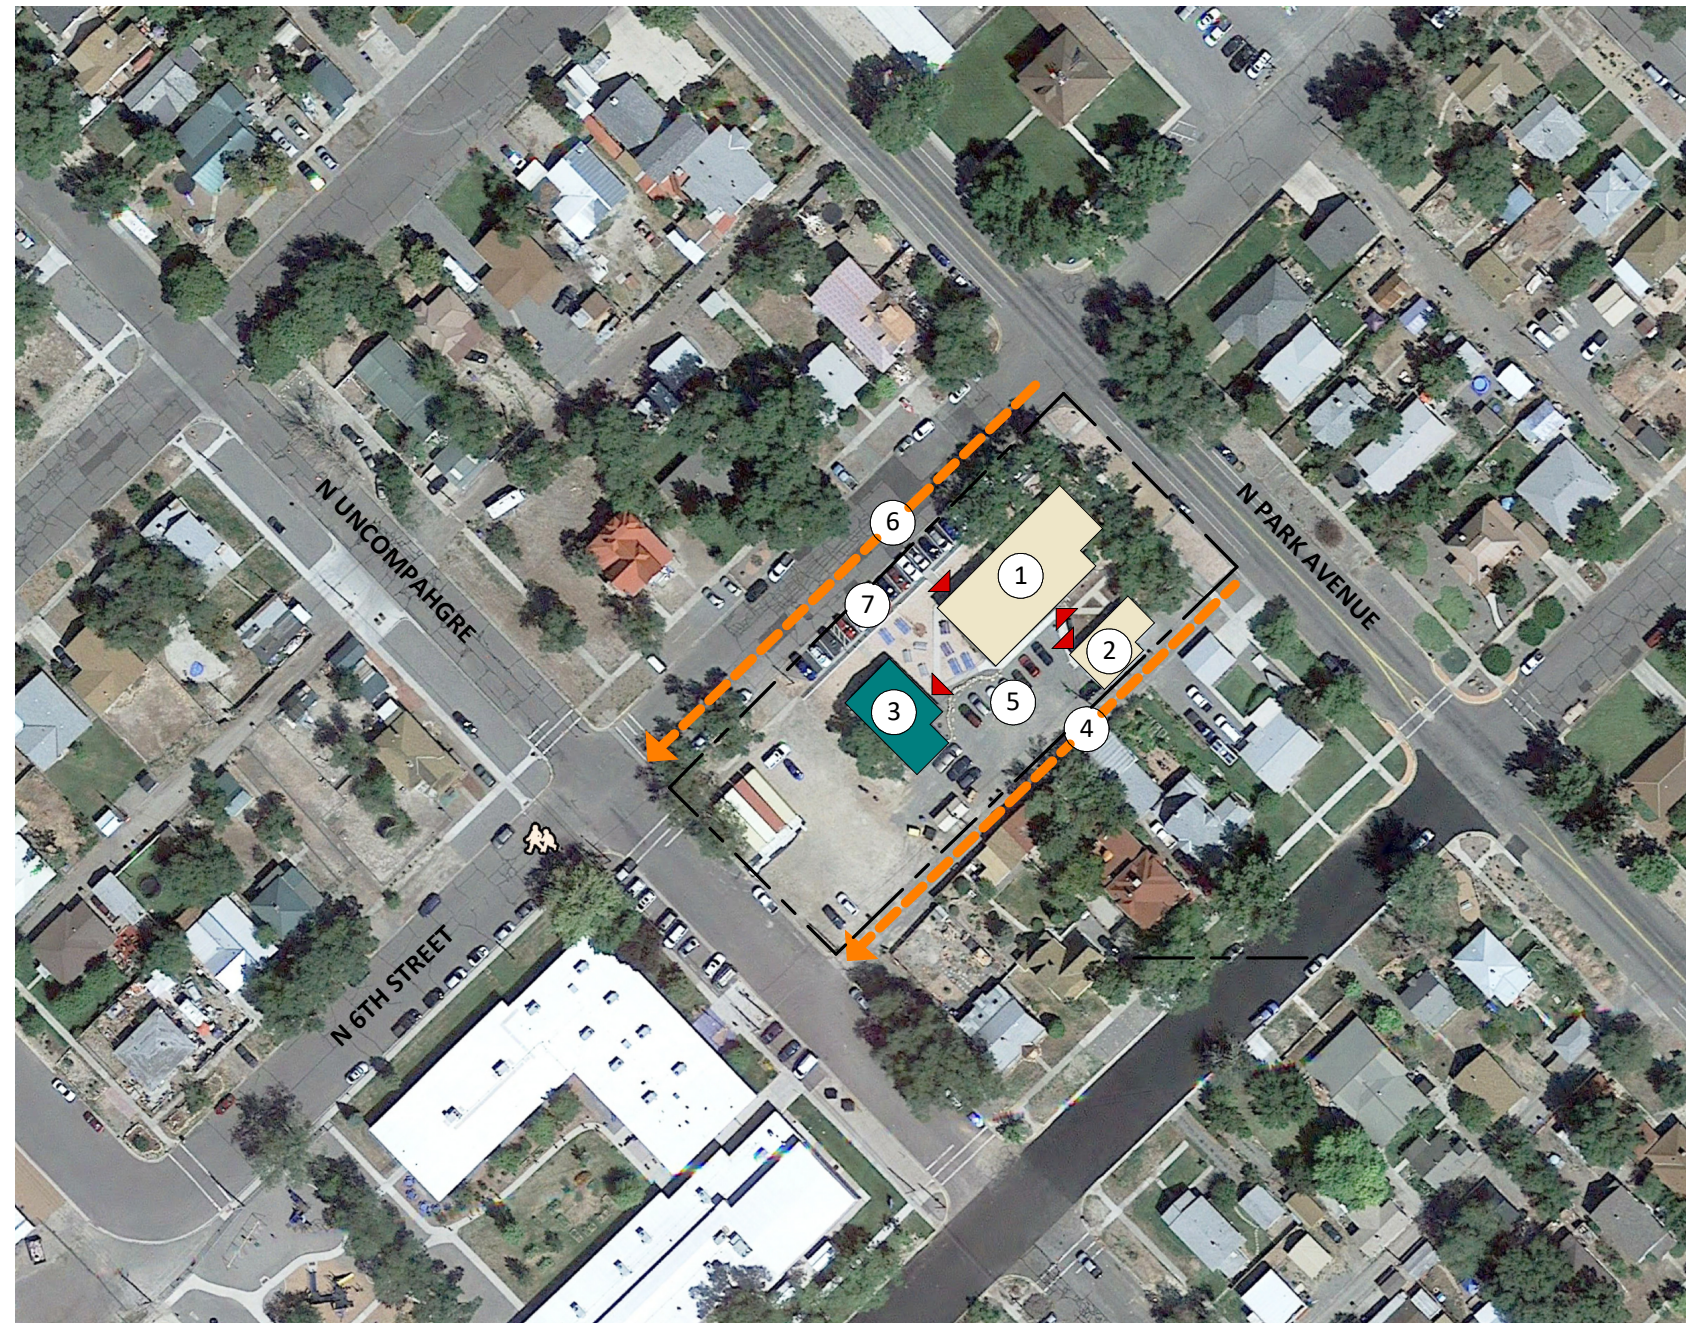
**SITE PLAN**

1. PEAK VIRTUAL ACADEMY BUILDING
2. KINDEGARTEN AND STUDENT SERVICES
3. MODULAR 41
4. PARENT DROP OFF / PICK-UP 3RD - 5TH
5. STAFF PARKING
6. PARENT DROP OFF / PICK-UP 6TH - 12TH
7. PARENT PARKING

- SITE BOUNDARY
- PERMANENT BUILDING FOOTPRINT
- MODULAR BUILDING FOOTPRINT
- PARENT PICK-UP / DROP-OFF LOOP
- MAIN ENTRY

Approximately 20 paved on-street parking spaces are provided perpendicular to 6<sup>th</sup> Street, requiring vehicles to back in the street. A smaller parking area lot is gravel and contiguous with the gravel

alley running southwest to northeast between Uncompahgre and Park. An open space between the main building and the modular contains several picnic tables. The school has been addressing accessibility issues on the site. There is no significant play area on the site.

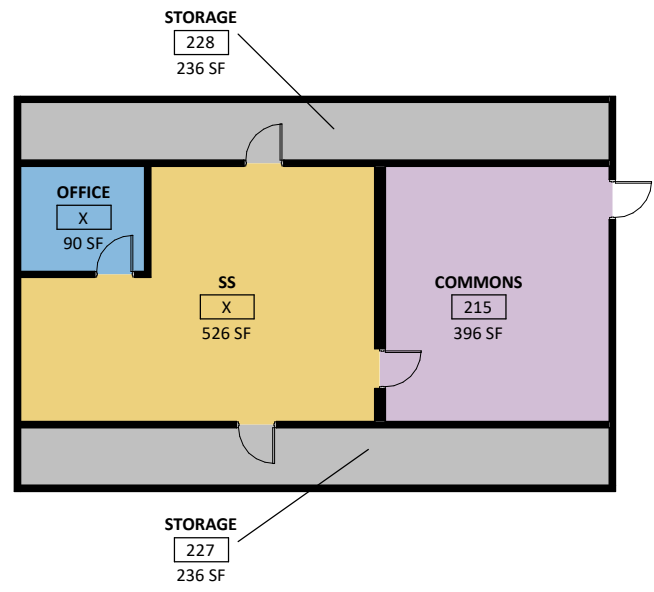
## SECOND FLOOR PLAN - CAPACITY

1/16" = 1'-0"

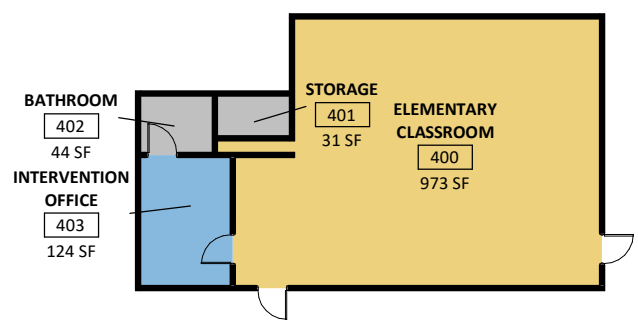
## FIRST FLOOR PLAN - CAPACITY

1" = 20'-0"

- Administration
- Art / Music
- Breakout Instruction / Intervention
- Computer Lab / STEM
- Dining/Commons
- Instructional Areas
- Library
- PE/Athletics
- Special Education
- Support

- Existing Walls
- TEST FIT Program Blocks
- New Entry Points

*NOTE: Plans shown are for TEST FIT purposes only. All future improvements are subject to stakeholder input through a future planning process.*
