Pomona Elementary School

1045 South Cascade. Montrose, CO 81401

Year Built: Library – 1920, Building B – 1961, Art Building 1978, Main Building 1992 & 2007

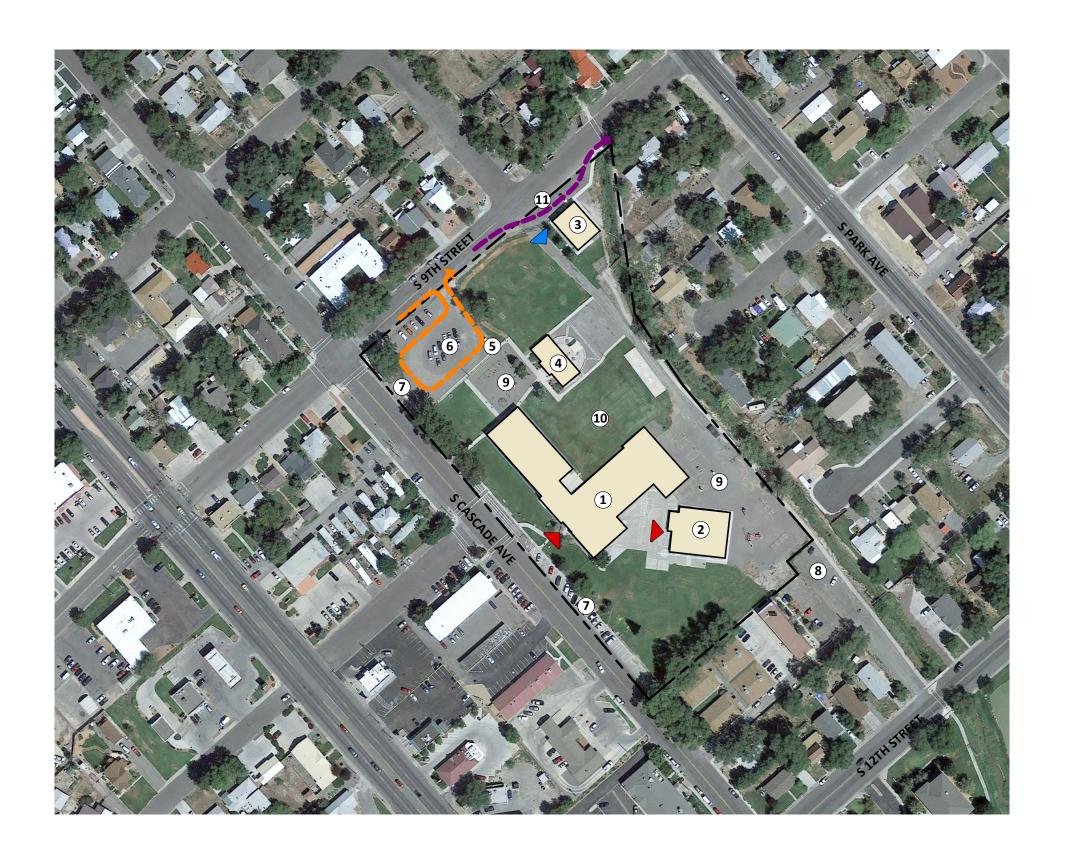
POMONA ELEMENTARY

scale: 1" = 160'-0"

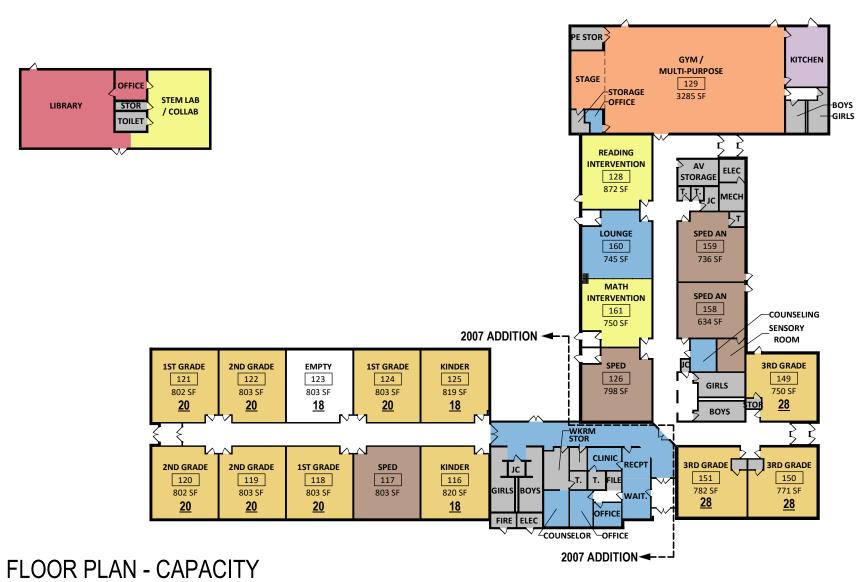
CLASSROOM CAPACITY DISTRICT CDE CDE CAPACITY SF/PUPIL CAPACITY 1ST GRADE 803 SF 1ST GRADE 121 802 SF 32 32 1ST GRADE 124 803 SF 20 1ST GRADE: 3 2408 SF 2ND GRADE 803 SF 119 20 32 2ND GRADE 120 802 SE 20 2ND GRADE 122 803 SF 2ND GRADE: 3 3RD GRADE 149 750 SF 150 3RD GRADE 771 SF 3RD GRADE 151 782 SF 3RD GRADE: 3 2303 SF 4TH GRADE 201 910 SF 4TH GRADE 202 896 SF 203 30 4TH GRADE 891 SF 4TH GRADE: 3 2697 SF 5TH GRADE 204 893 SF 28 5TH GRADE 205 901 SF 30 30 5TH GRADE 206 904 SF 5TH GRADE: 3 2698 SF 123 803 SF EMPTY: 1 803 SF KINDER 820 SF 18 22 38 125 22 KINDER: 2 1638 SF

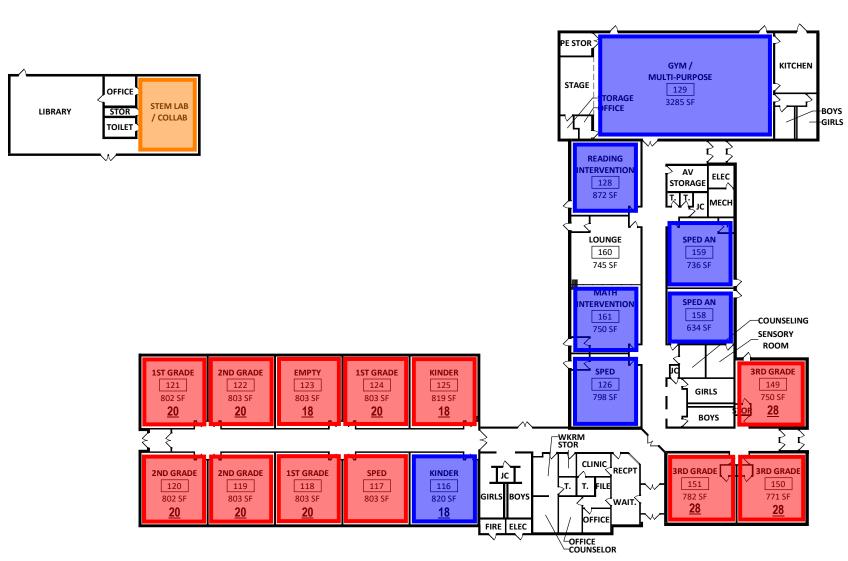
3 Track Classroom **Spaces Educational Support** Spaces **Educational Support** Spaces in Separate Classroom Buildings Total Educational 28 Spaces
